Inspection Report

Cylinder liner inspection, Anonymous vessel @
142,394 Engine hours

Daniel Grunditz
Tel: +46 702 276900
daniel.grunditz@chris-marine.com

August 31st 2020

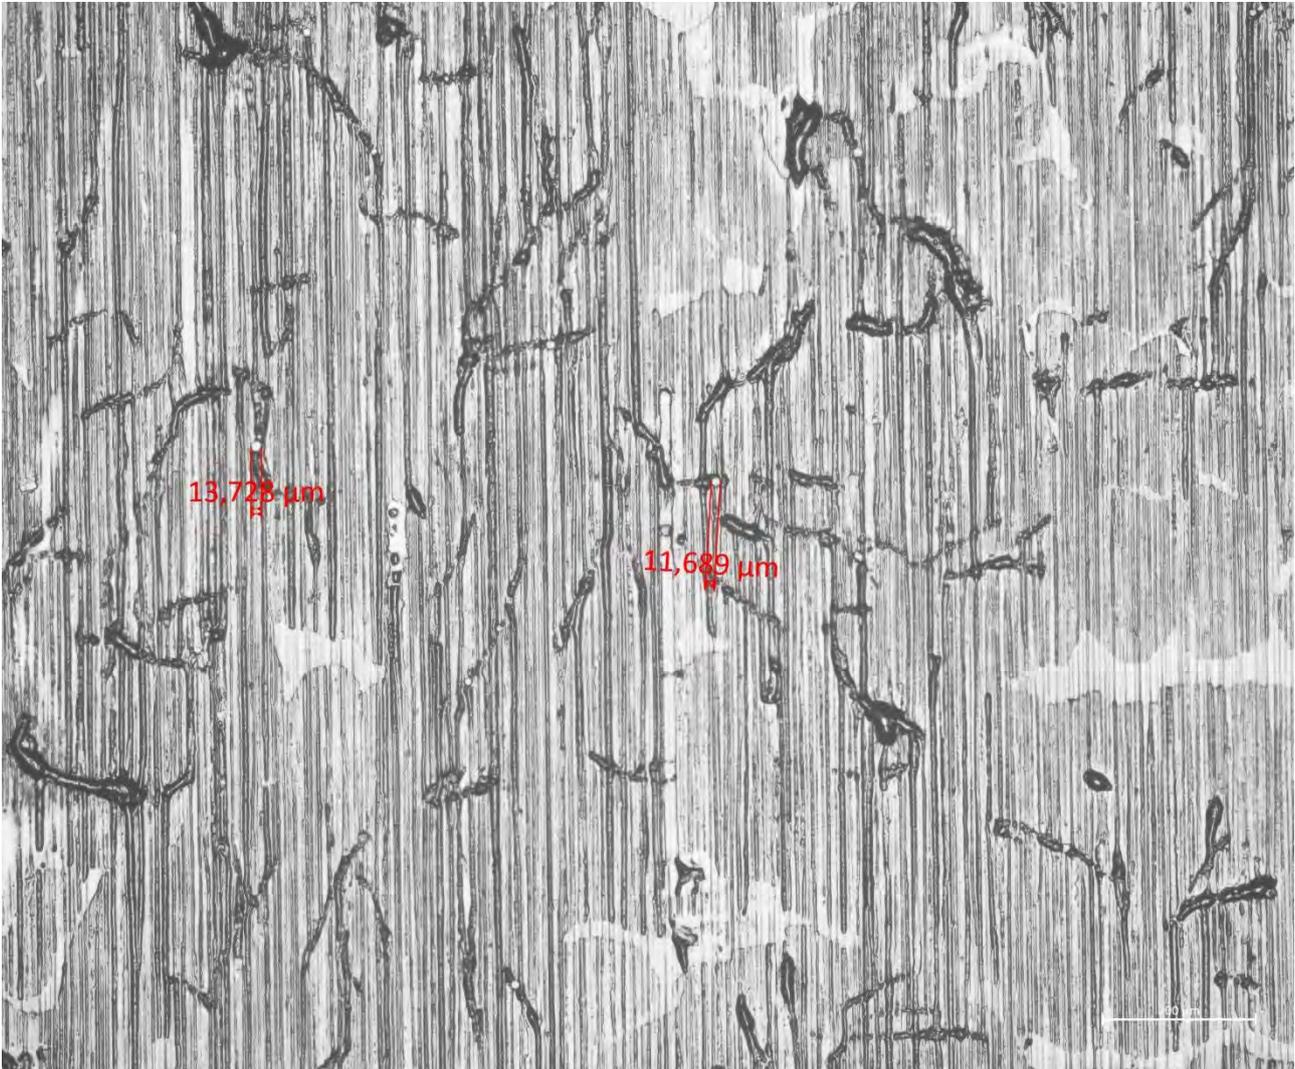
Cylinder #1 - 10x magnification

Observations: Normal, abrasive wear pattern and open graphite structure. A few visible cat fines, the largest being 14 microns.

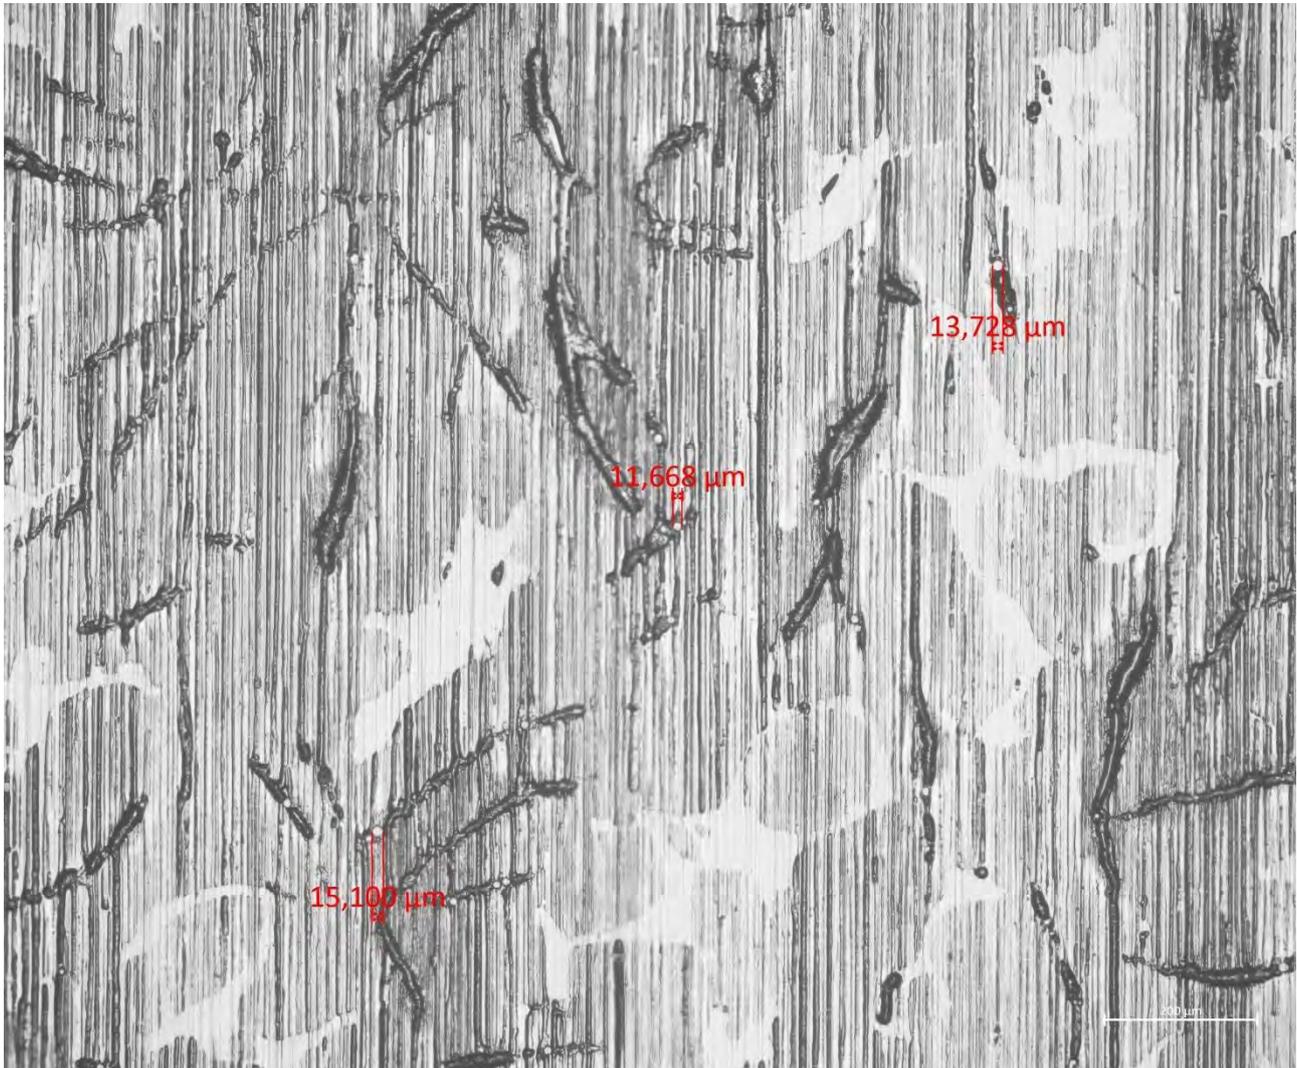
Cylinder #2 - 10x magnification

Observations: Normal, abrasive wear pattern and open graphite structure. A few visible cat fines, the largest being 15 microns.

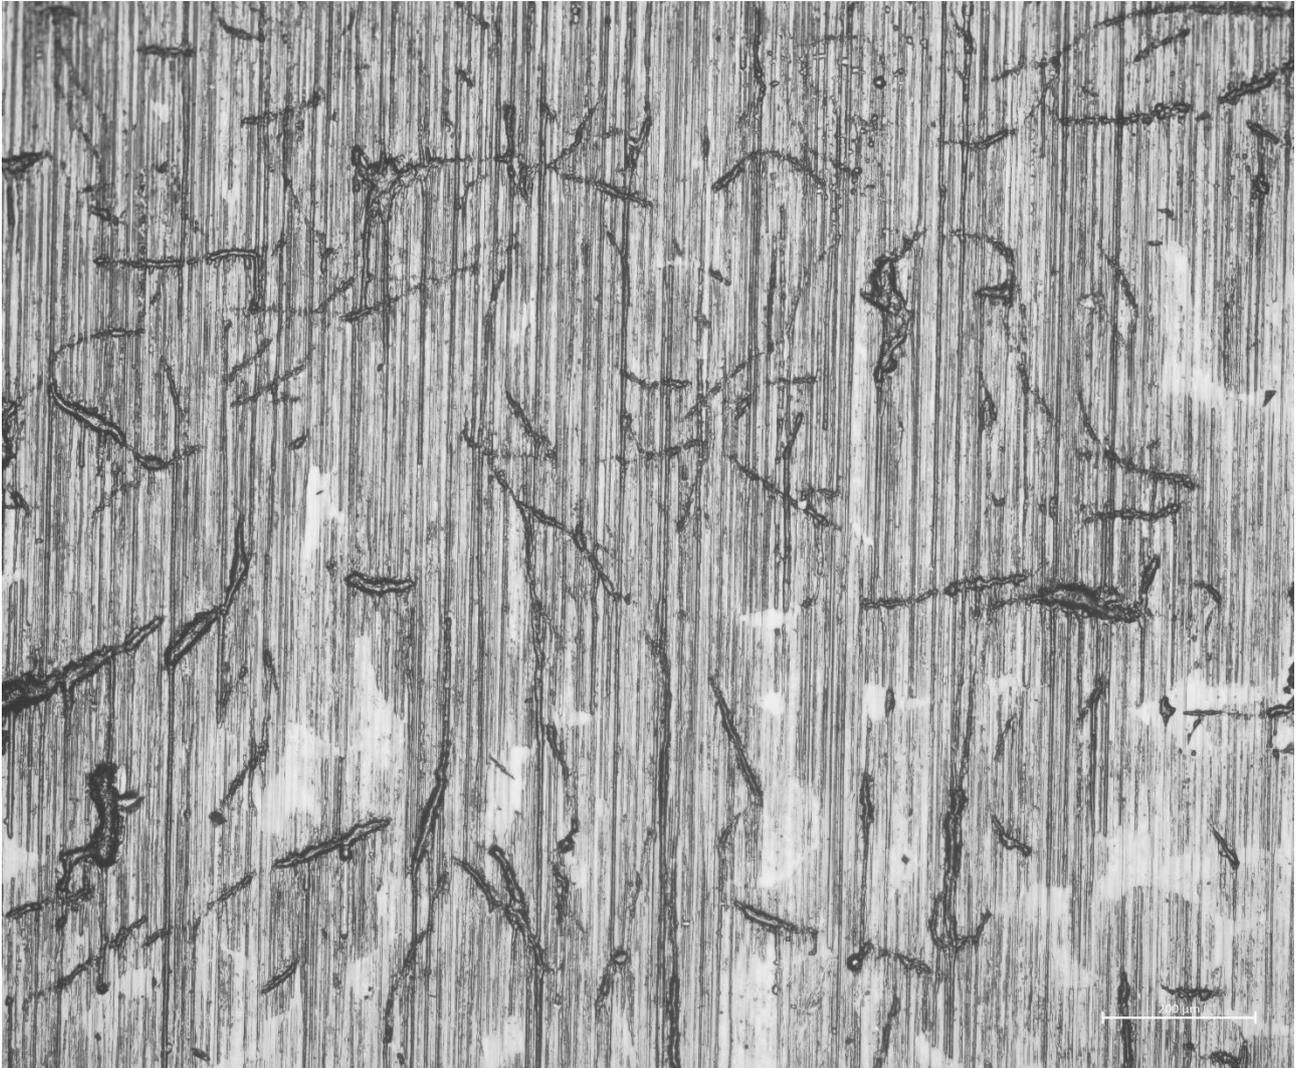
Cylinder #3 - 10x magnification

Observations: Normal, abrasive wear pattern and open graphite structure. No visible cat fines.

- Honing and optionally also wave-cut grinding or replacement of unit #3 should be planned as soon as possible, as the cylinder condition is likely to deteriorate in the near future.

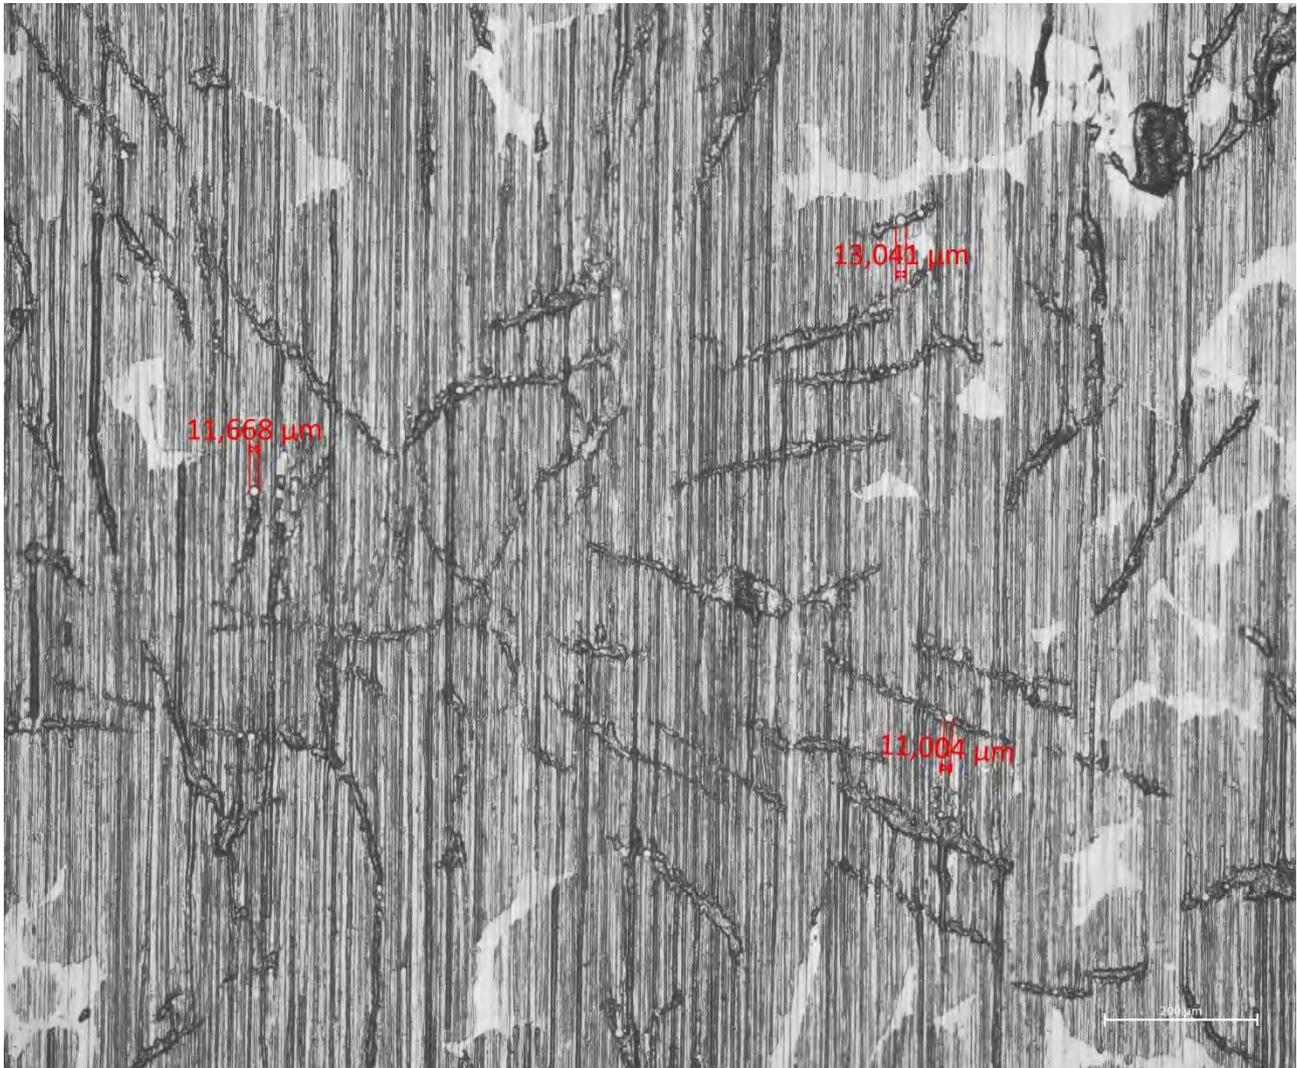
Cylinder #4 - 10x magnification

Observations: Normal, abrasive wear pattern and open graphite structure. A few visible cat fines, the largest being 13 microns.

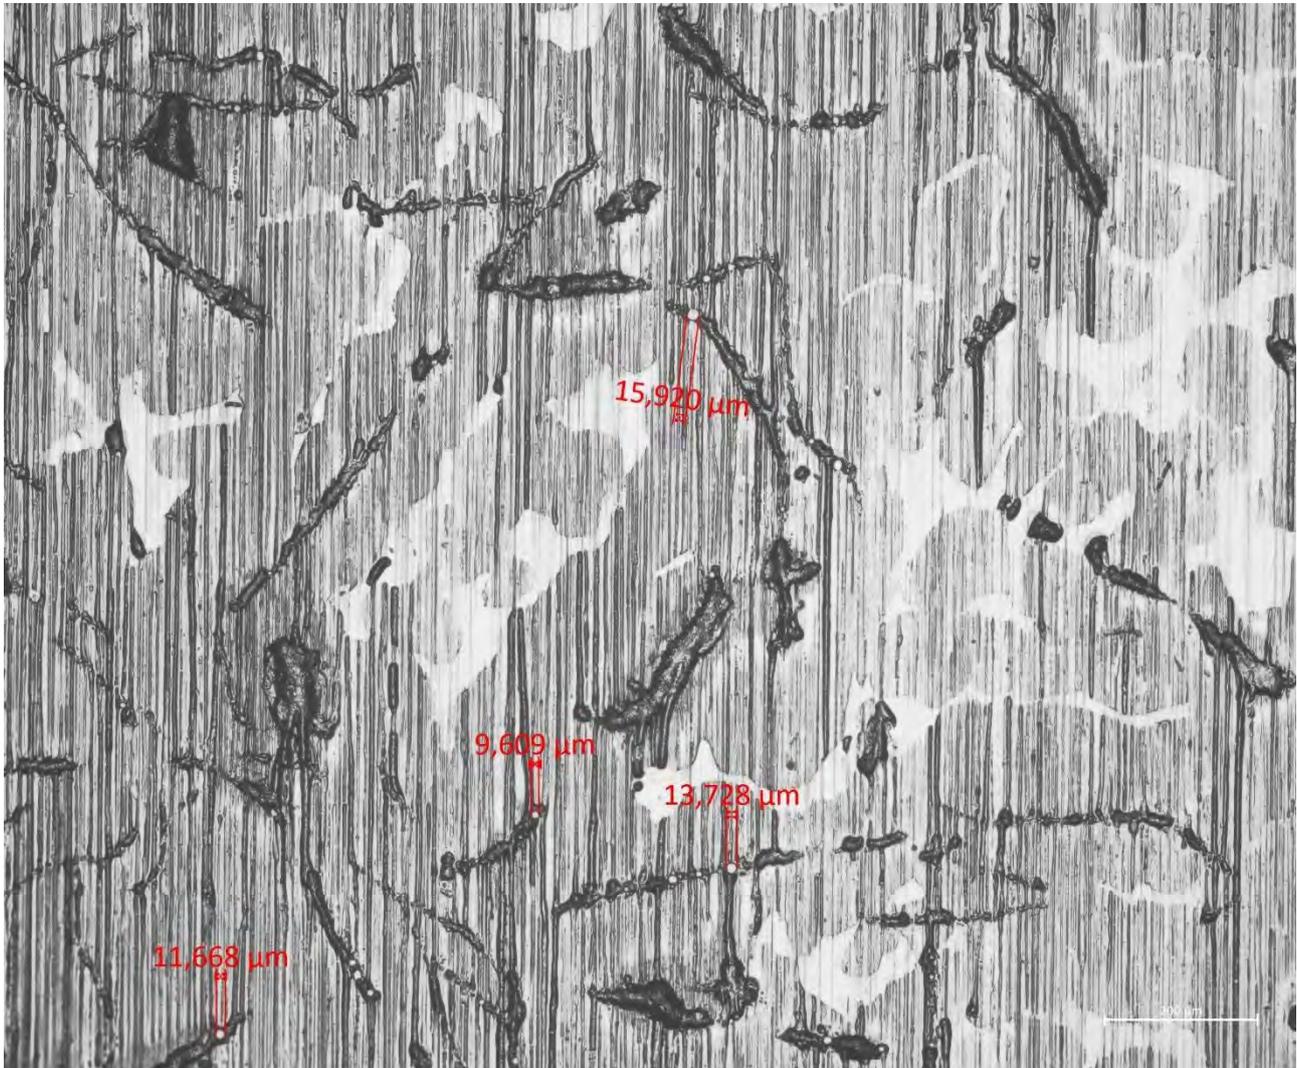
Cylinder #5 - 10x magnification

Observations: Normal, abrasive wear pattern and open graphite structure. A few visible cat fines, the largest being 16 microns.

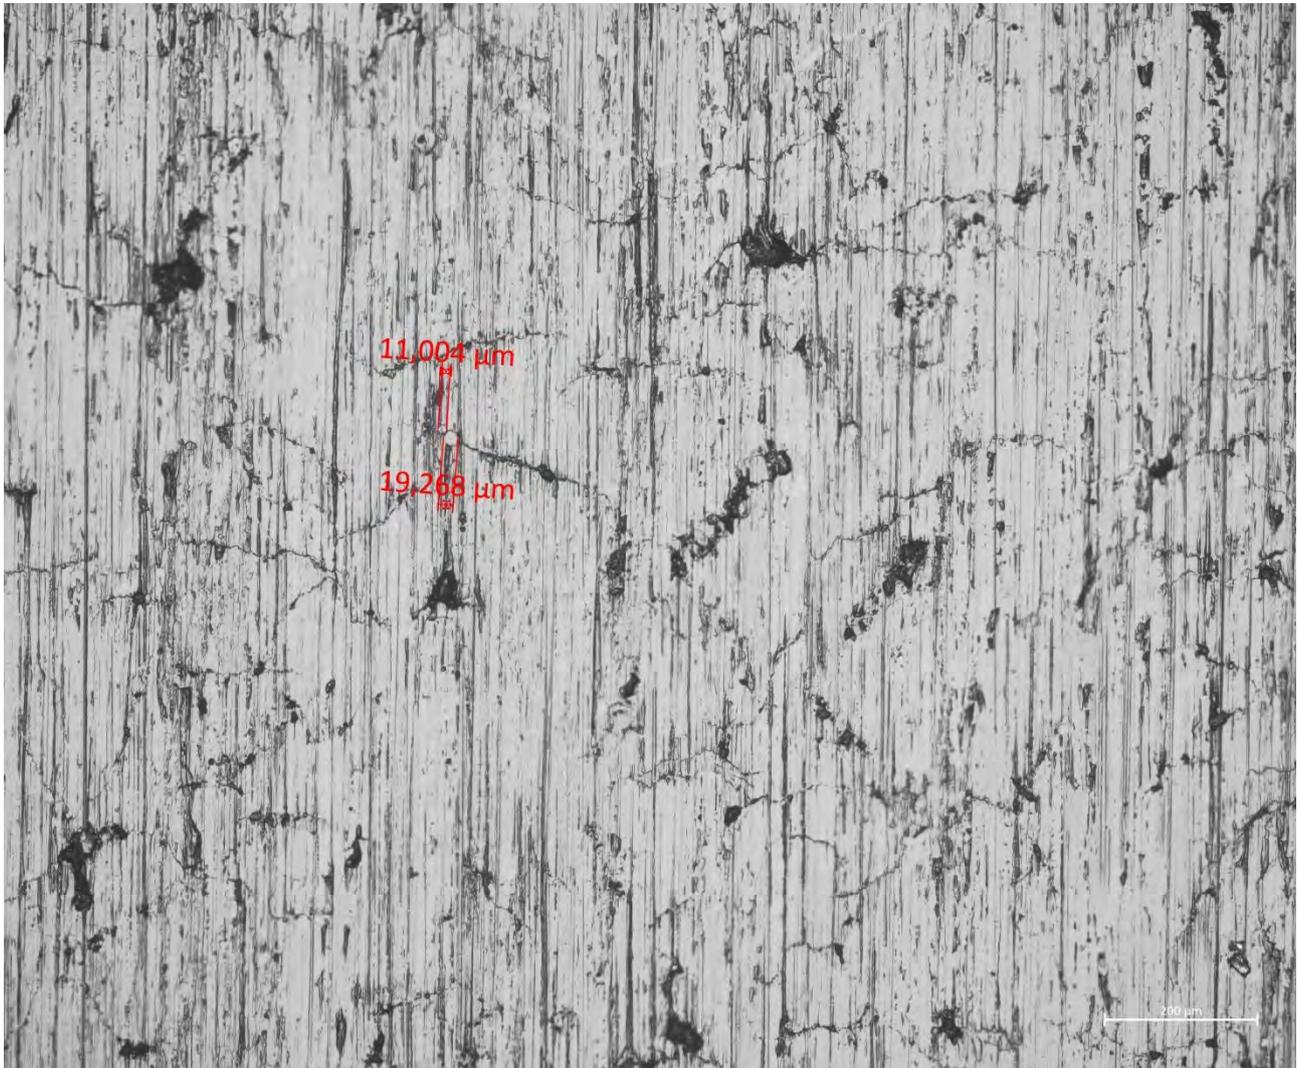
Cylinder #6 - 10x magnification

- Immediate honing and optionally also wave-cut grinding or replacement of unit #6 is needed as it is currently scuffing. The scuffing is yet not clearly visible on rings, but micro-cracks have formed in the liner surface as a result of over-heating.

Observations: Cylinder scuffing with partially developed network of micro-cracks. A few visible cat fines.

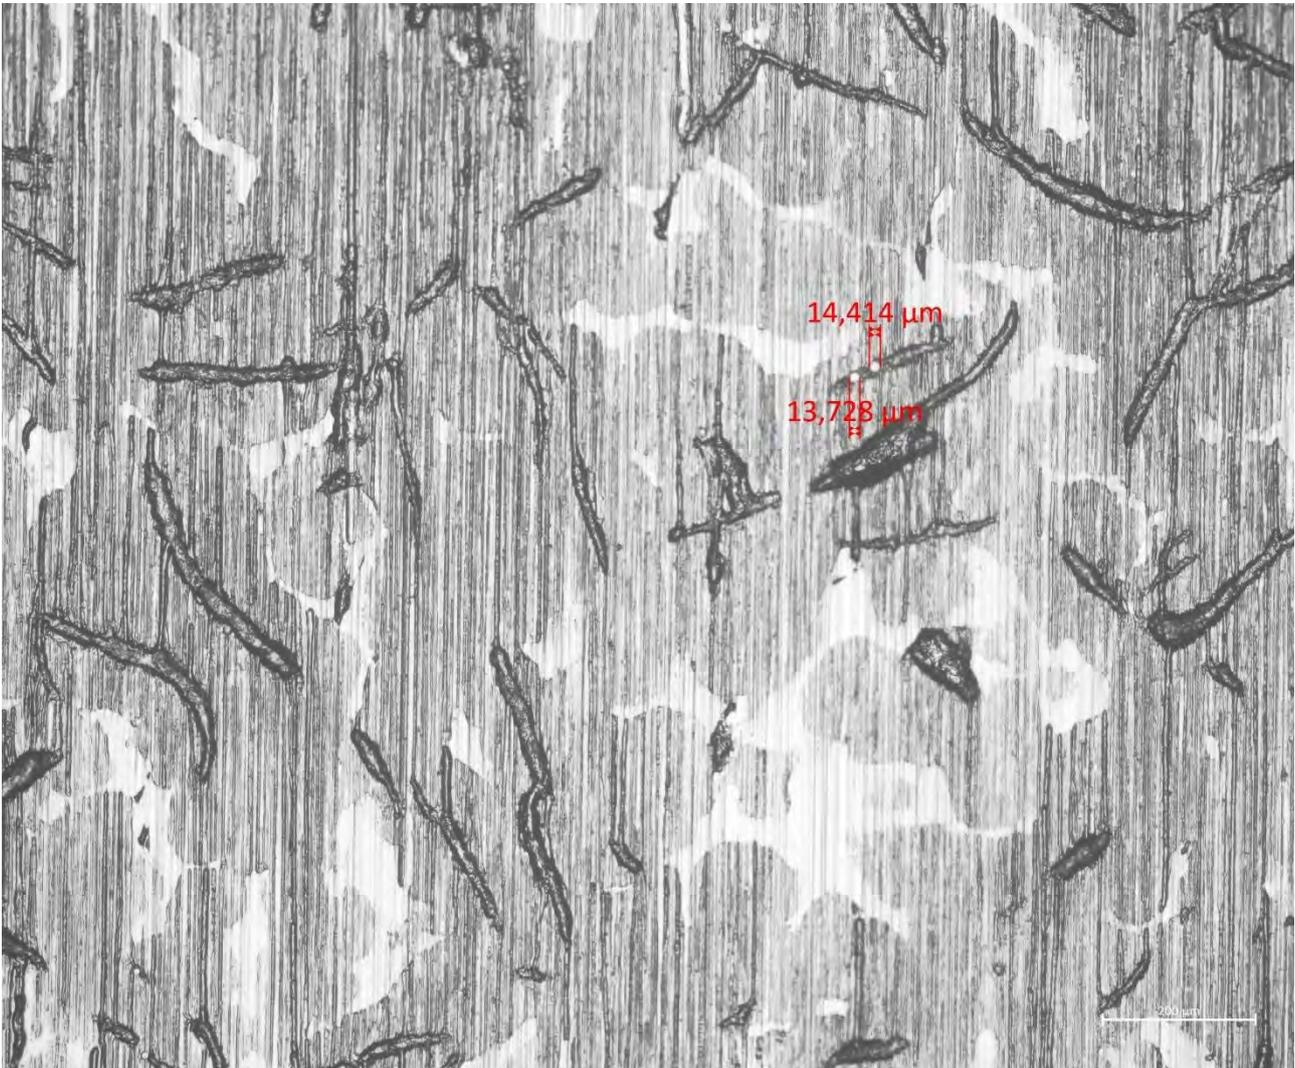
Cylinder #7 - 10x magnification

Observations: Normal, abrasive wear pattern and open graphite structure. A few visible cat fines, the largest being 14 microns.

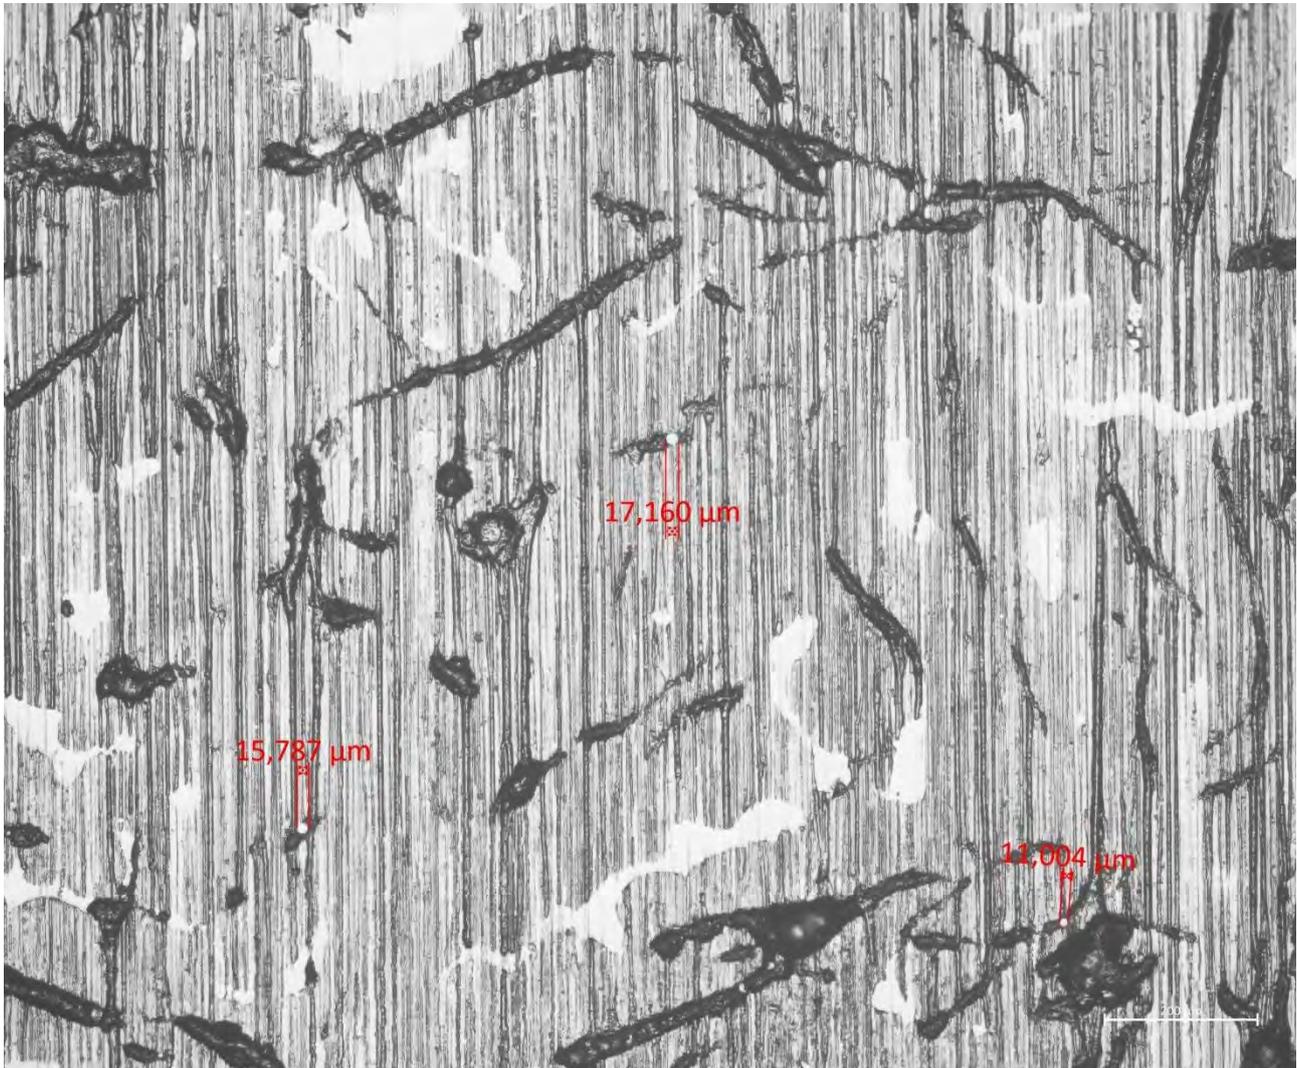
Cylinder #8 - 10x magnification

Observations: Normal, abrasive wear pattern and open graphite structure. A few visible cat fines, the largest being 17 microns.

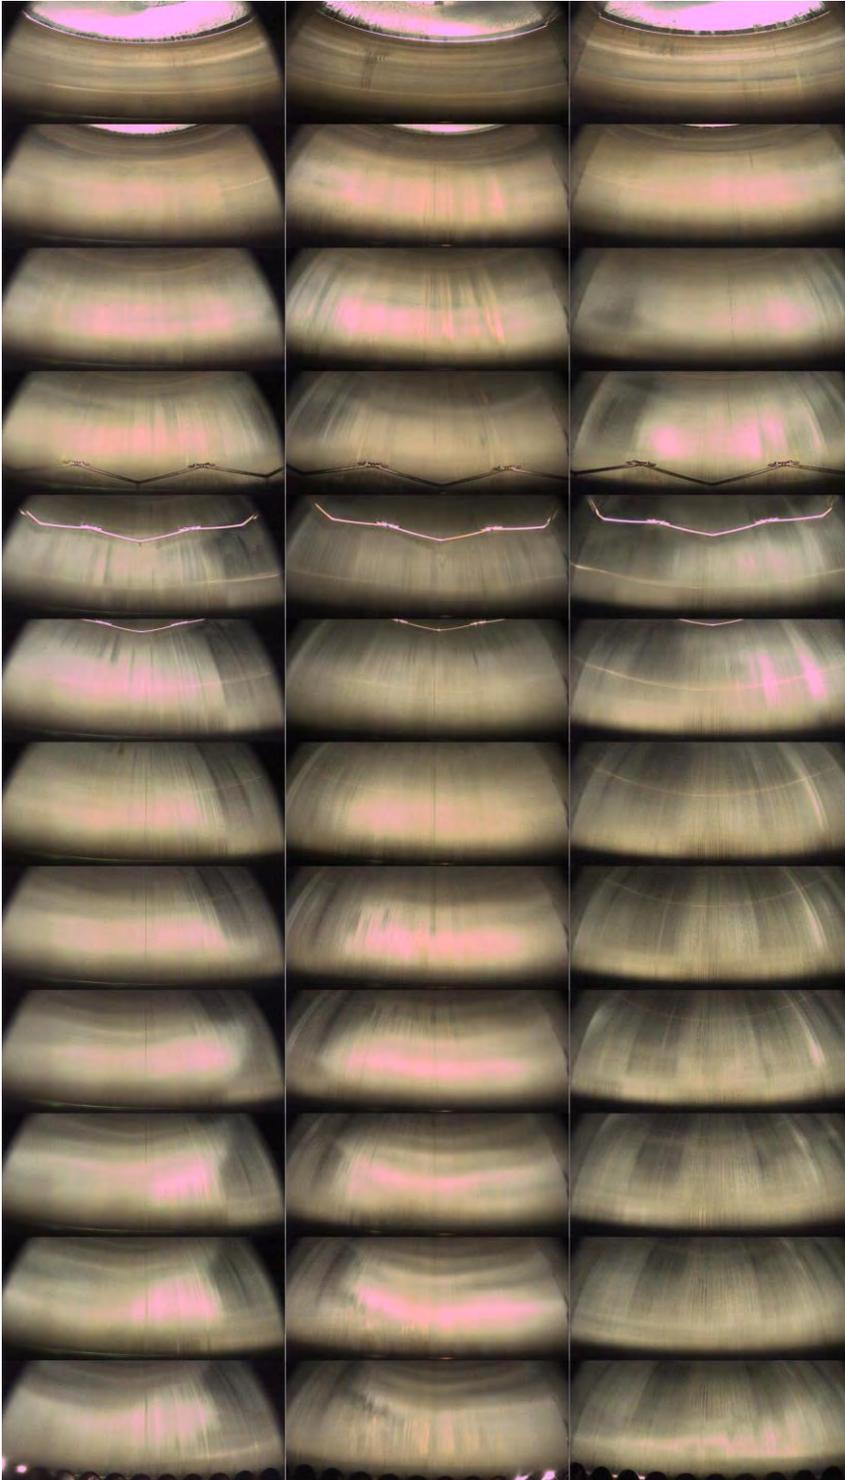
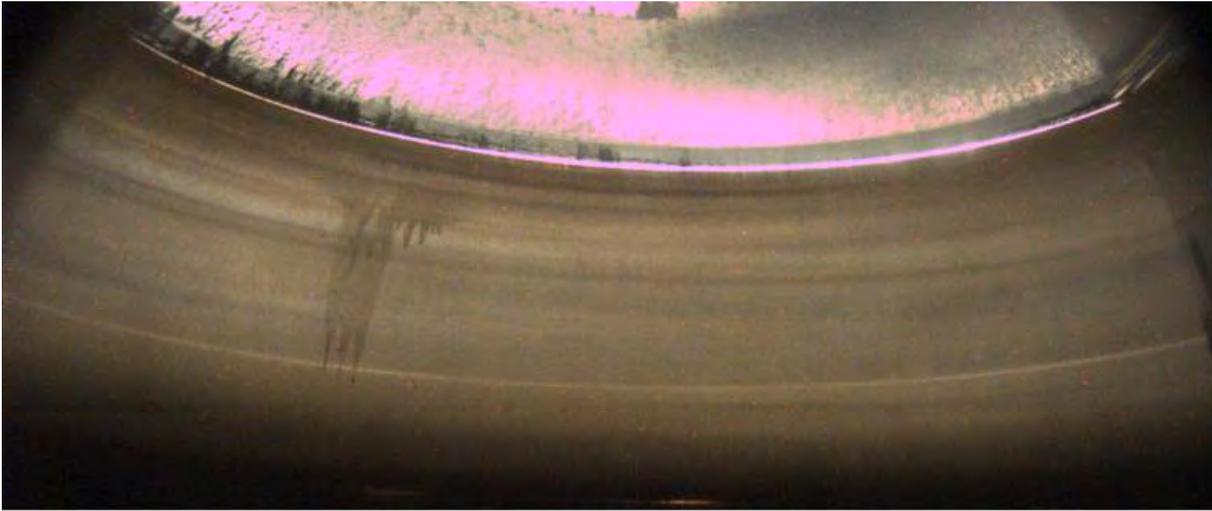
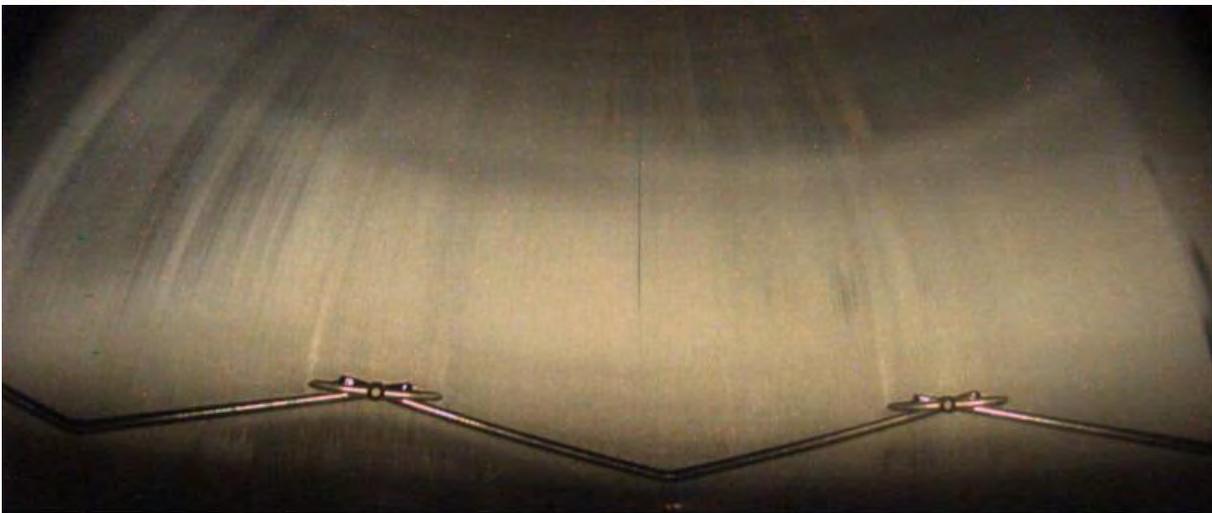
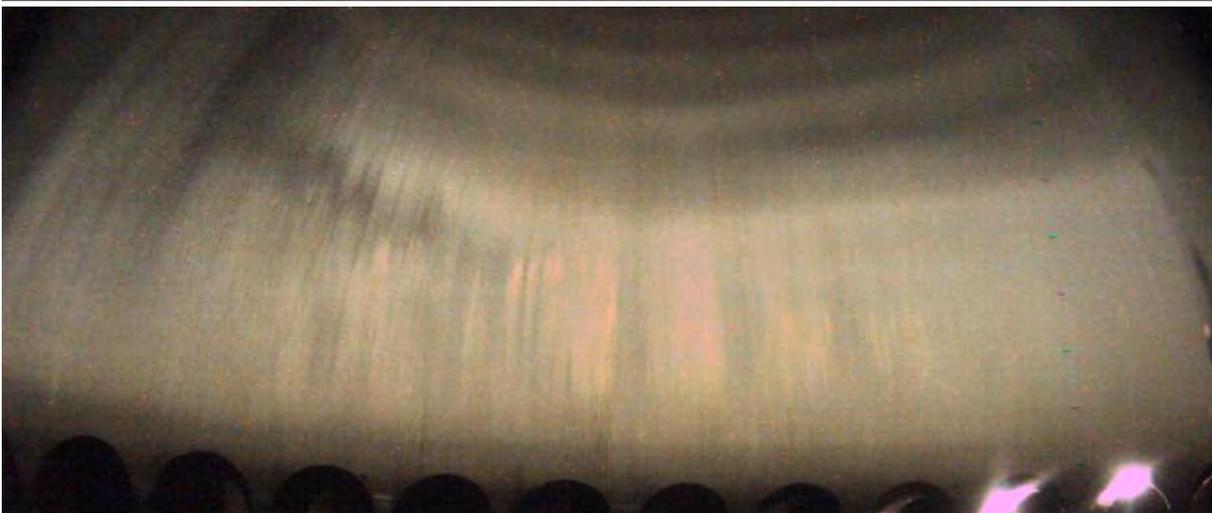
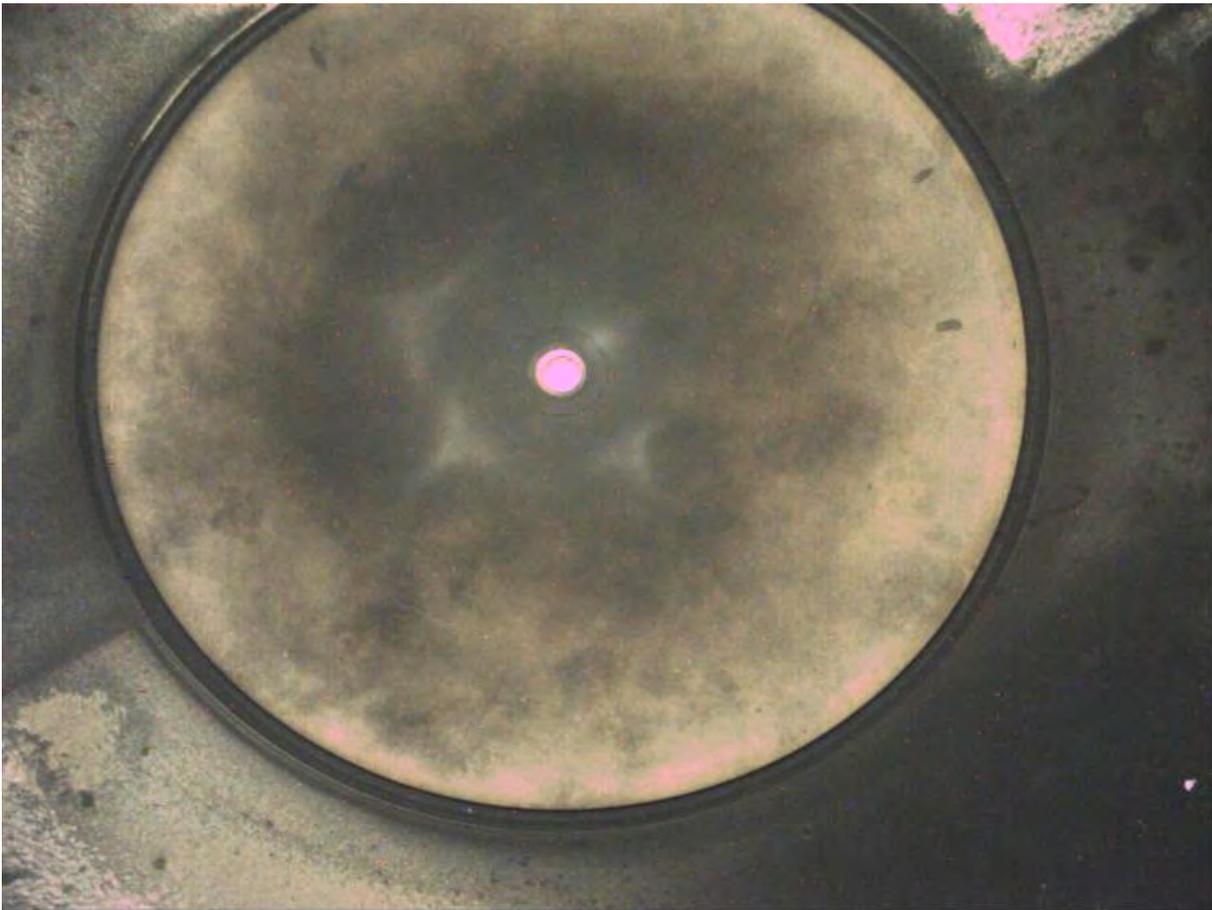
Unit #1 – Liner

Observations: Bright liner surface in good condition with minor black deposits. No wave-cut visible. Exhaust valve in good condition.

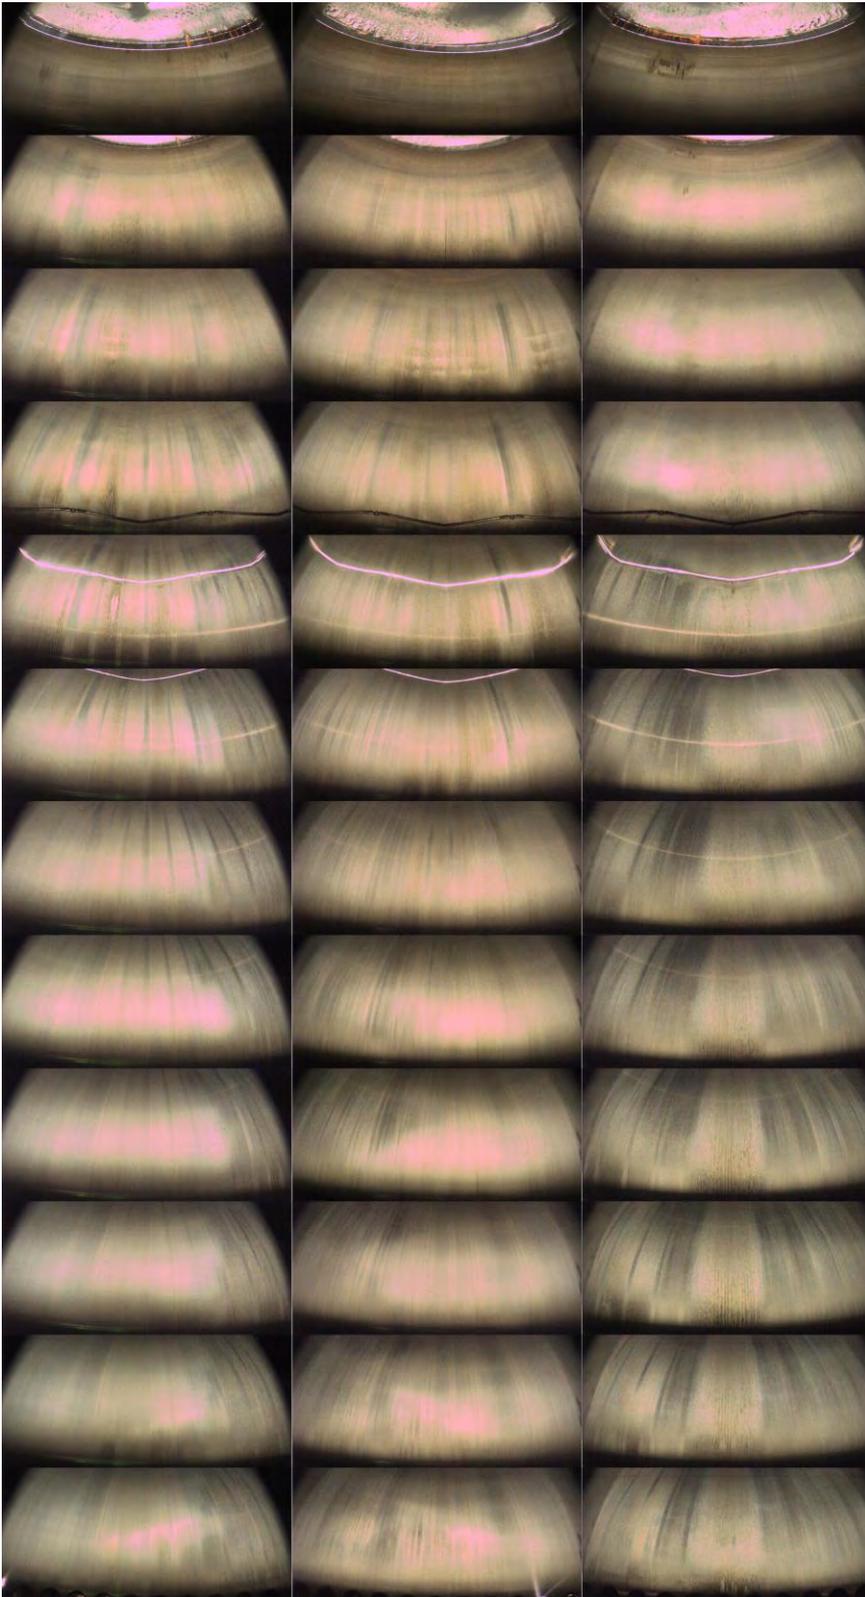
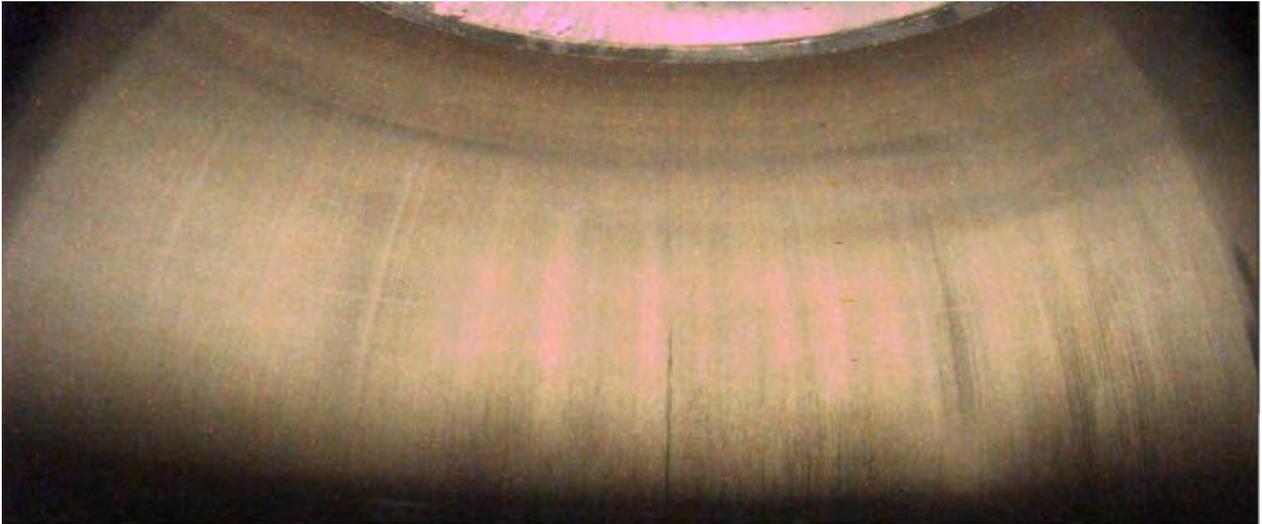
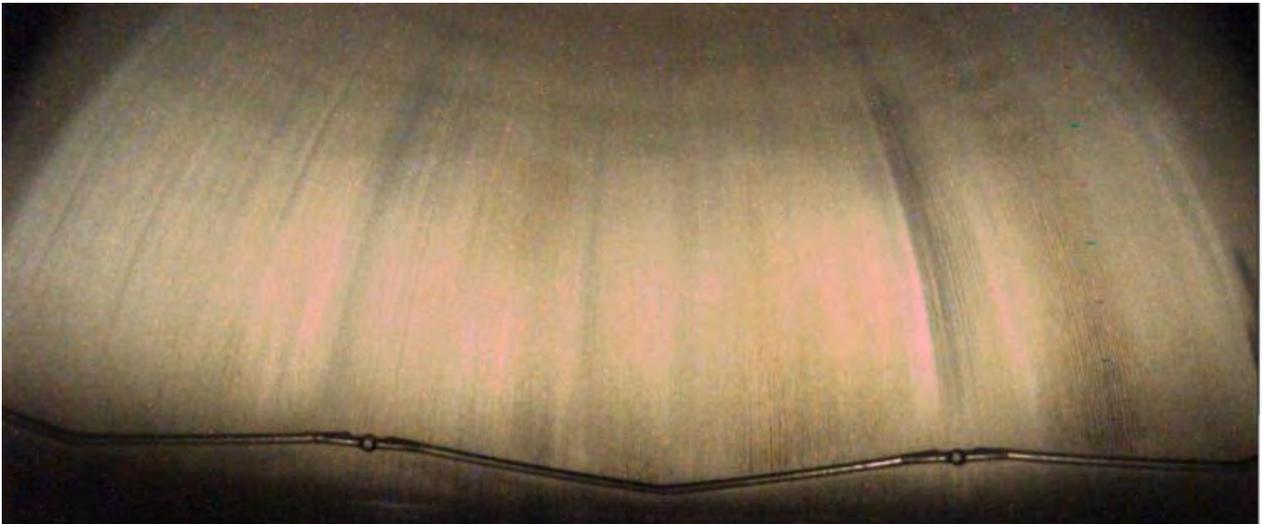
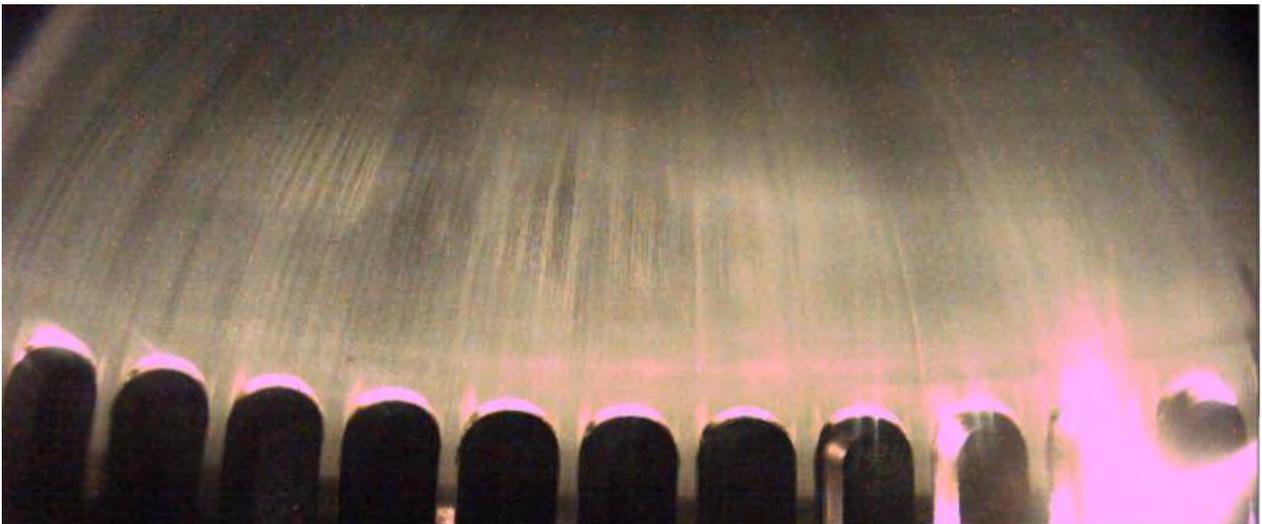
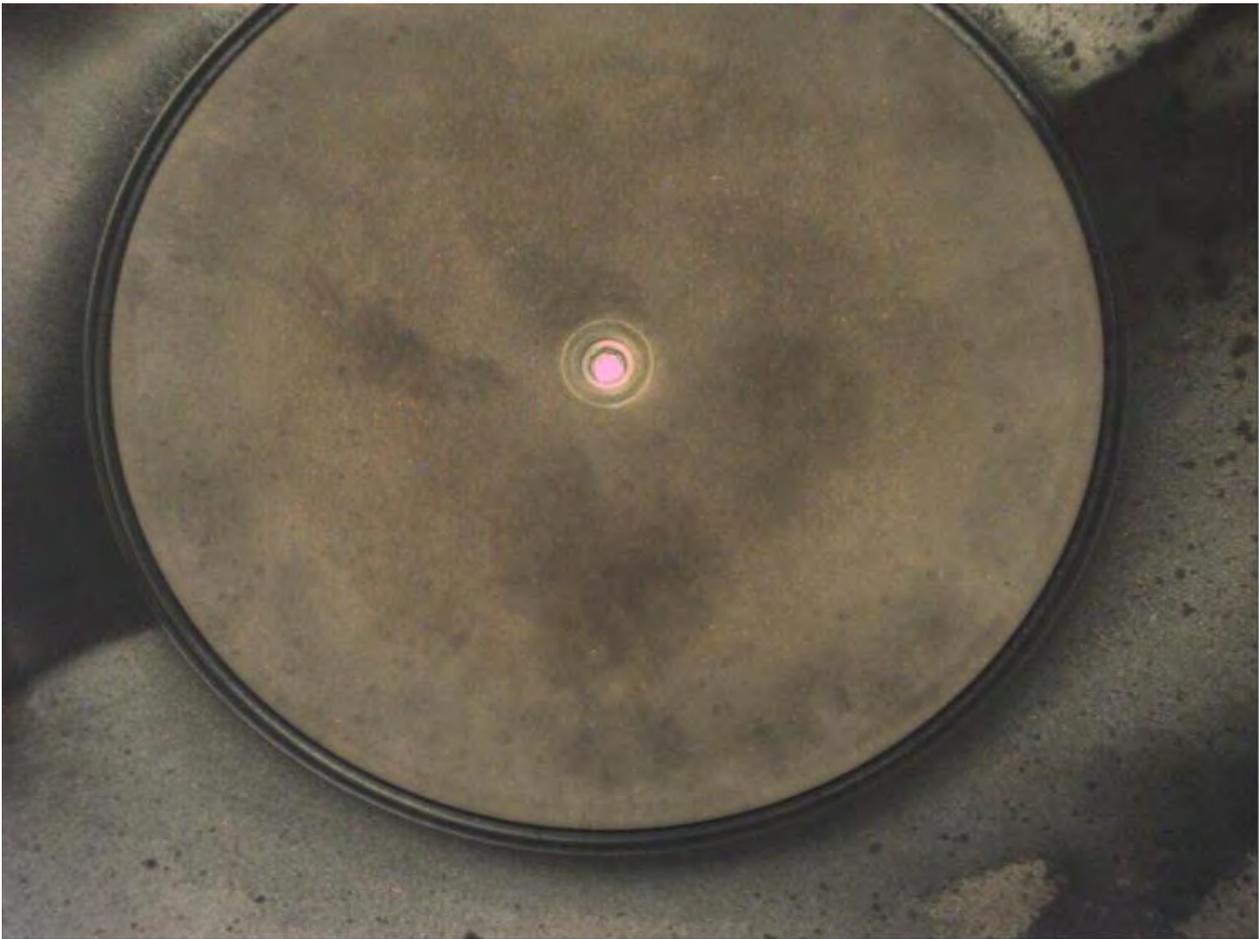
Unit #2 – Liner

Observations: Mat liner surface in good condition with minor black deposits. No wave-cut visible. Exhaust valve in good condition.
