Inspection Report

Cylinder liner inspection, Anonymous vessel @
142,394 Engine hours

Daniel Grunditz
Tel: +46 702 276900
daniel.grunditz@chris-marine.com

August 31st 2020

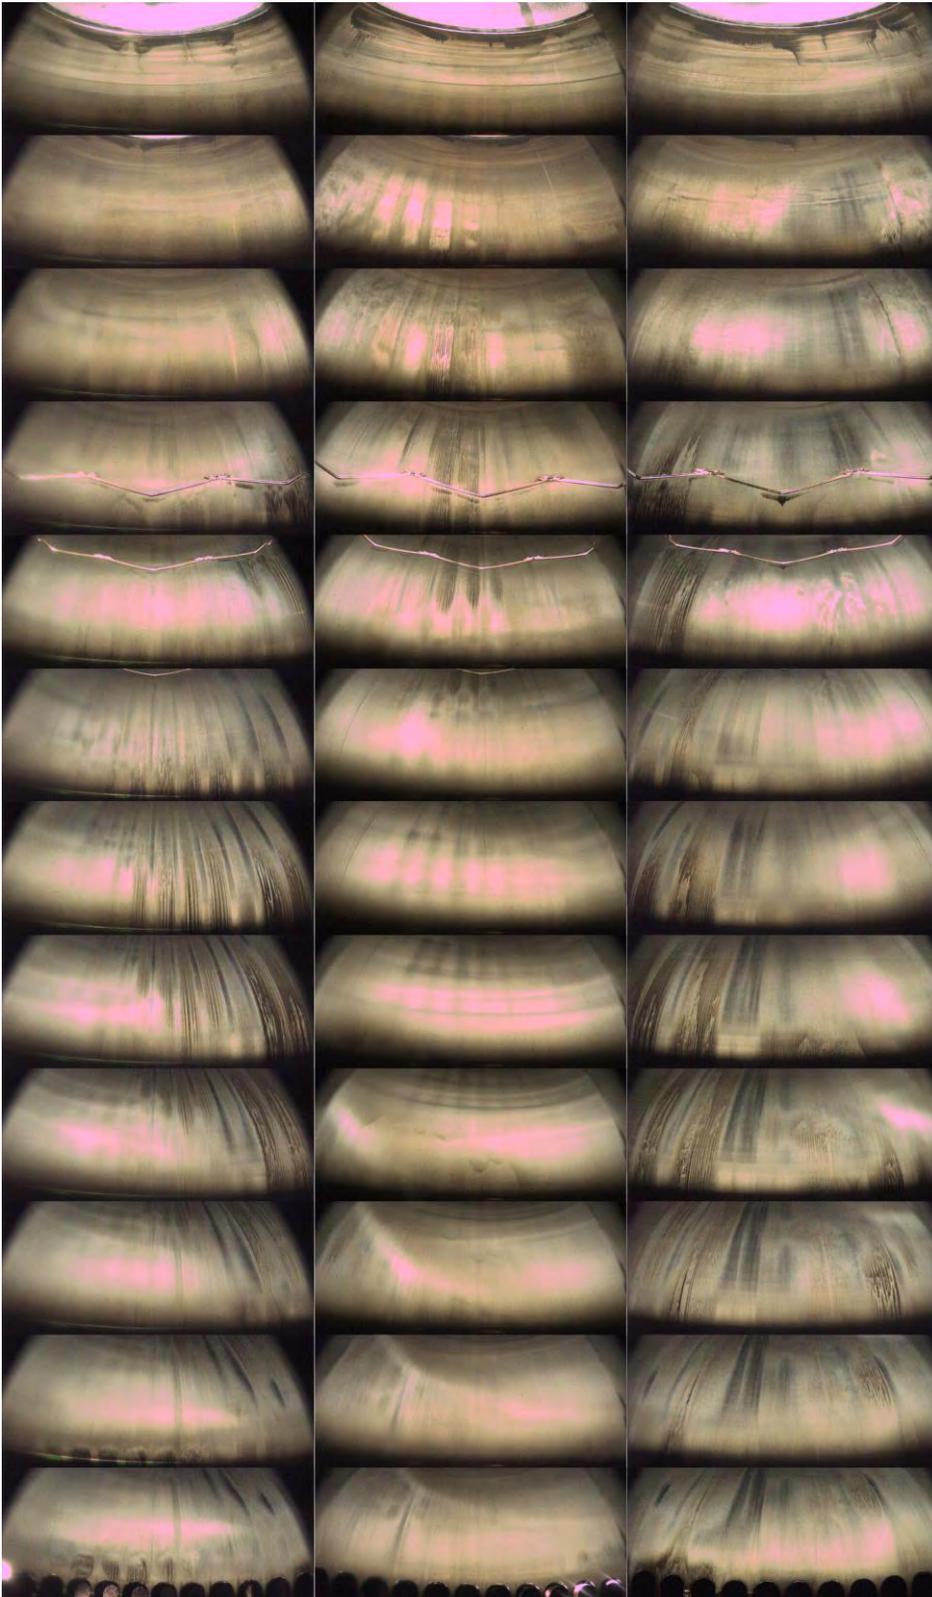
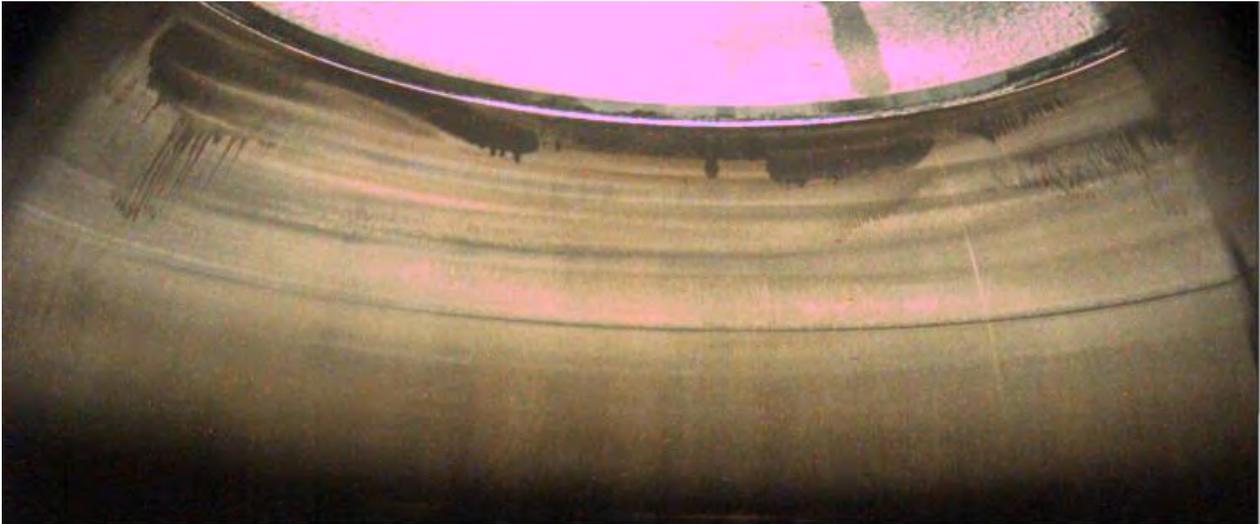
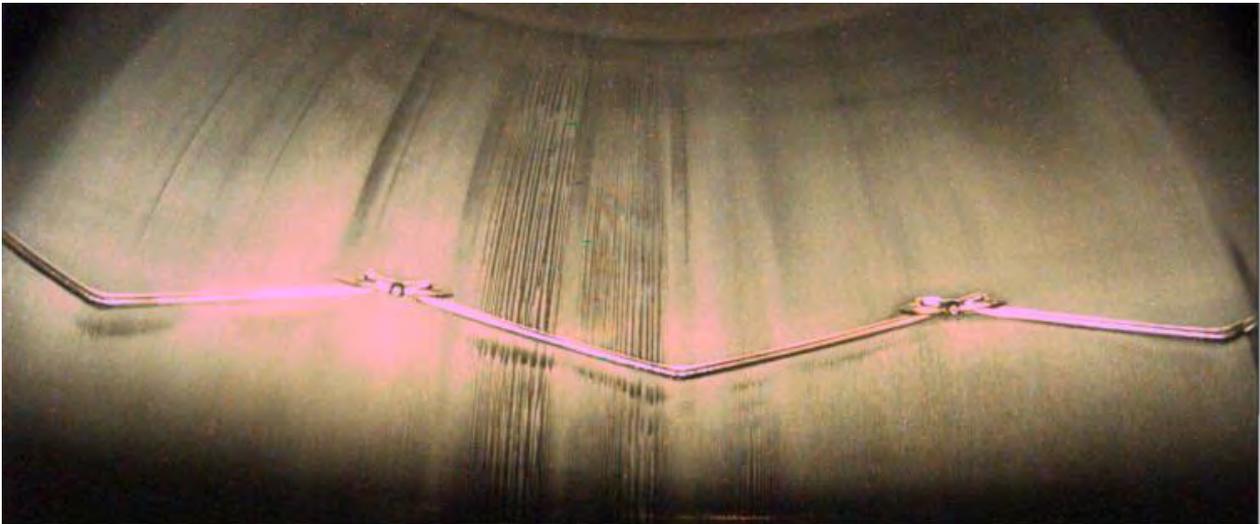
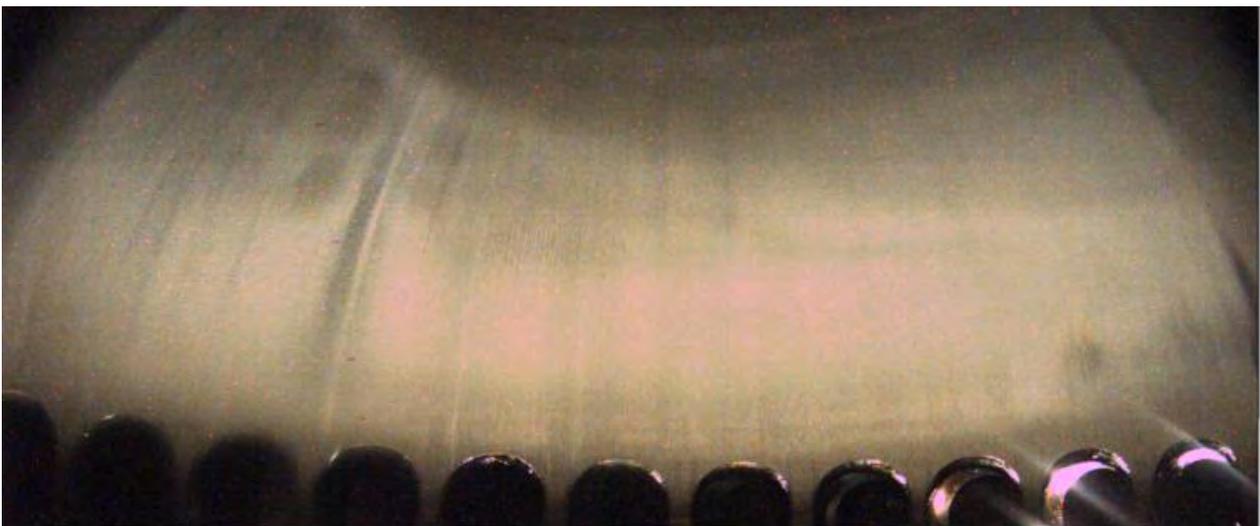
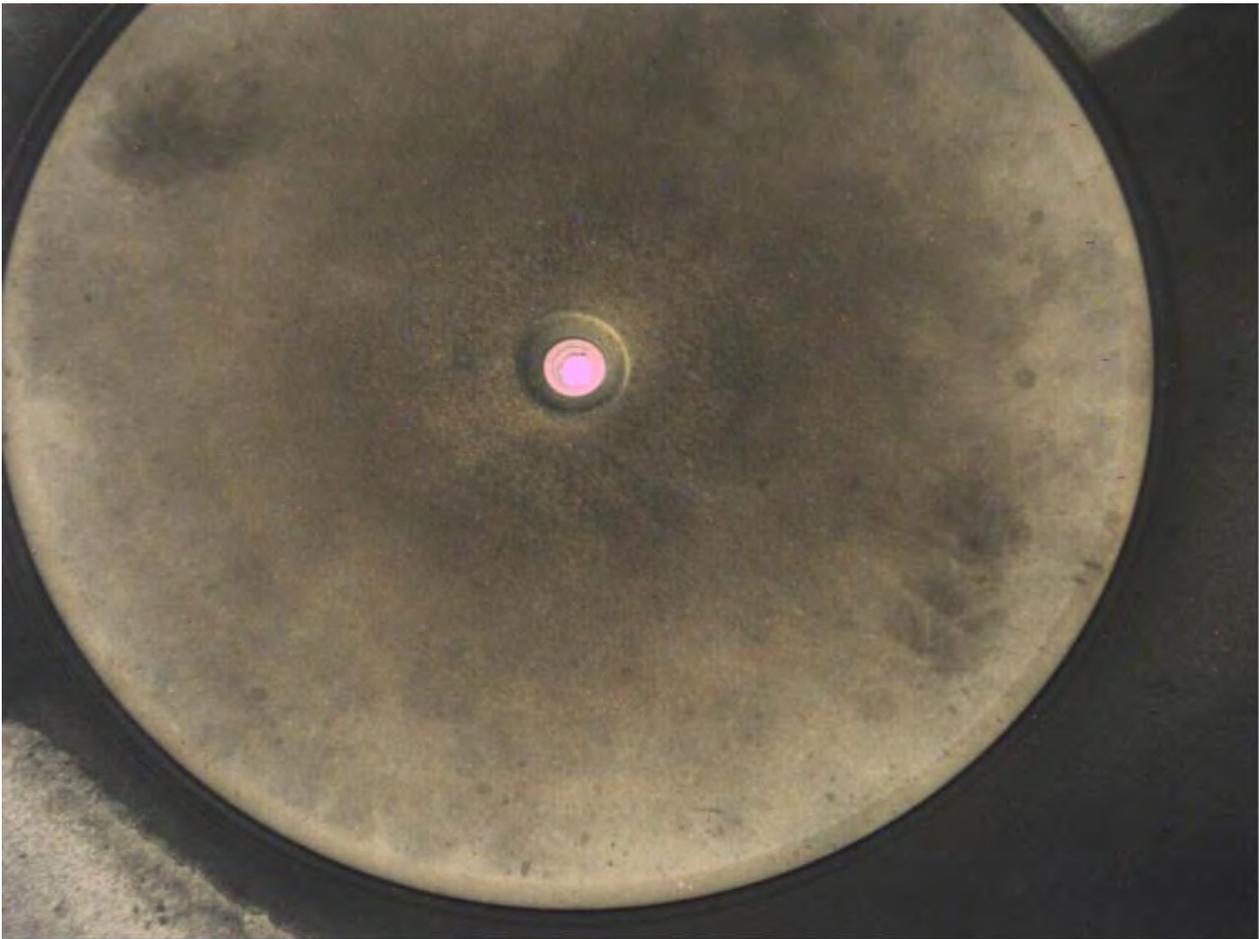
Unit #3 – Liner

Observations: Bright liner surface in good condition with some black deposits. No wave-cut visible. Exhaust valve in good condition.

- Honing and optionally also wave-cut grinding or replacement of unit #3 should be planned as soon as possible, as the cylinder condition is likely to deteriorate in the near future.

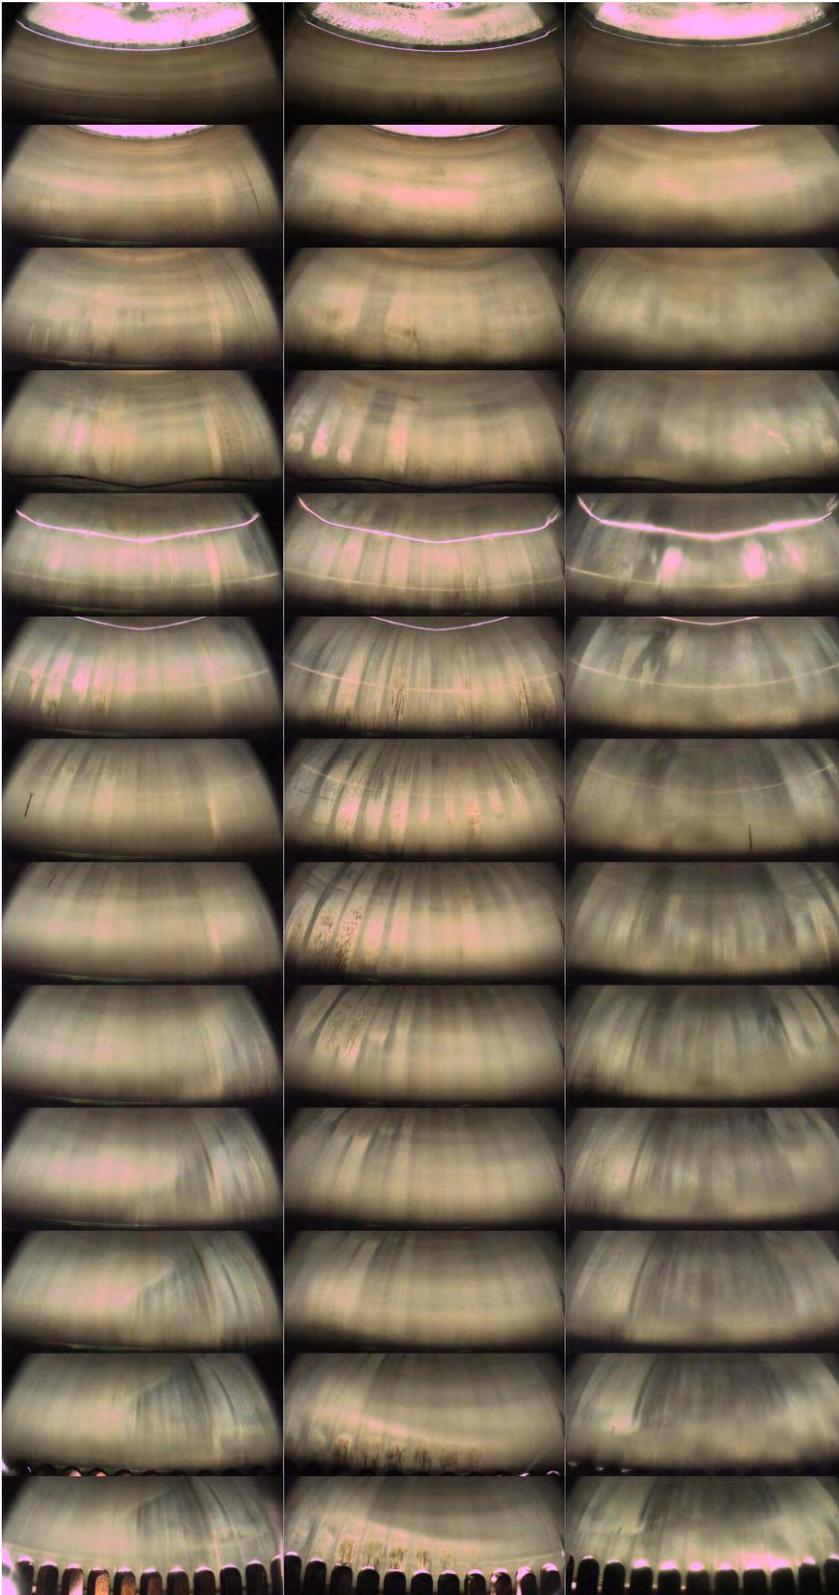
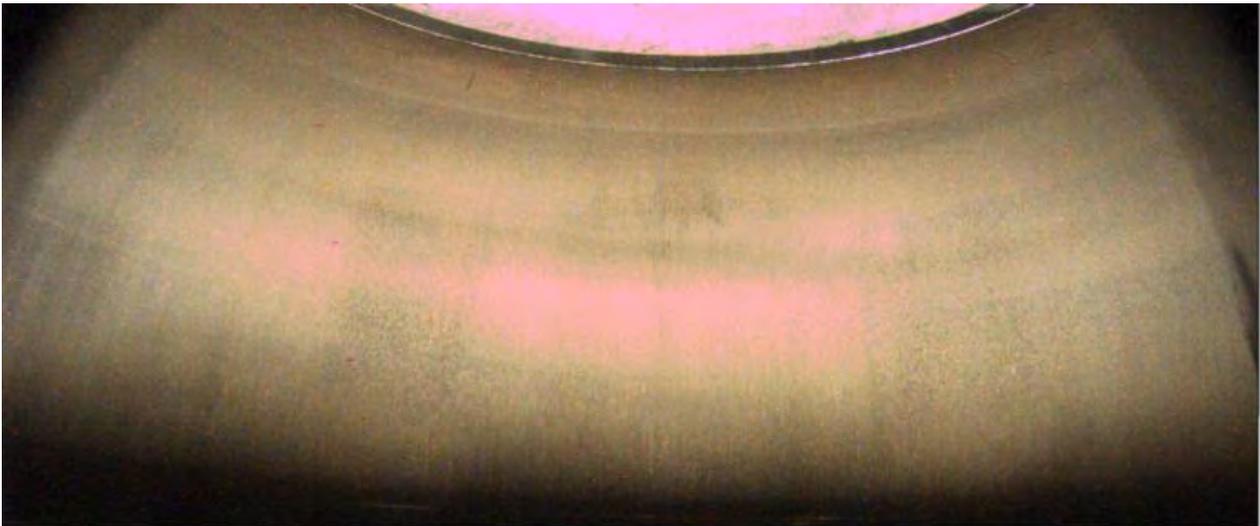
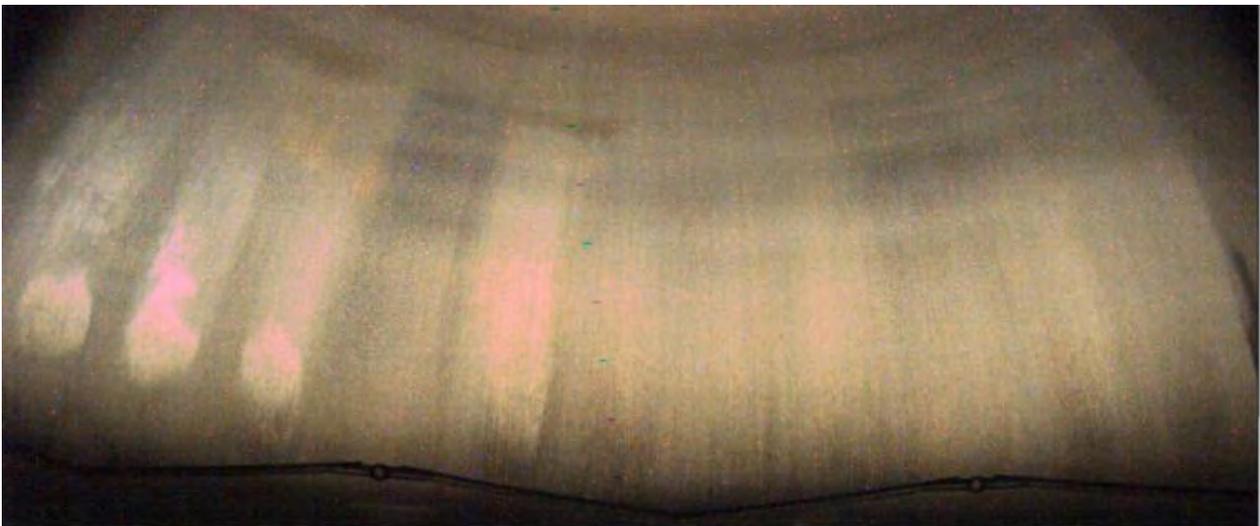
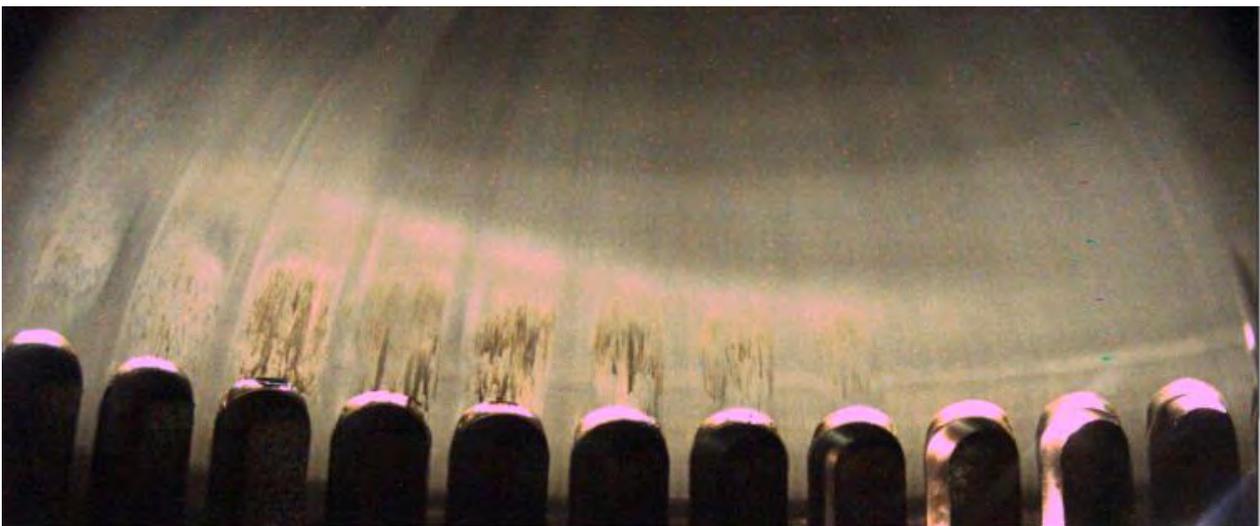
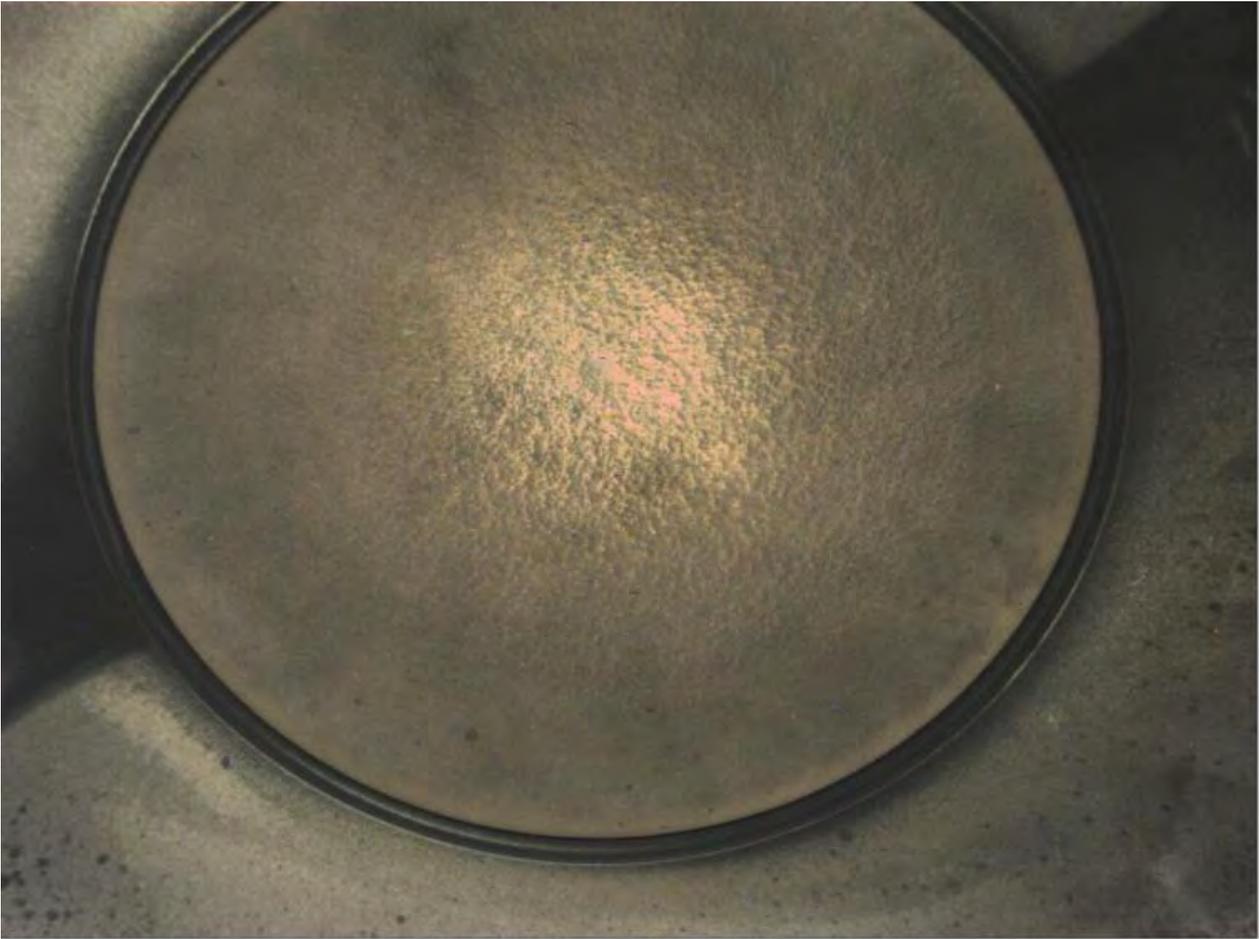
Unit #4 – Liner

Observations: Mat liner surface with some black deposits and possible scuff marks. No wave-cut visible. Exhaust valve in good condition.

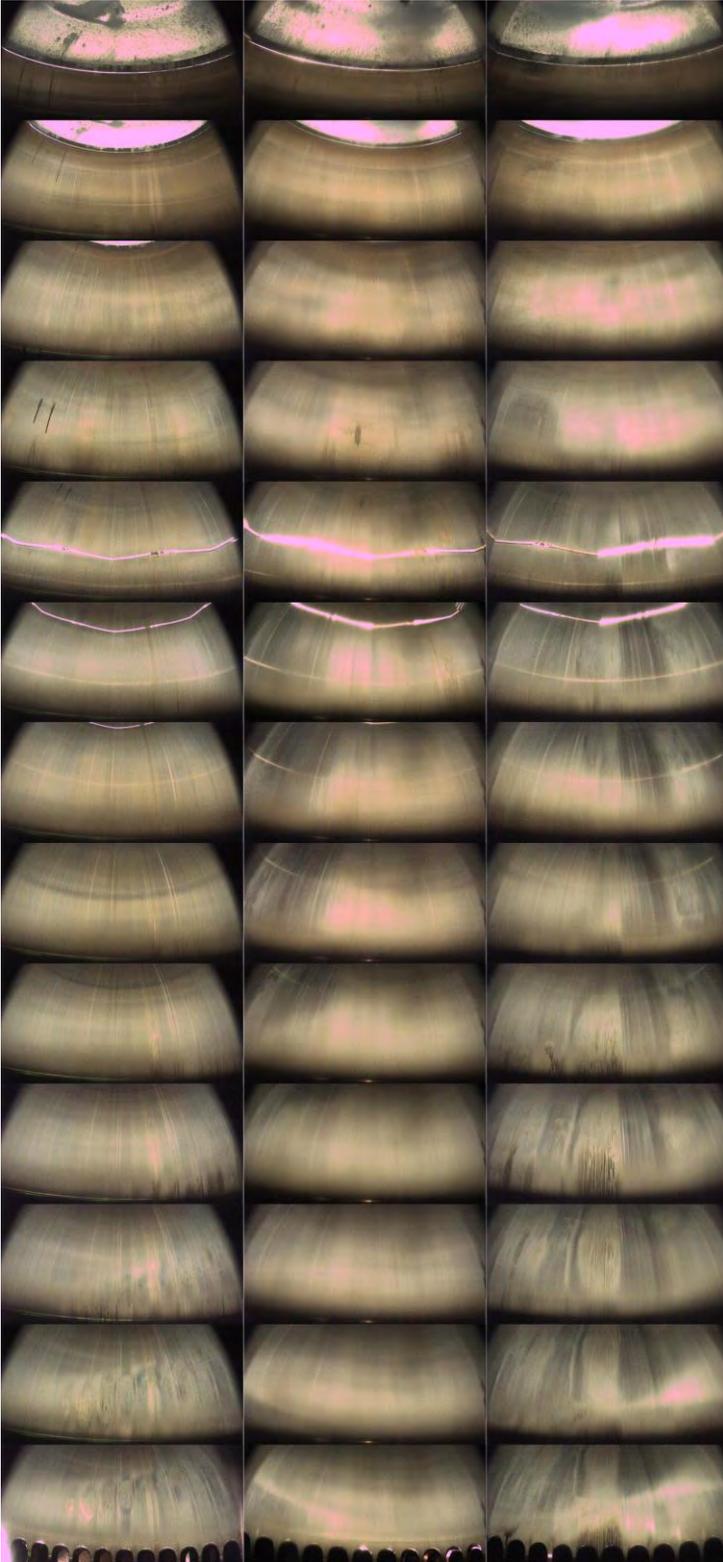
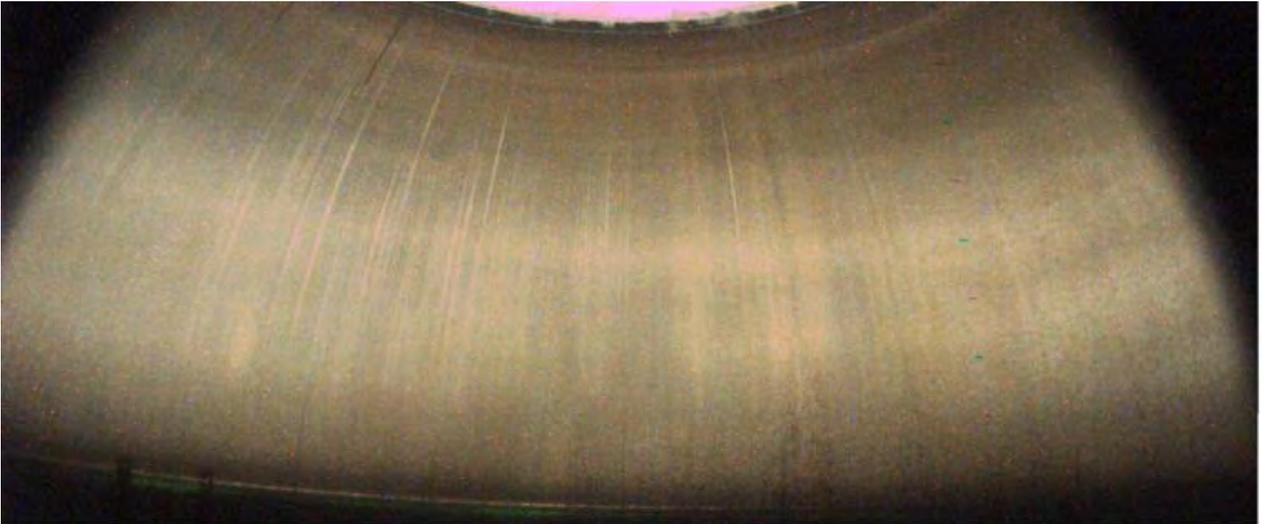
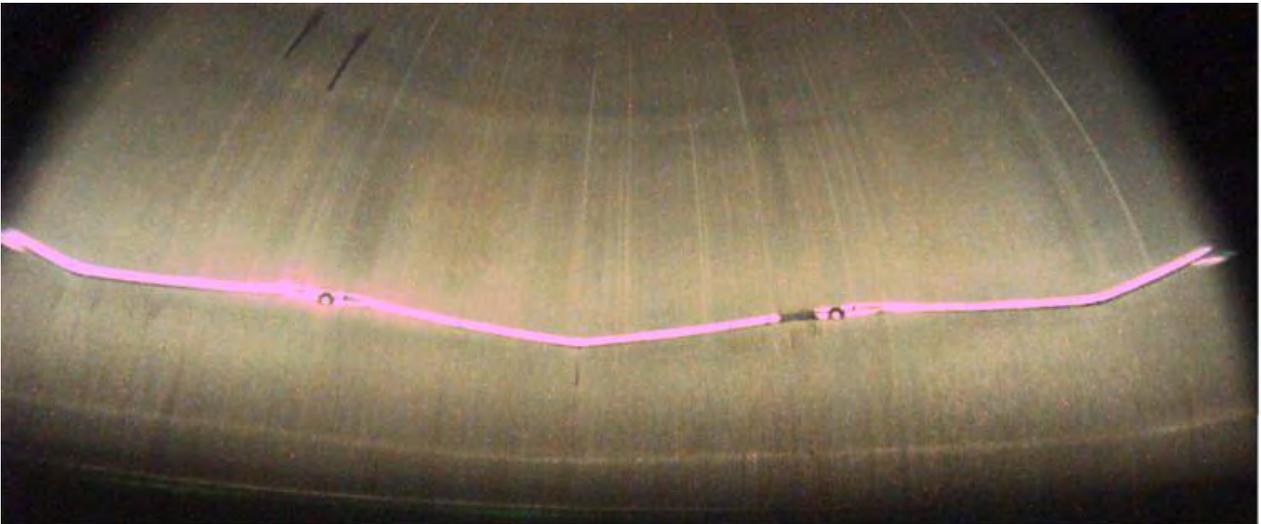
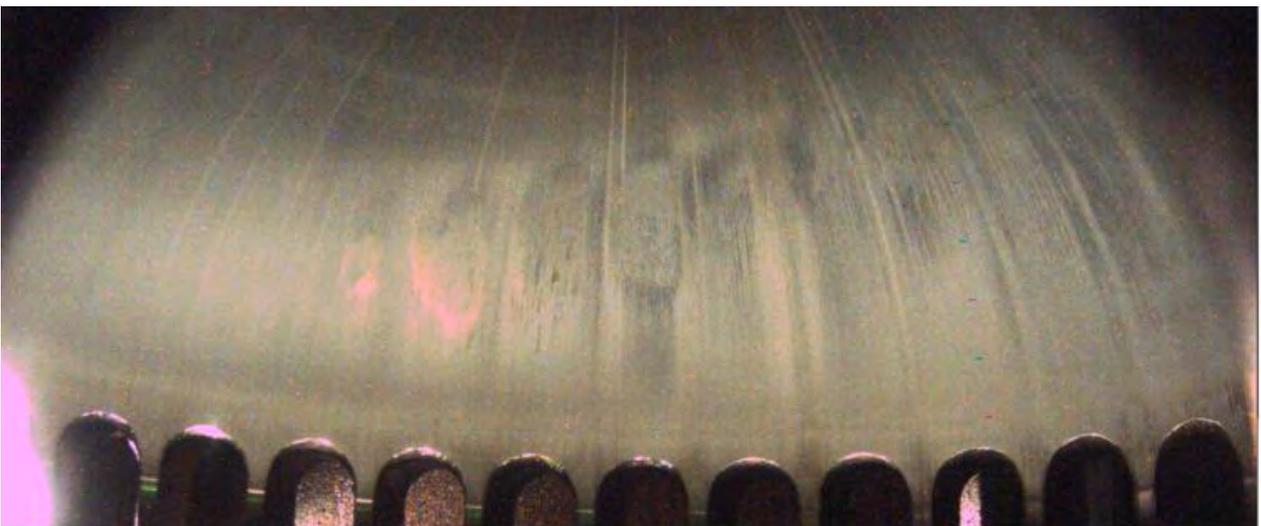
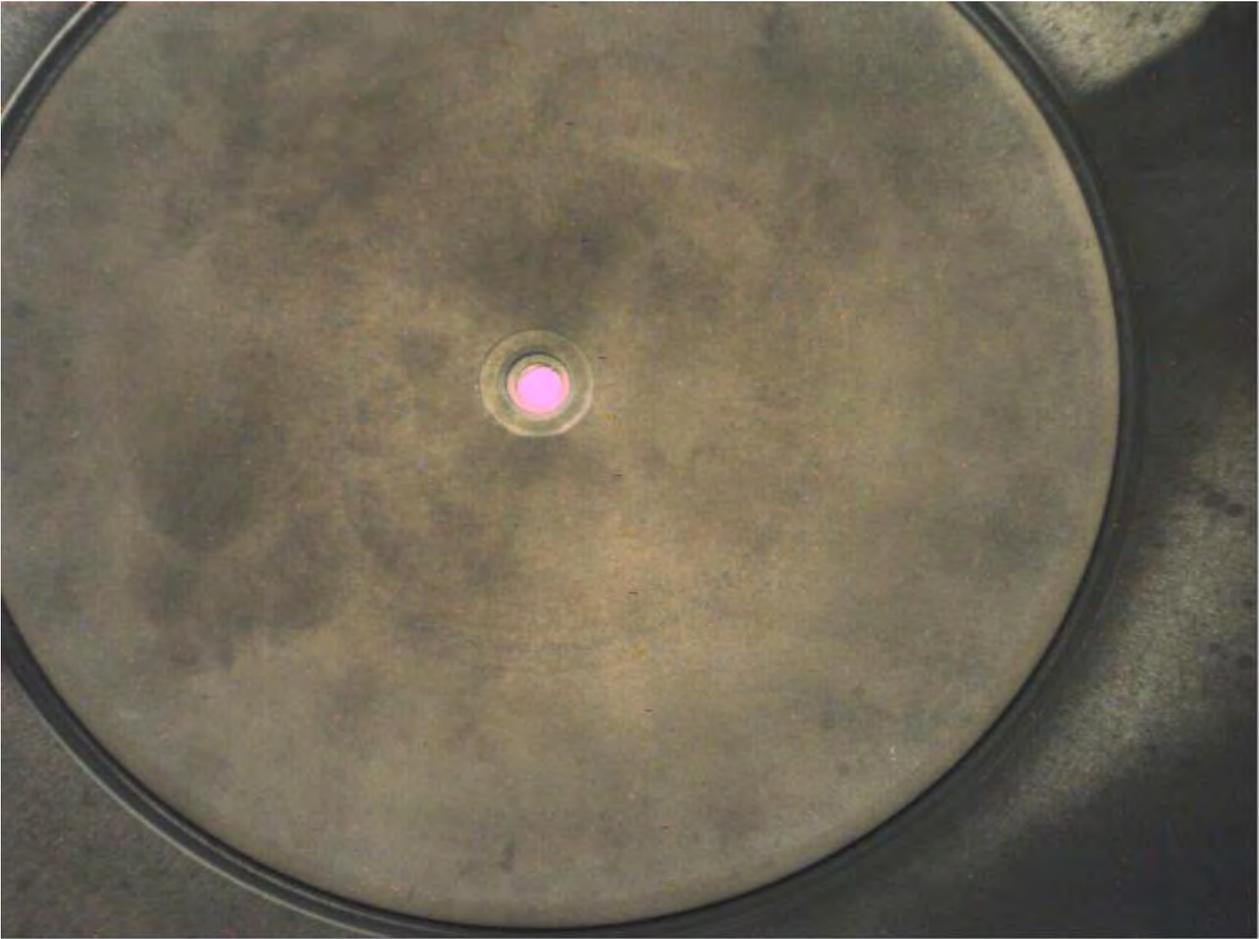
Unit #5 – Liner

Observations: Mat liner surface with some black deposits. No wave-cut visible. Exhaust valve in good condition.

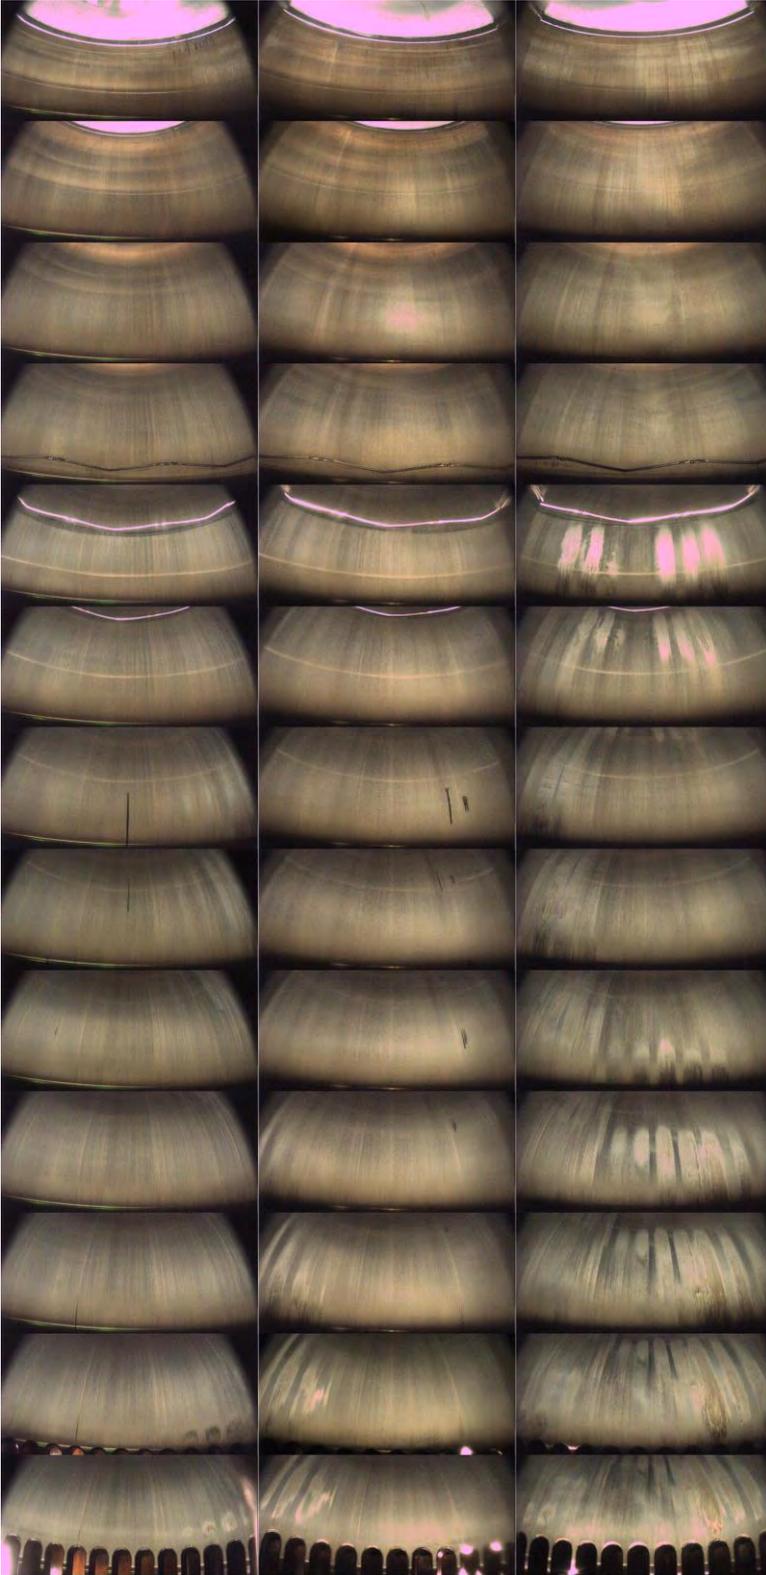
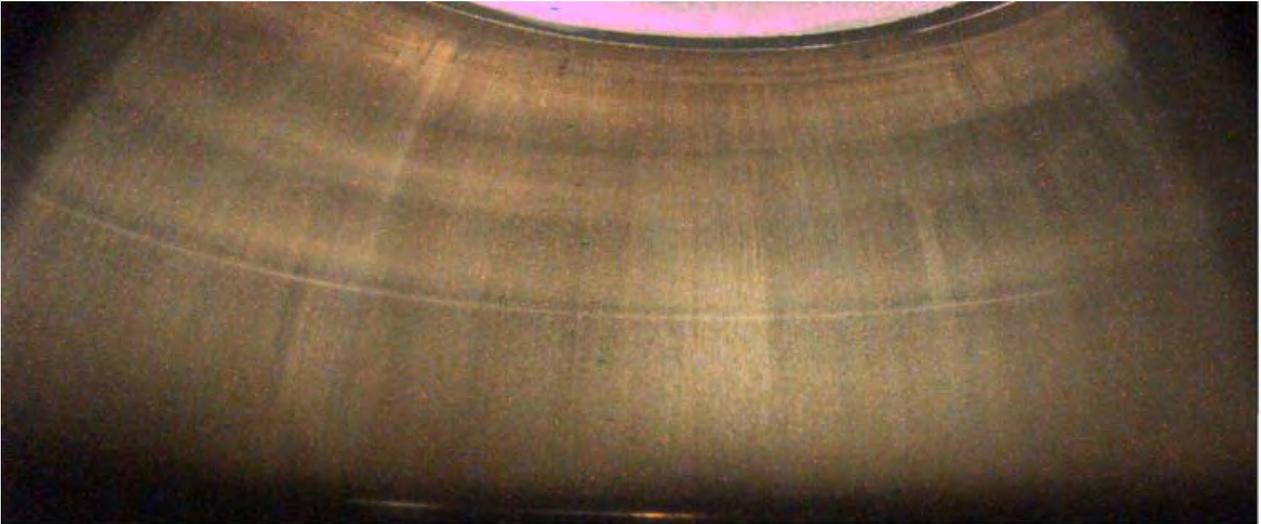
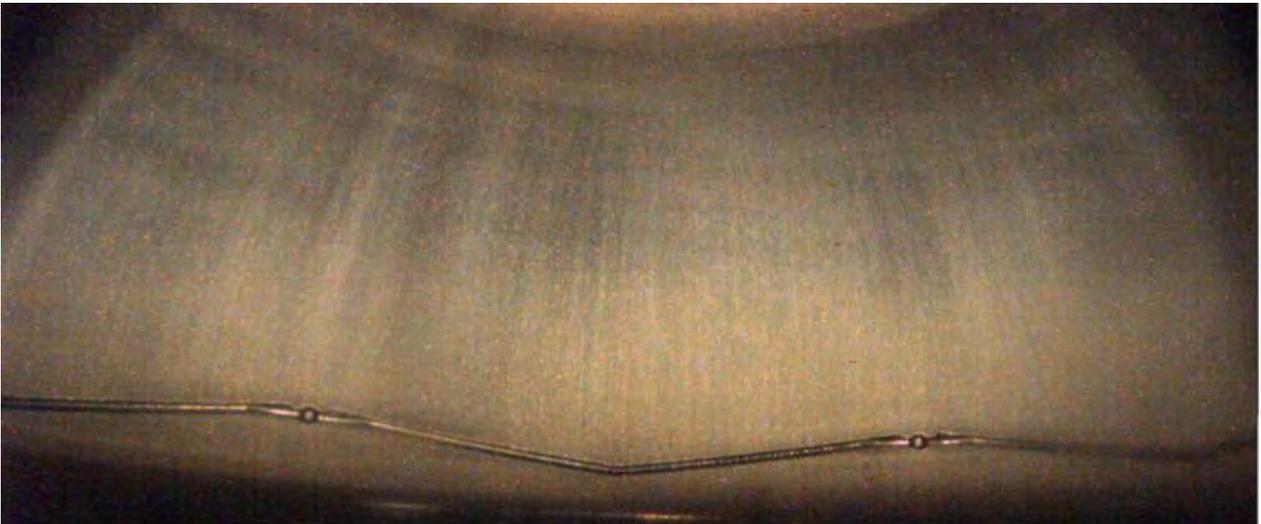
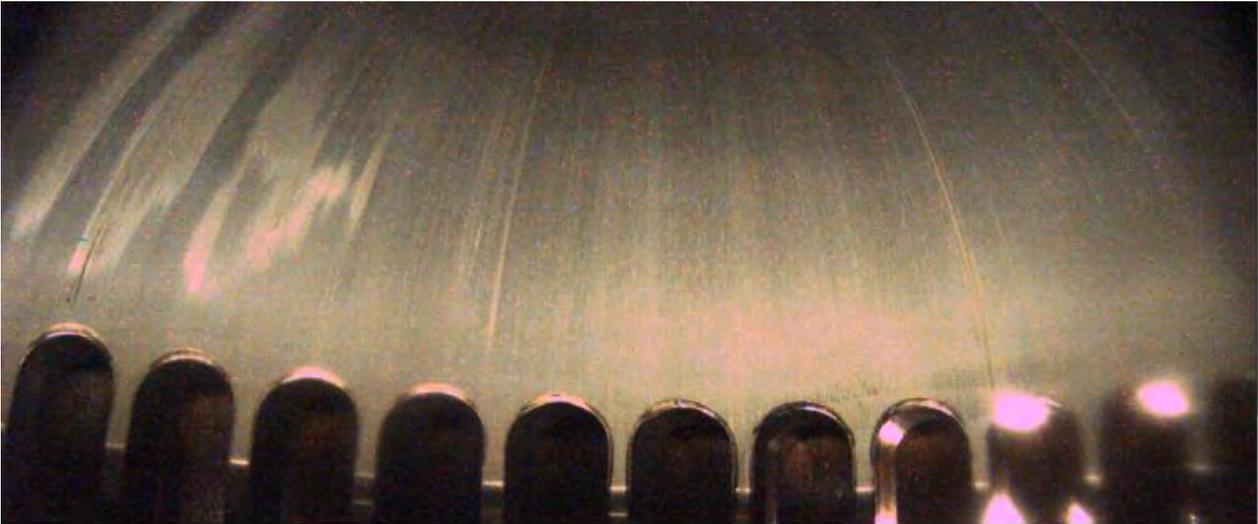
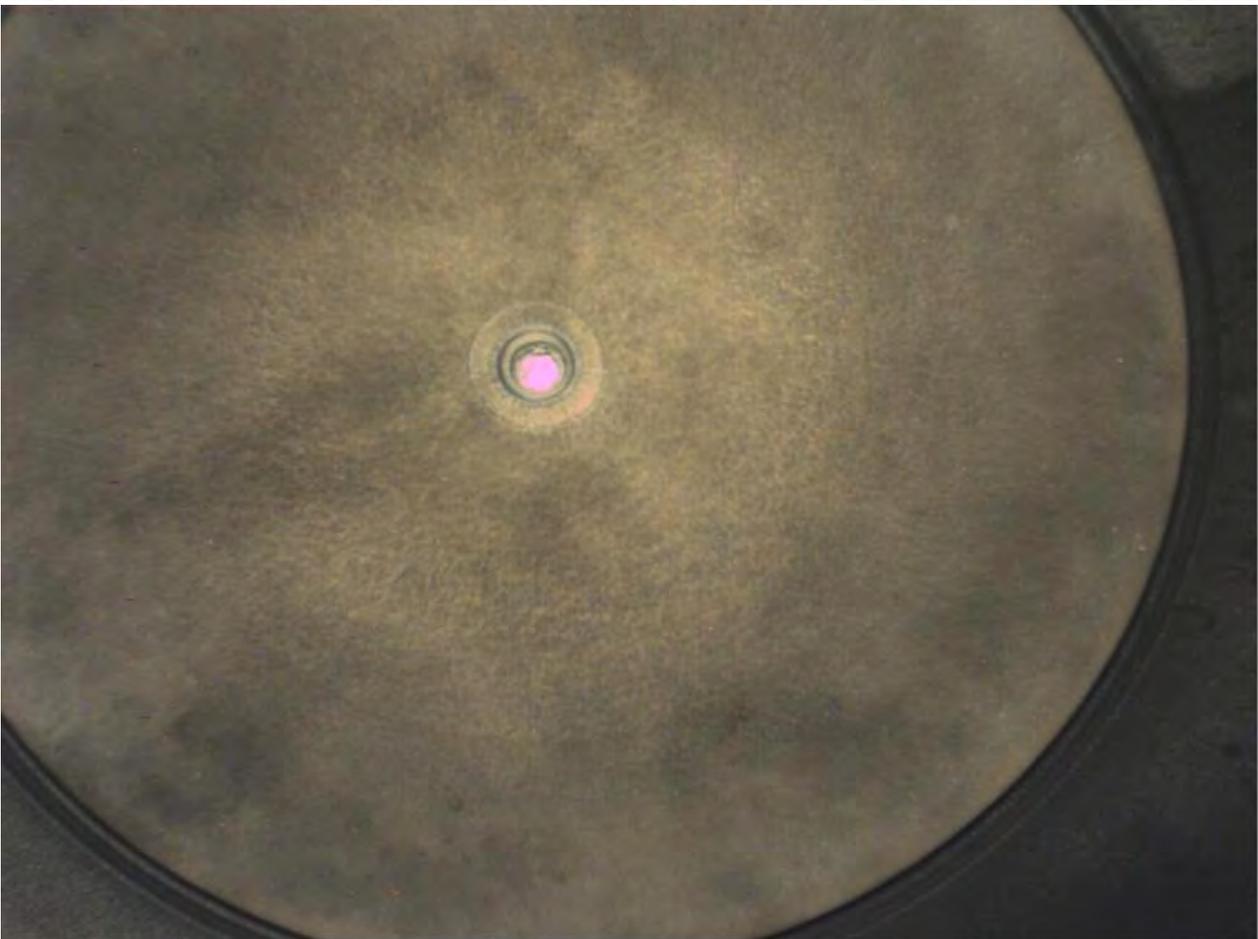
Unit #6 – Liner

Observations: Mat liner surface with some black deposits and possible scuff marks. No wave-cut visible. Exhaust valve in good condition.

- Immediate honing and optionally also wave-cut grinding or replacement of unit #6 is needed as it is currently scuffing. The scuffing is yet not clearly visible on rings, but micro-cracks have formed in the liner surface as a result of over-heating.

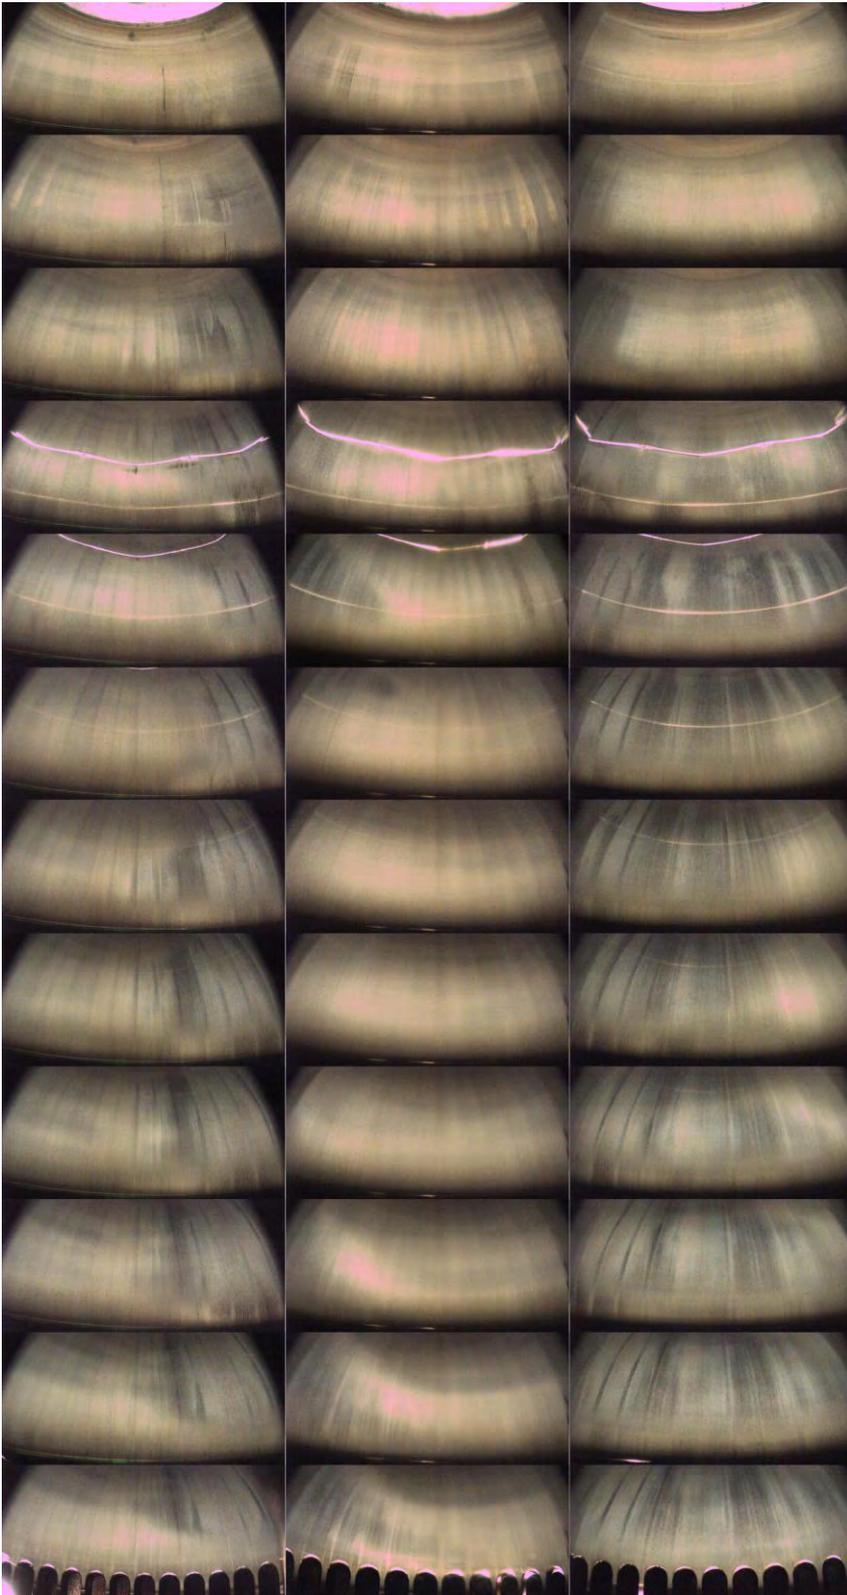
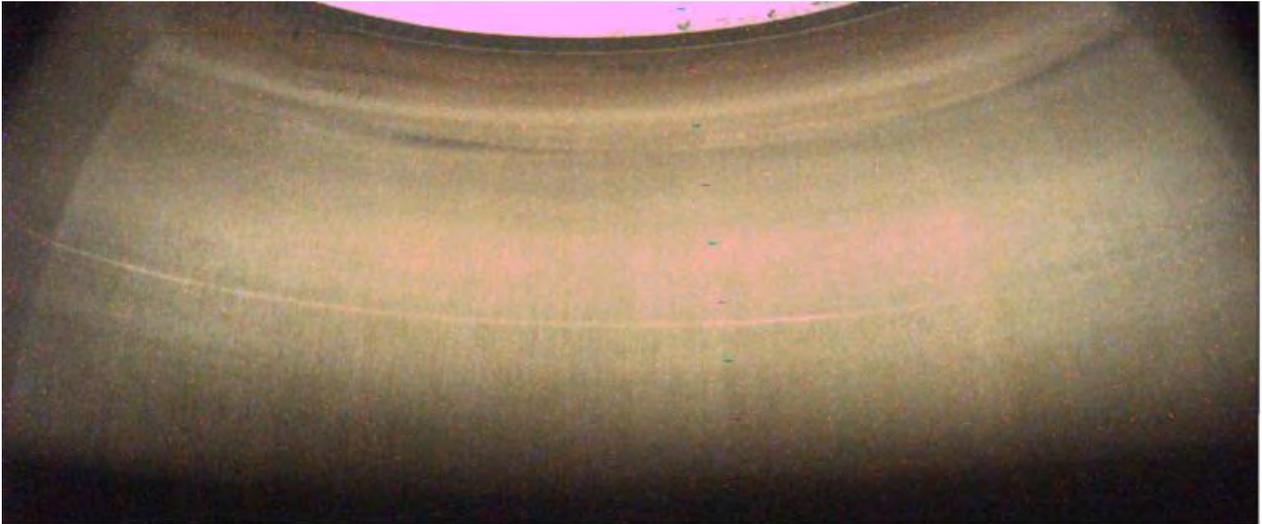
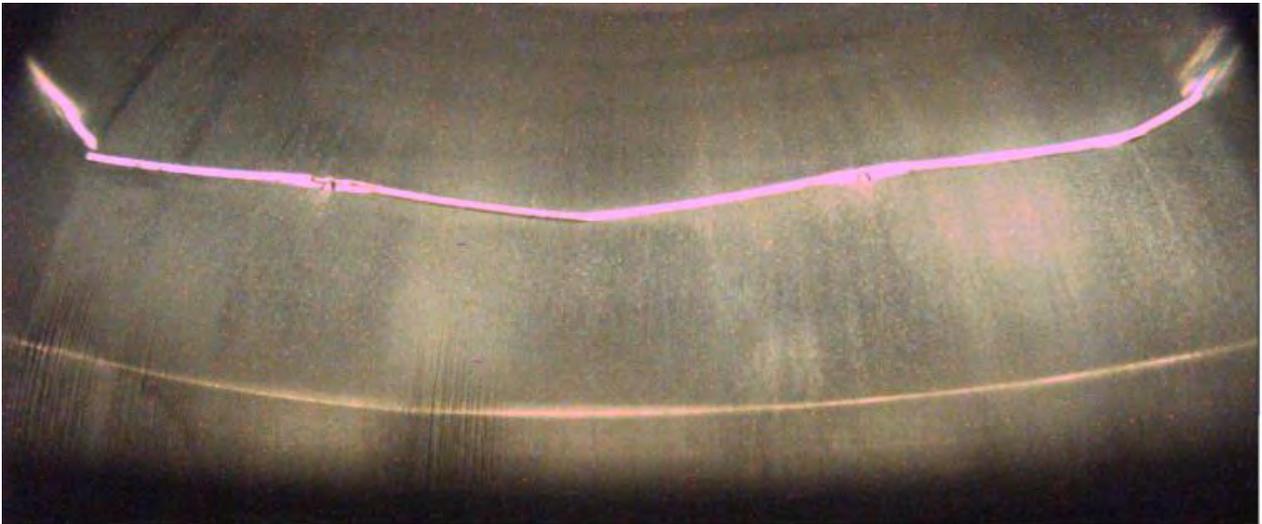
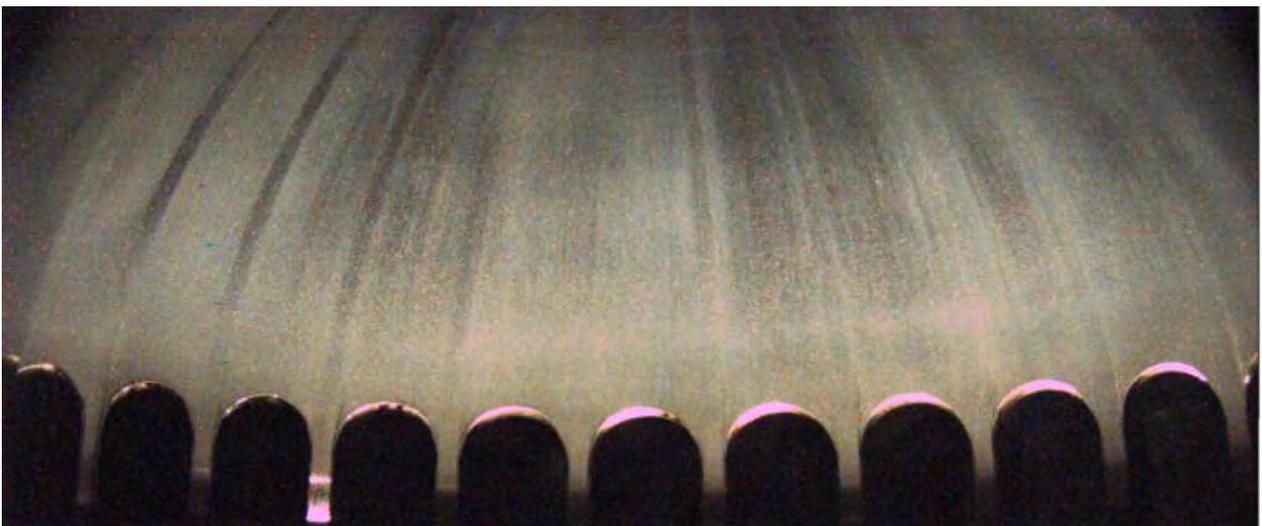
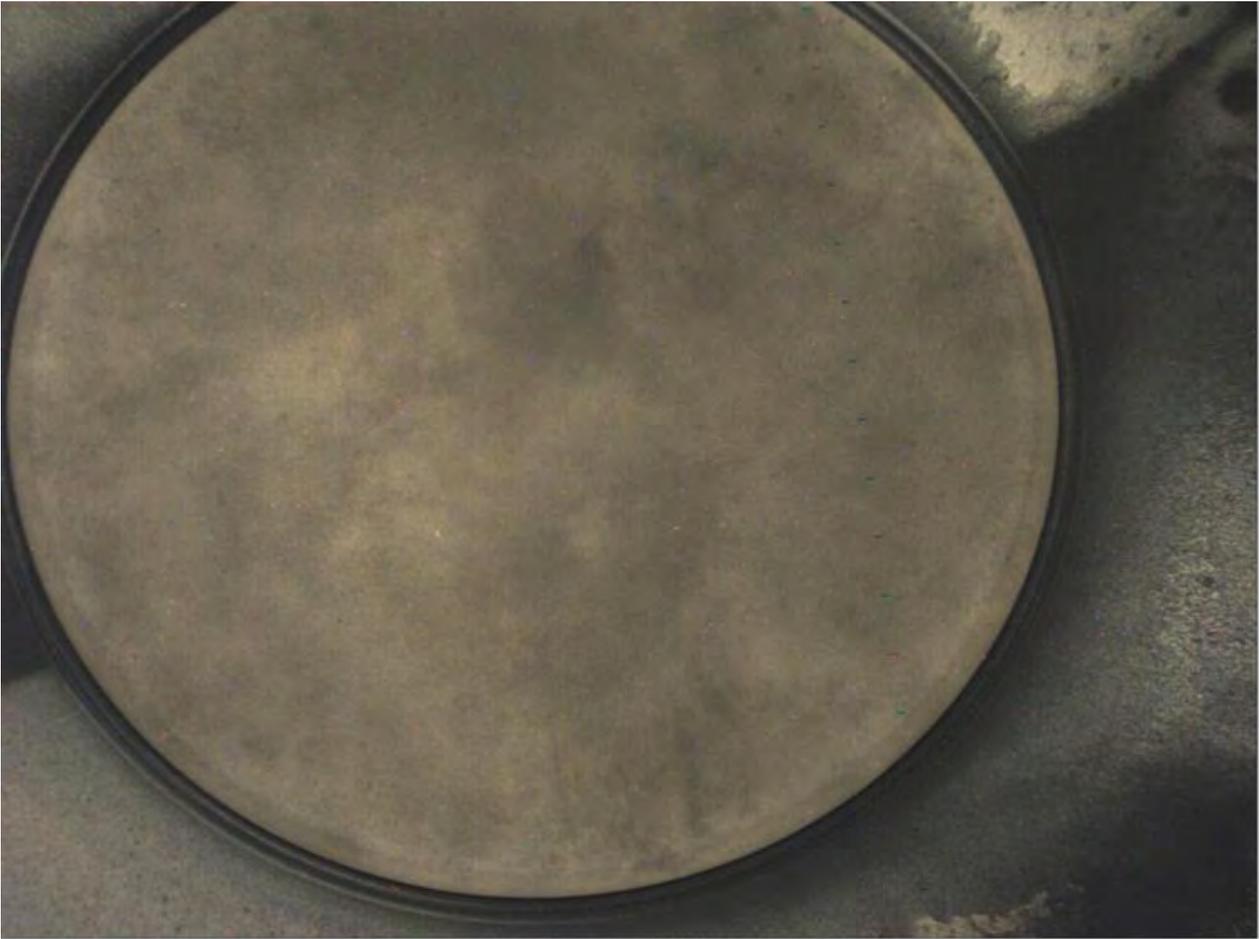
Unit #7 – Liner

Observations: Mat liner surface with black deposits and possible scuff marks. No wave-cut visible. Exhaust valve in good condition.
