Inspection Report

Cylinder liner inspection, Anonymous vessel @
142,394 Engine hours

Daniel Grunditz
Tel: +46 702 276900
daniel.grunditz@chris-marine.com

August 31st 2020

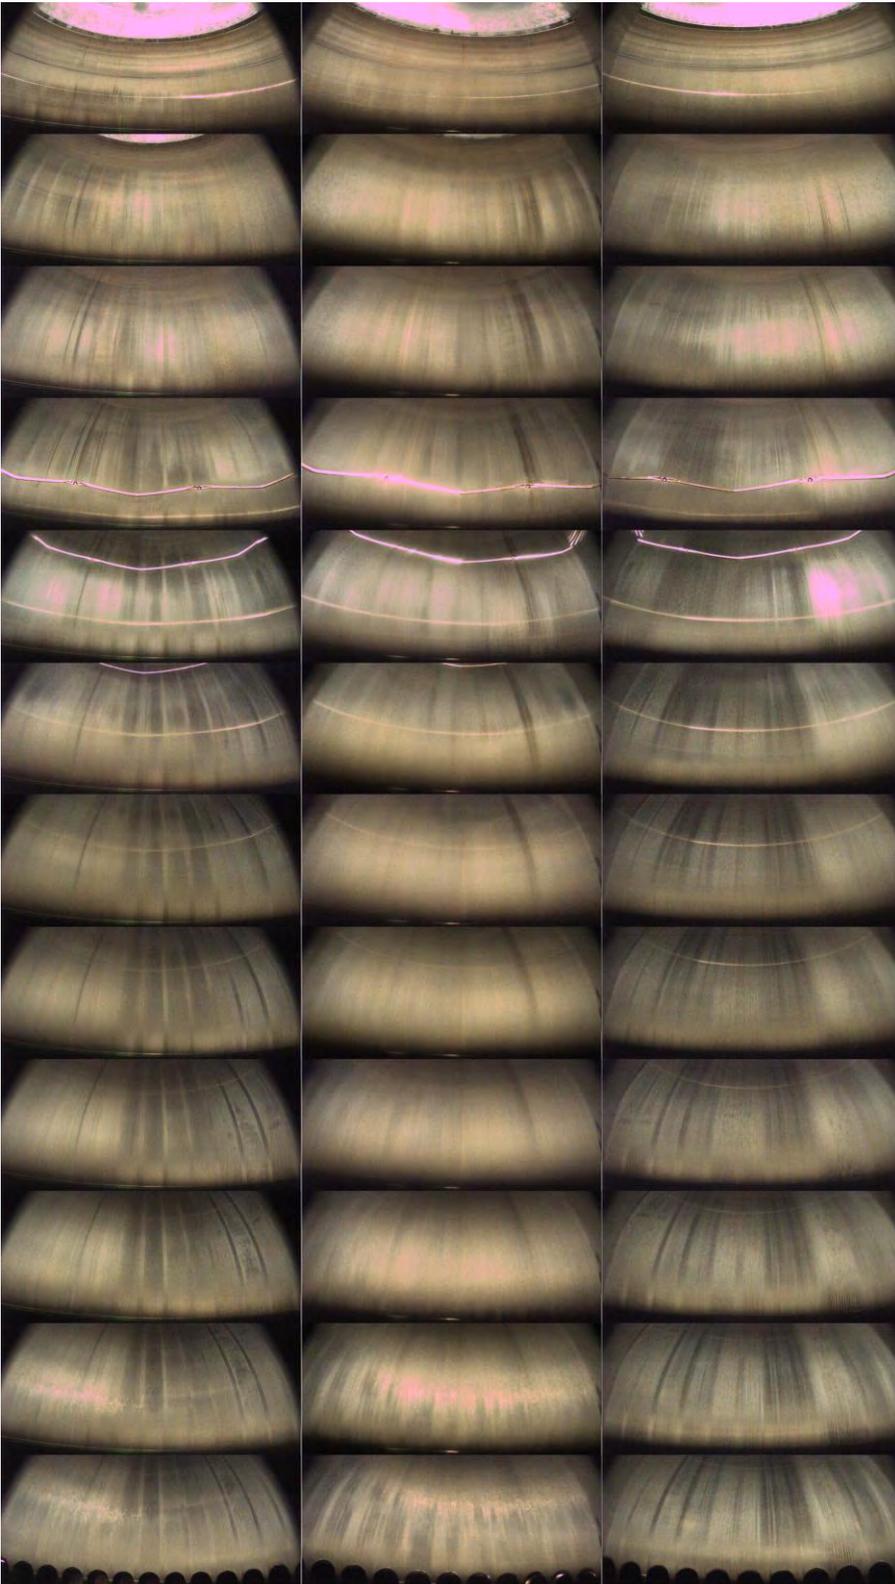
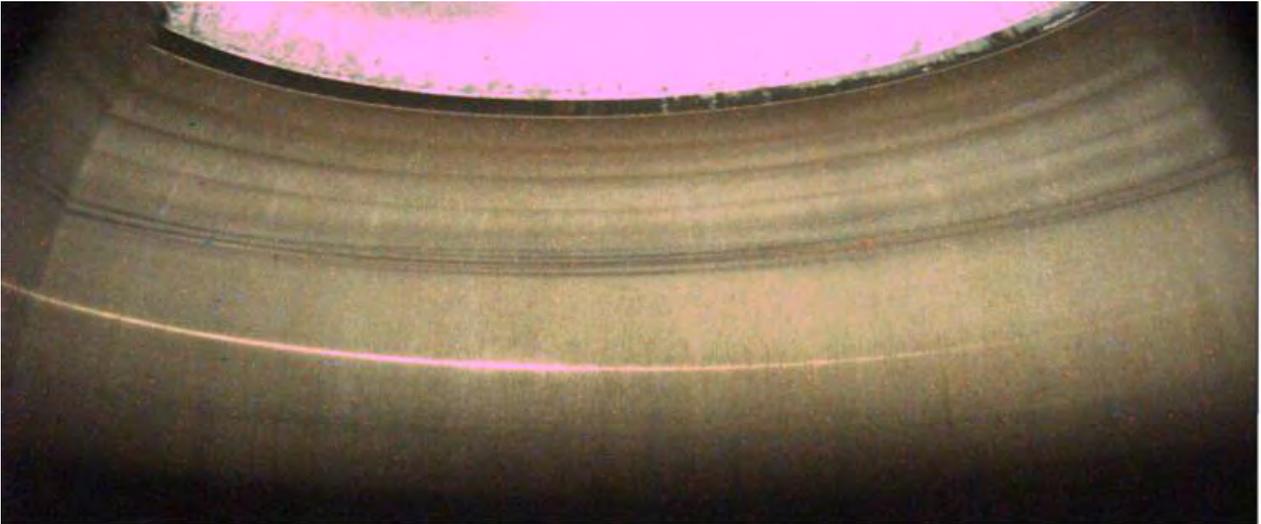
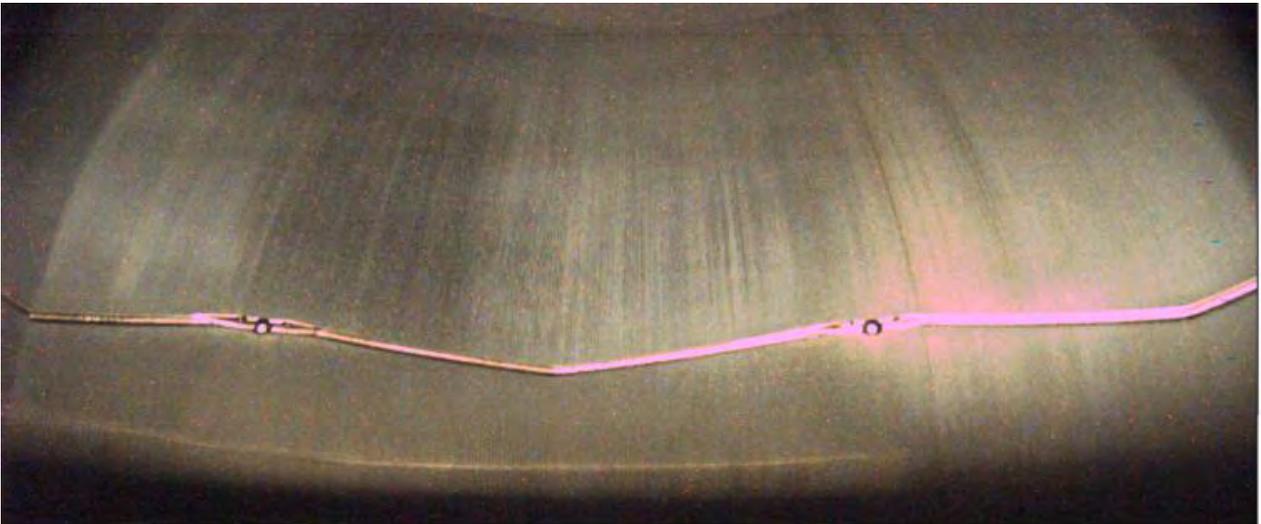
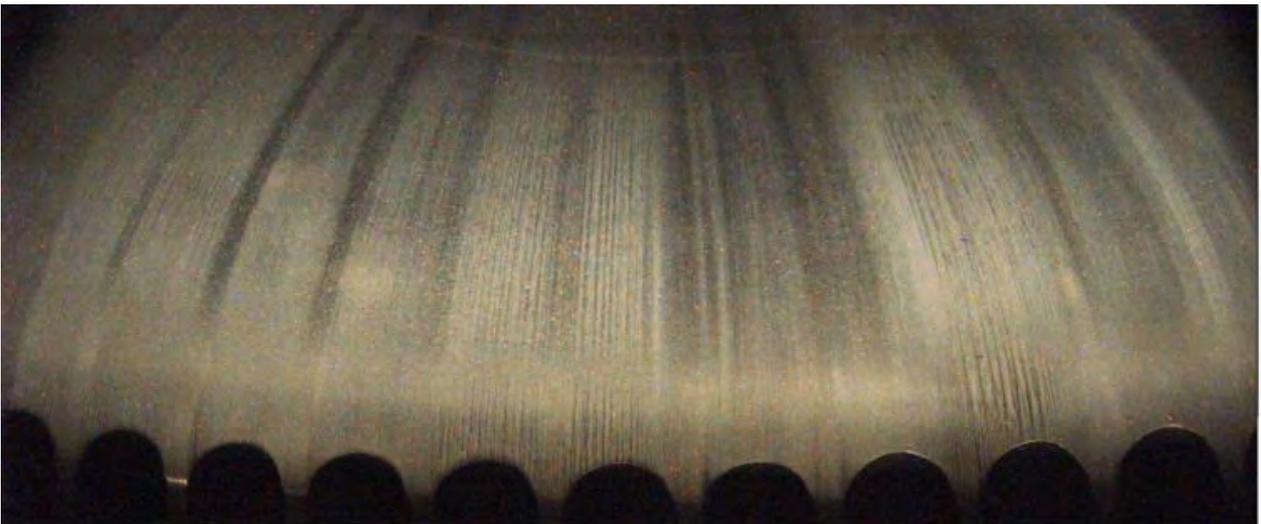
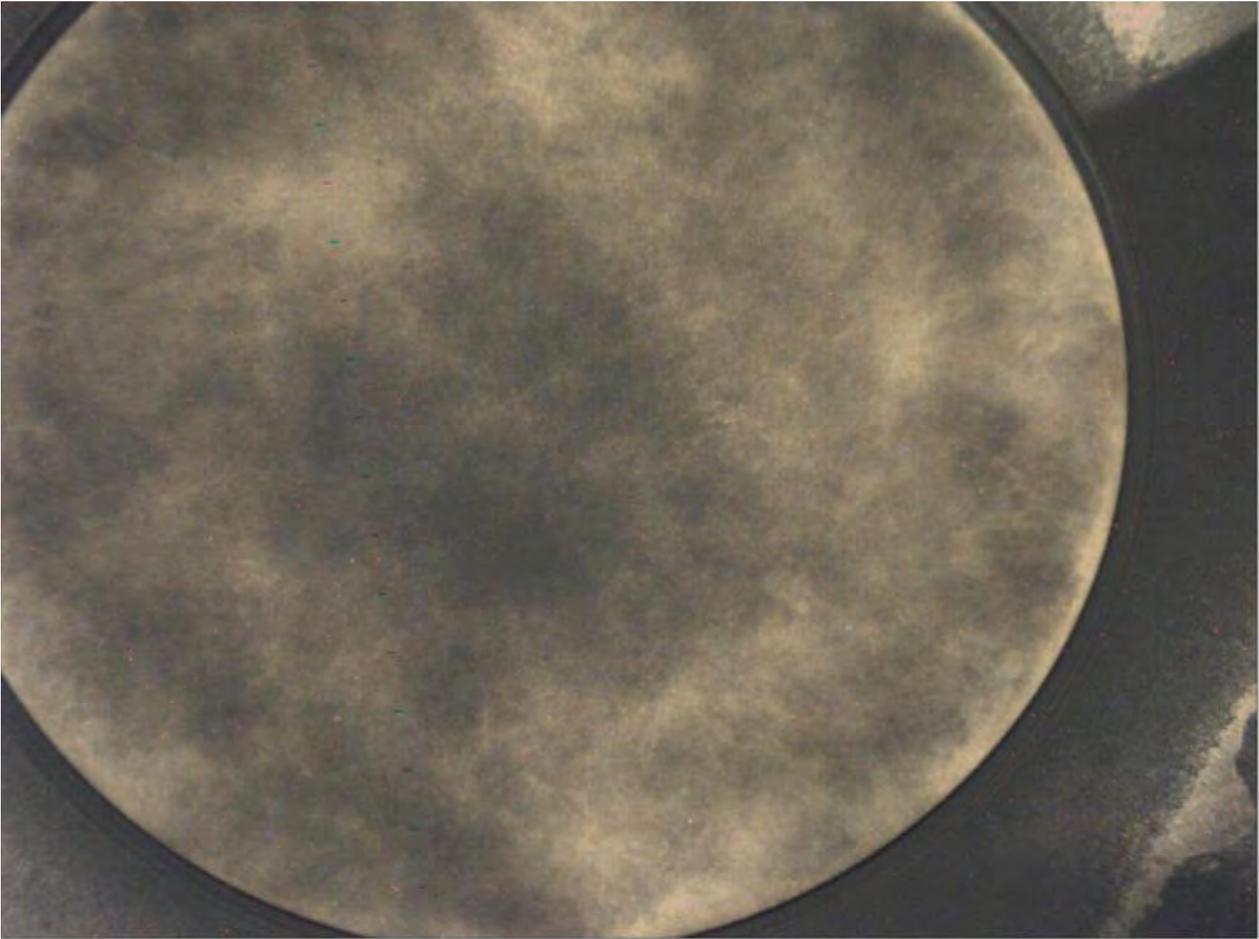
Unit #8 – Liner

Observations: Mat liner surface with black deposits. No wave-cut visible. Exhaust valve in good condition, but with some black deposits.

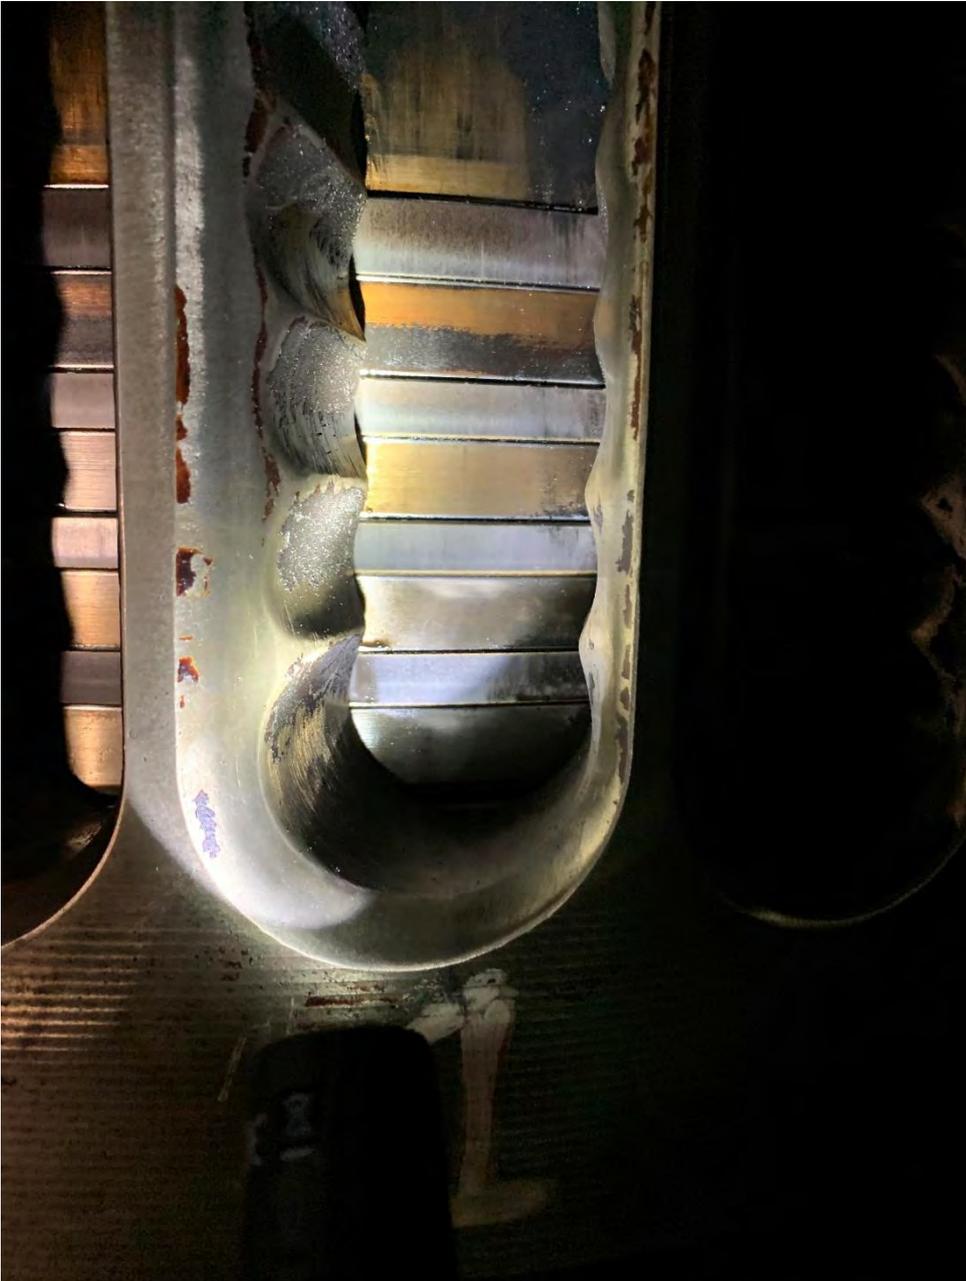
Unit #1 – Piston ring pack

Observations: Ring pack in good condition. No coke deposits. Possible hard contact on 1st ring.

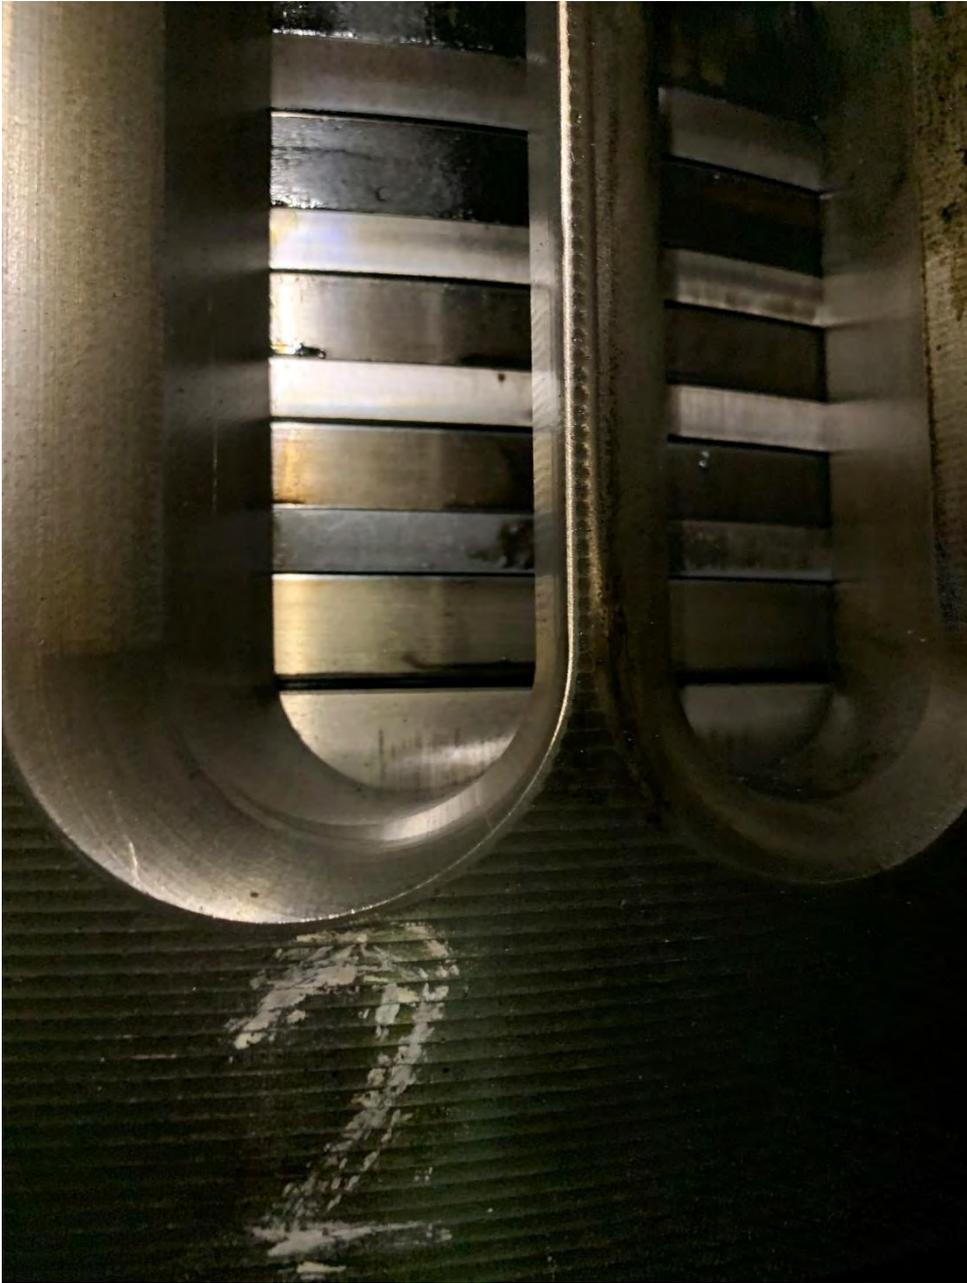
Unit #2 – Piston ring pack

Observations: Ring pack in good condition. No coke deposits.

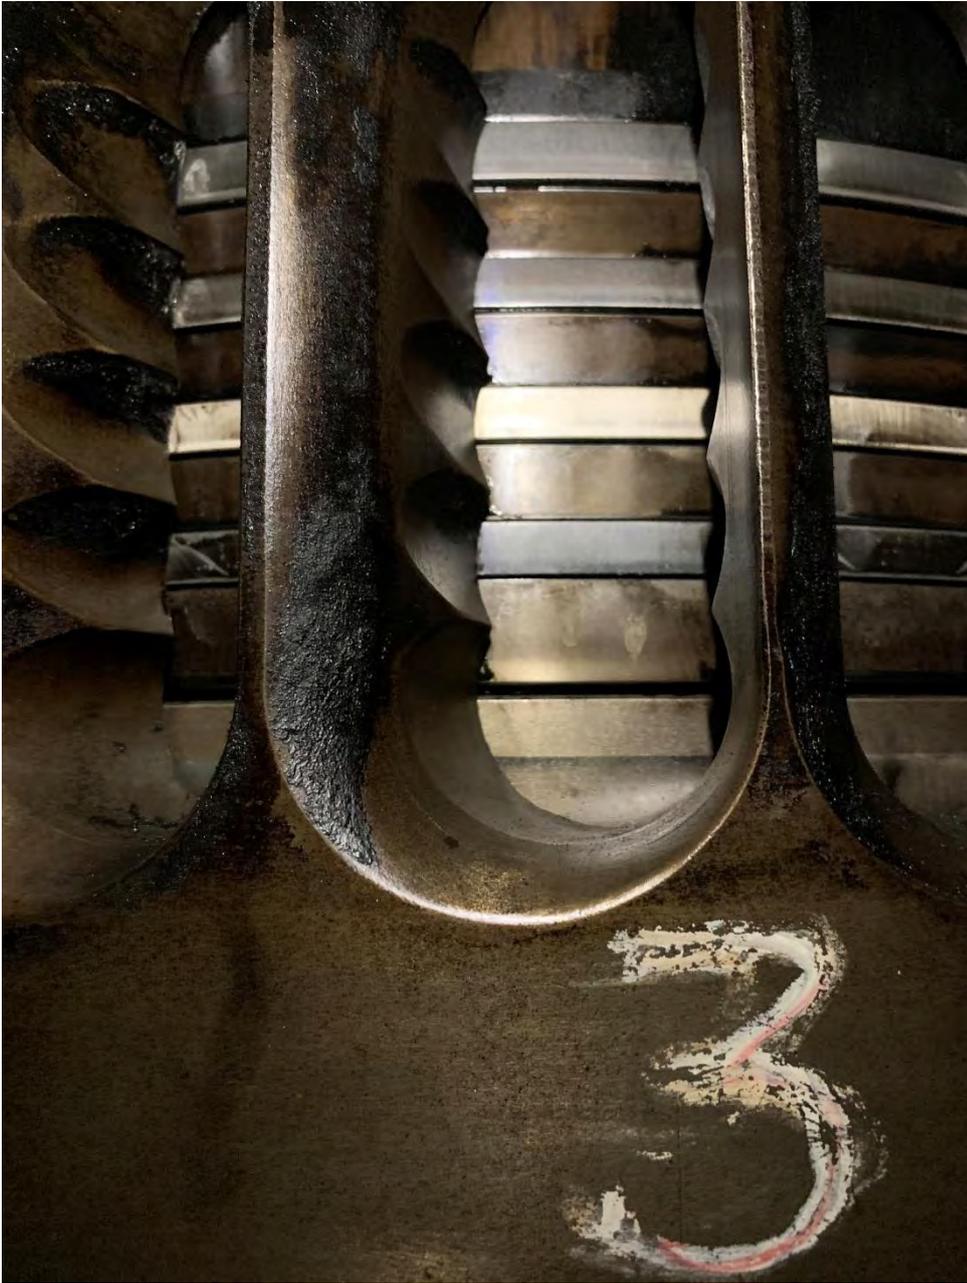
Unit #3 – Piston ring pack

Observations: Ring pack in good condition. No coke deposits.

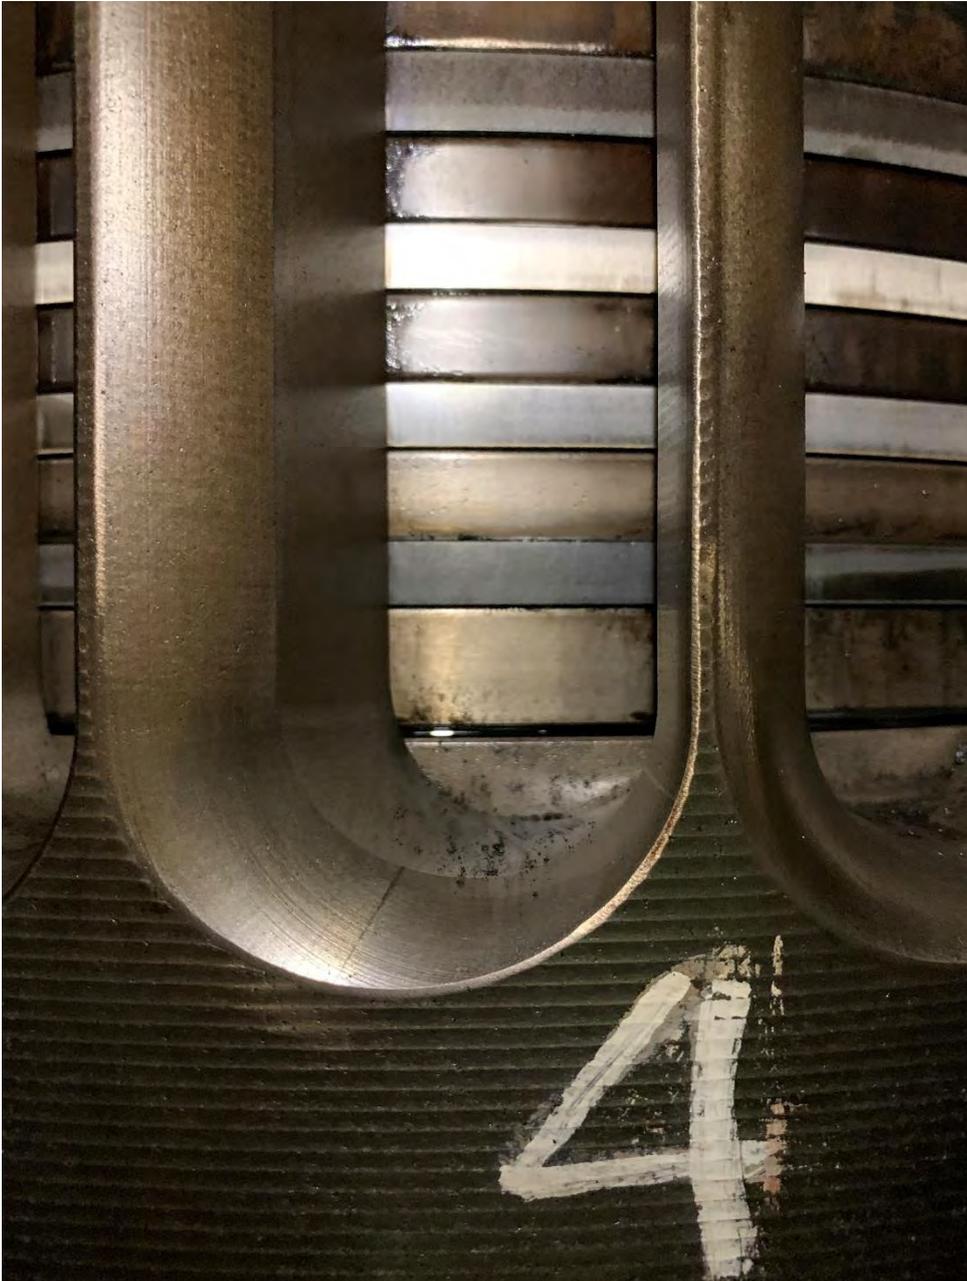
Unit #4 – Piston ring pack

Observations: Ring pack in good condition. No coke deposits. Possible hard contact on 1st ring.

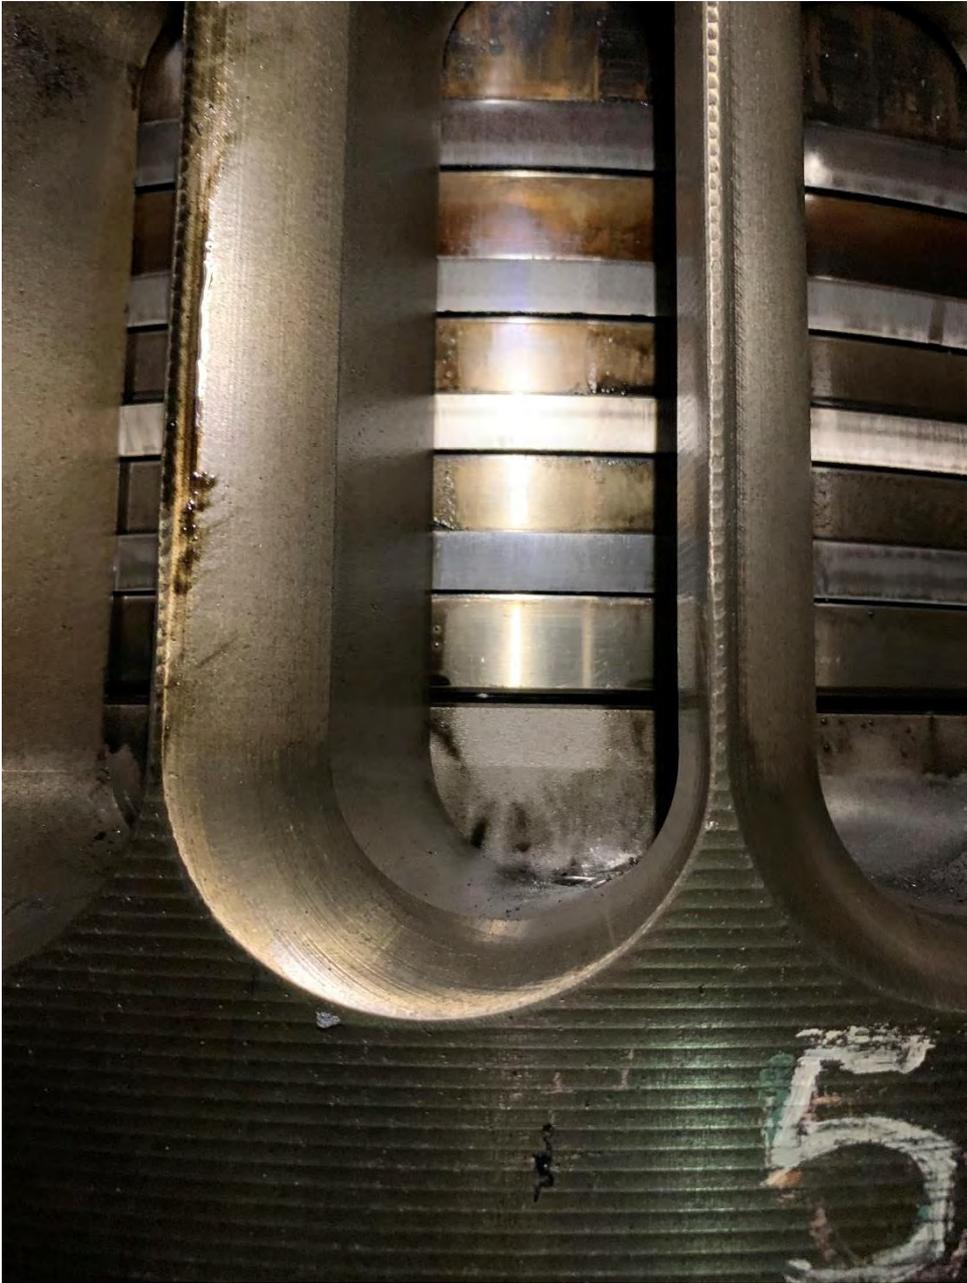
Unit #5 – Piston ring pack

Observations: Ring pack in good condition. No coke deposits. Possible hard contact on 1st ring.

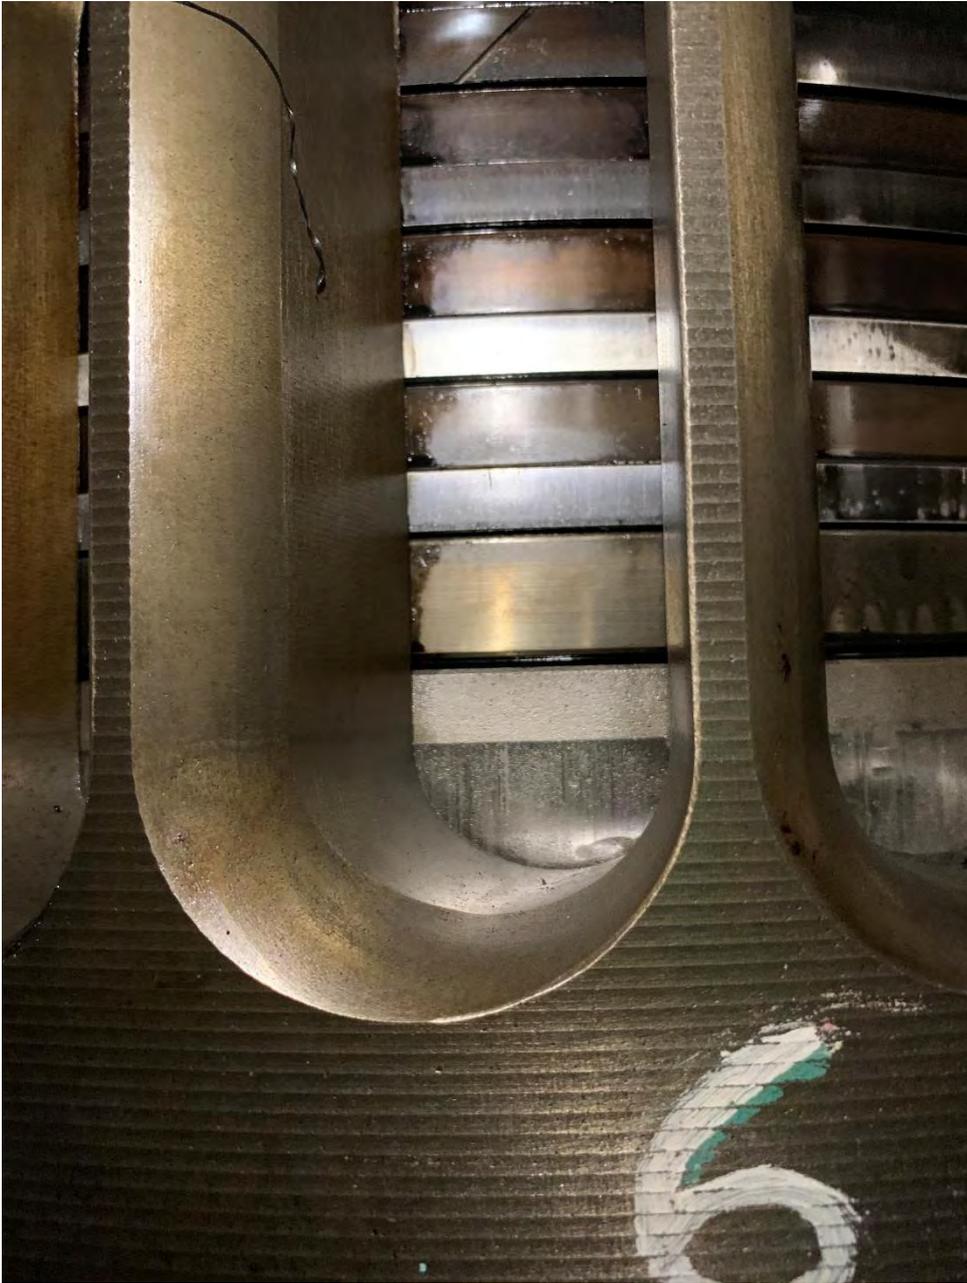
Unit #6 – Piston ring pack

Observations: Ring pack in good condition. No coke deposits. 1st and 2nd rings appear to have been over-heated.

- Immediate honing and optionally also wave-cut grinding or replacement of unit #6 is needed as it is currently scuffing. The scuffing is yet not clearly visible on rings, but micro-cracks have formed in the liner surface as a result of over-heating.

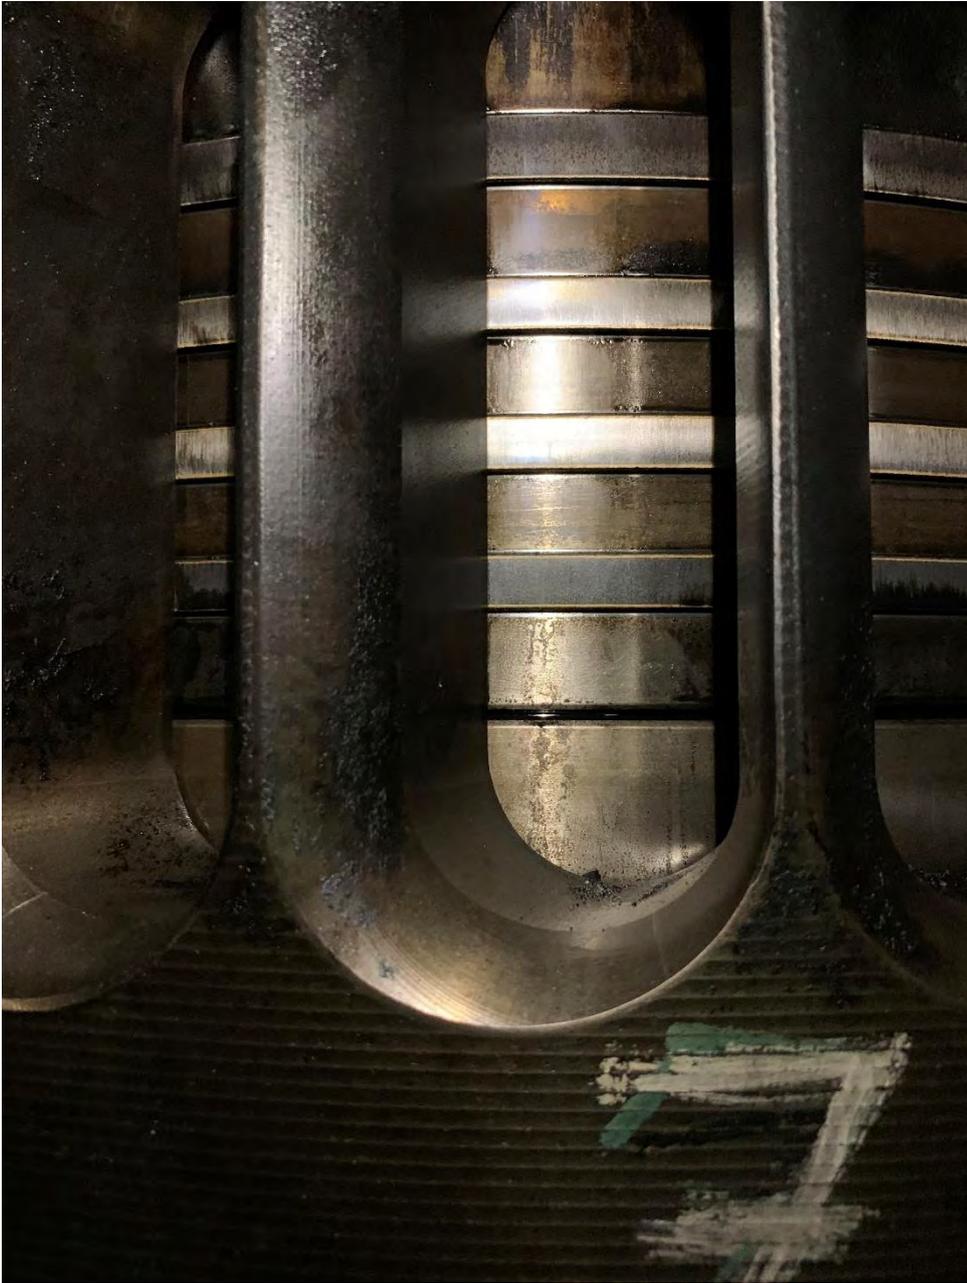
Unit #7 – Piston ring pack

Observations: Ring pack in good condition. No coke deposits. Possible hard contact on 1st ring.

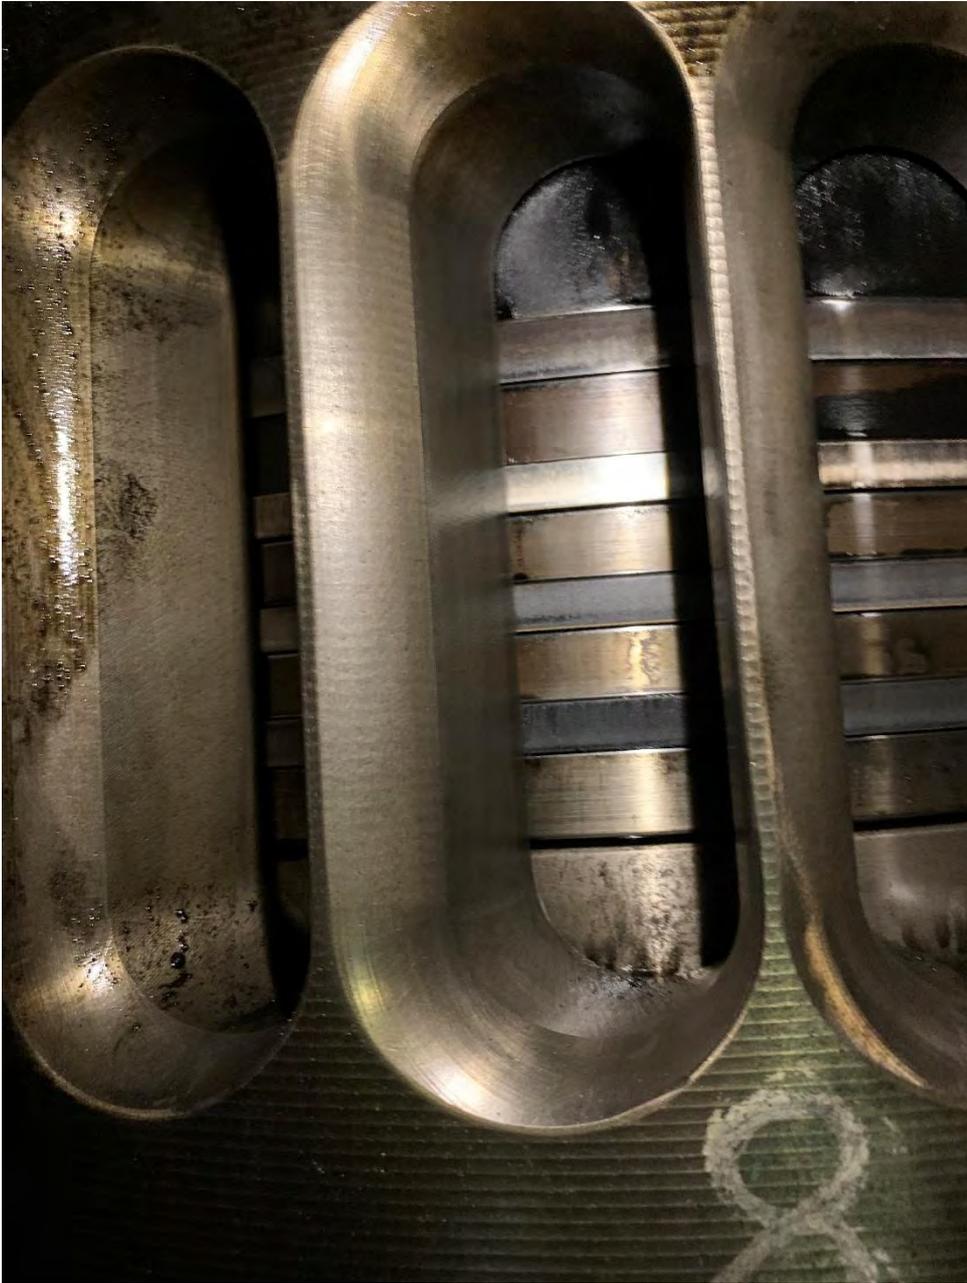
Unit #8 – Piston ring pack

Observations: Ring pack in good condition. No coke deposits.
