EXPERIENCE SHARE BULLETIN

OKTO Engineering

THE FORGOTTEN PARTS OF MAIN ENGINE

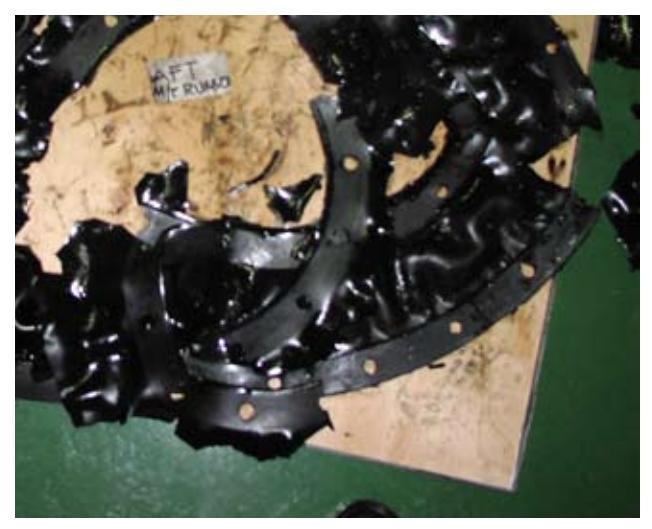
Defective rubber membranes may cause severe engine damage.

In both cases described above excessive quantities of water on the tank top entered the main engine sump tank, and subsequently contaminated the main engine lubricating oil system, resulting in severe damage to the main engine bearings.

In line with the recommendation issued by MAN Diesel A/S, Copenhagen, we recommend that all membranes are replaced in connection with every relevant scheduled inspection of the ship.

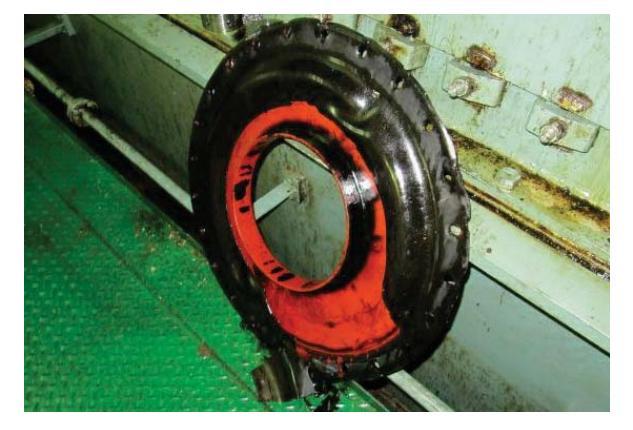
In all cases excessive quantities of water on the tank top have entered the main engine sump tank via the defective diaphragm and subsequently contaminated the main engine lubricating oil system, resulting in severe damage to the main engine bearings and journals.

Failed diaphragm

In line with the recommendation issued by MAN Diesel A/S, Copenhagen, we recommend that all diaphragms are replaced in connection with every relevant scheduled inspection of the ship.

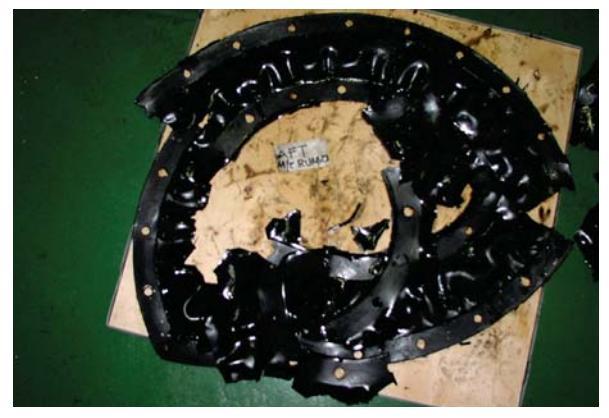
Deteriorated diaphragm

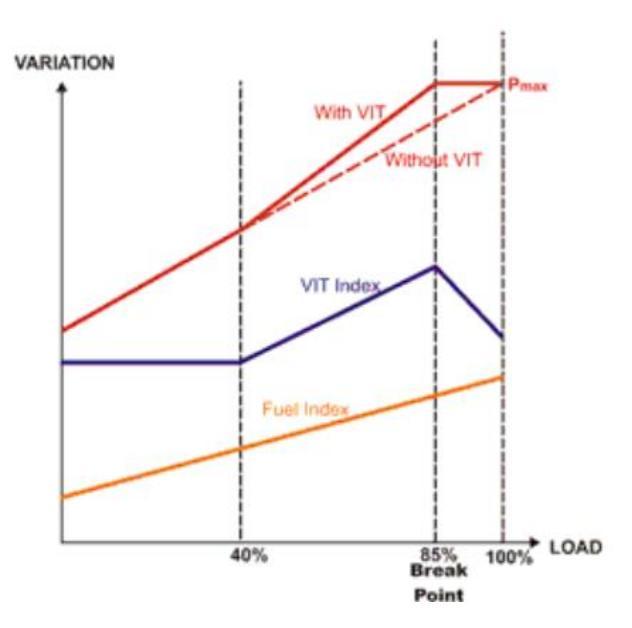
VIT SYSTEM FOUND AS BELOW.TEFLON RINGS INSTALLED, TIGHTENED WITH WIRE.IT IS NOT POSSIBLE TO ARM PUSH THE VIT CONTROL VALVE. VIT CAN NOT WORK.

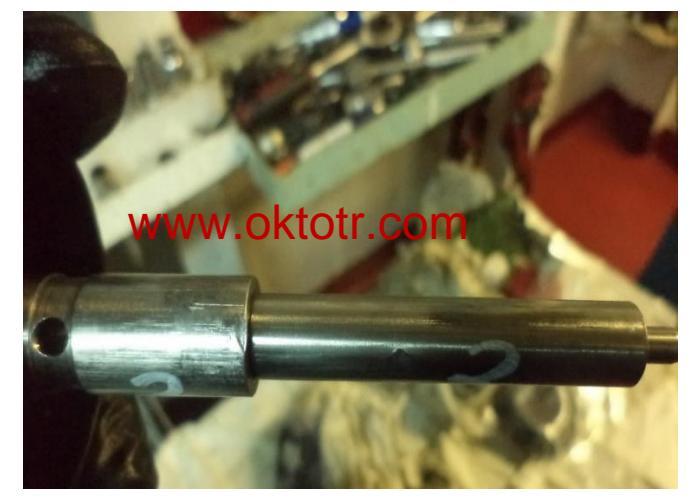
SCRATCH ON VIT ACTUATOR SPINDLE

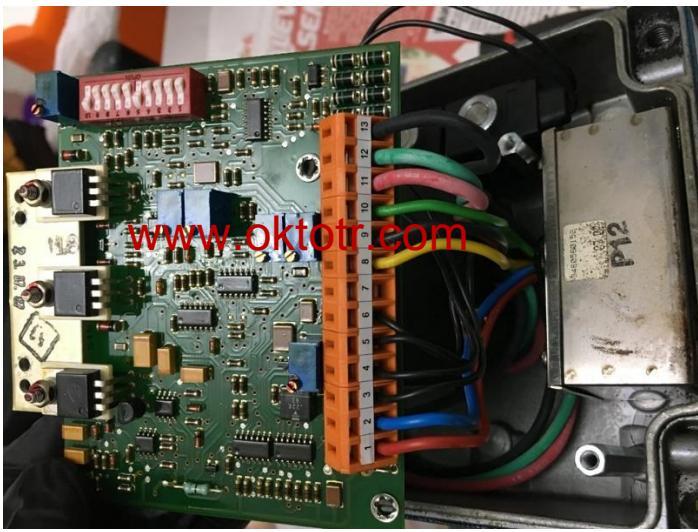
DEFECTIVE I/P CONVERTER

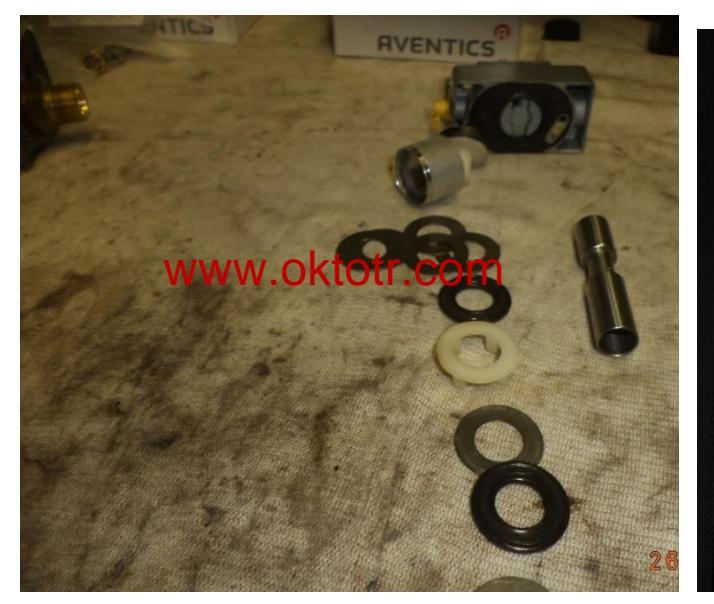
DEFECTIVE Pos.40 V/V

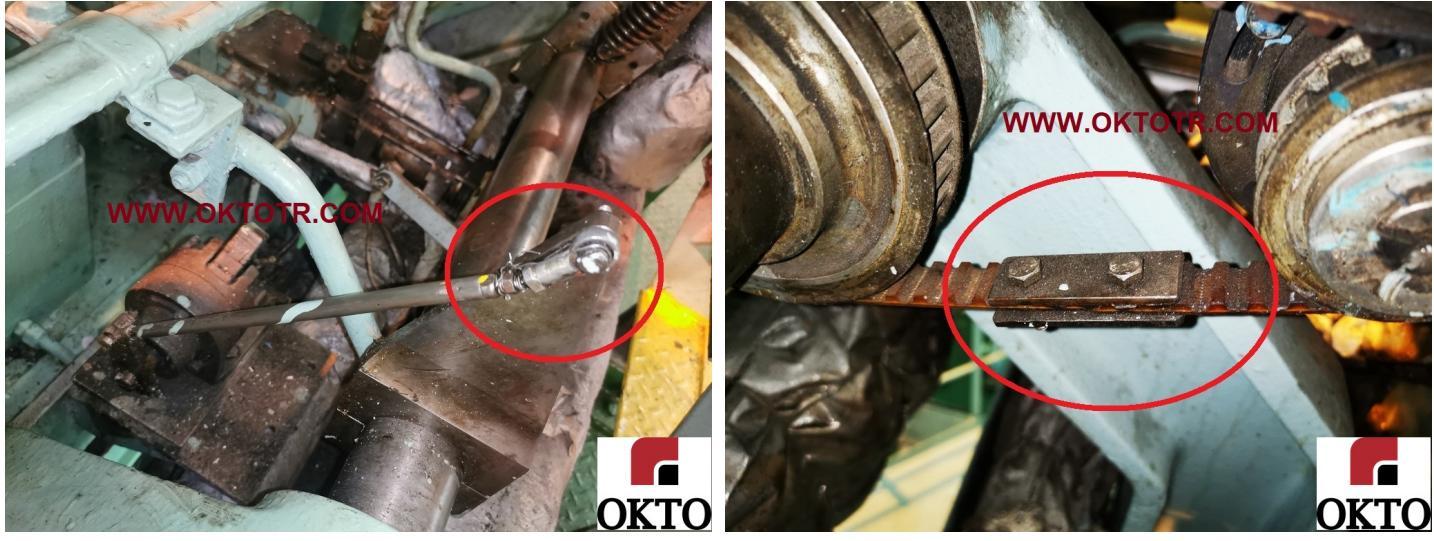
DEFECTIVE INDEX TRANSMITTER ARMS

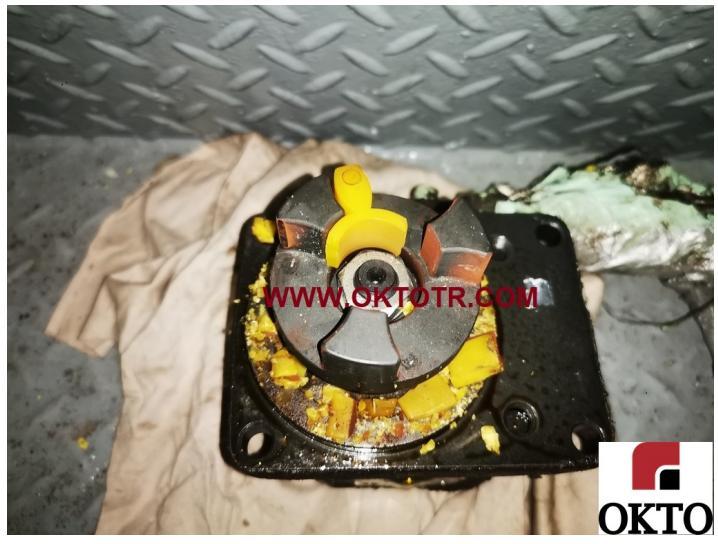
DAMAGED SPIDER COUPLING ELEMENT

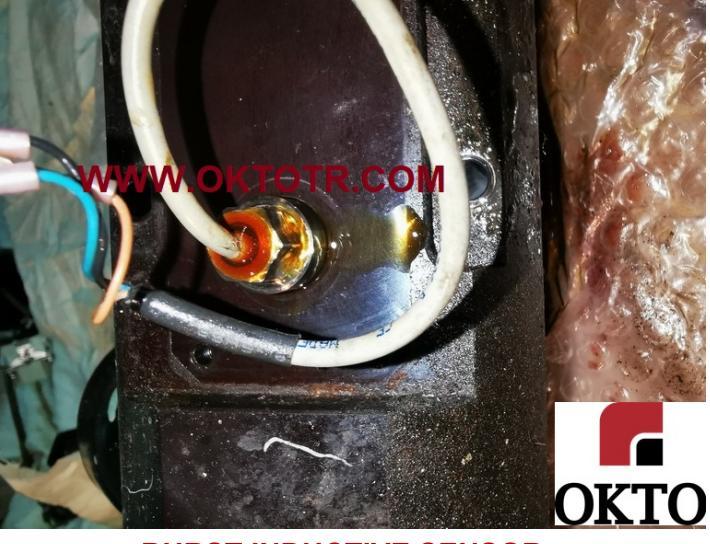
BURST INDUCTIVE SENSOR

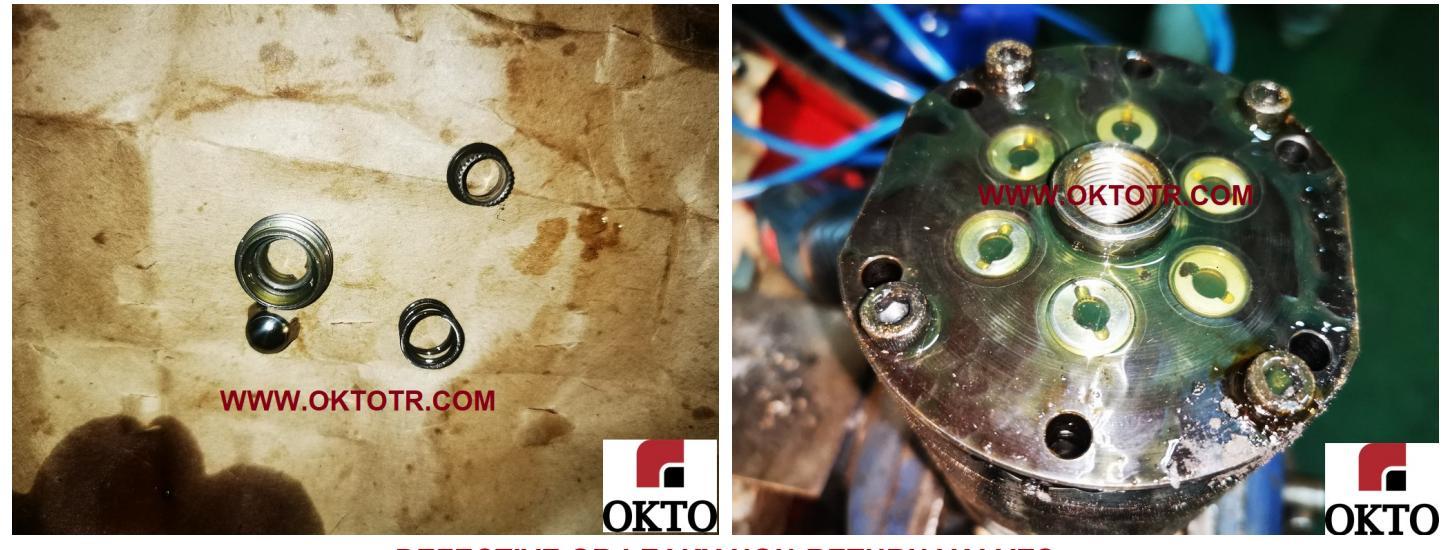
DEFECTIVE OR LEAKY NON-RETURN VALVES

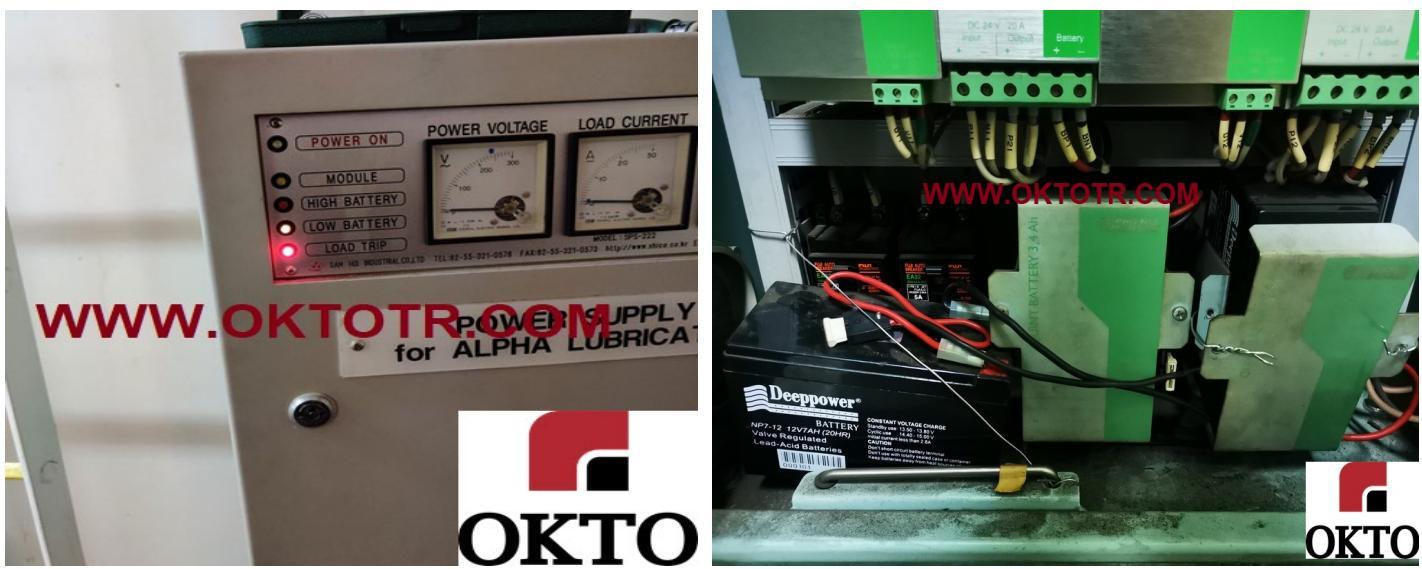
D. POWER SUPPLY UNIT AND EXPIRED BATTERY GROUP

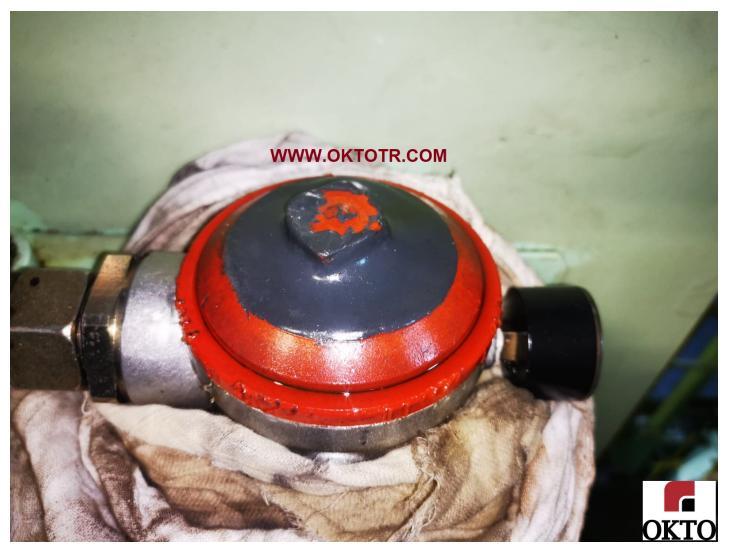
BROKEN FILTER COVERS

ALUMINIUM FILTER COVERS SUPPLIED BY OKTO

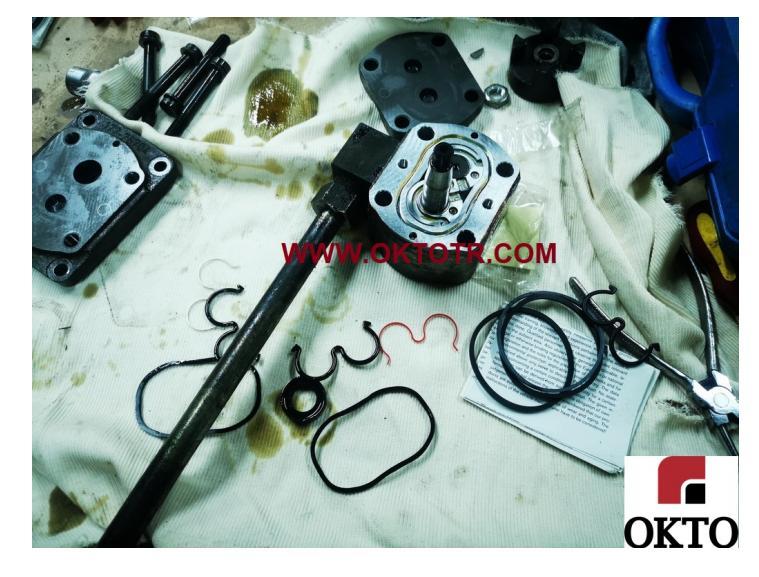
D. LUB OIL SUPPLY PUMPS

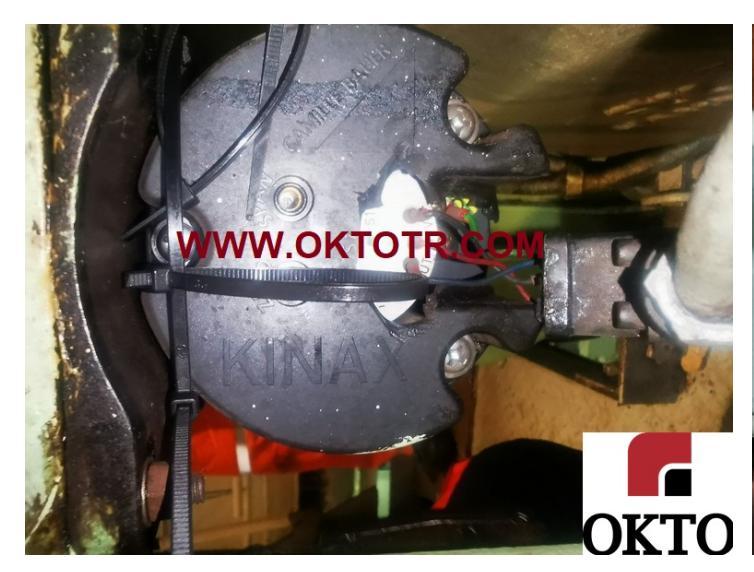
D. INDEX TRANSMITTER

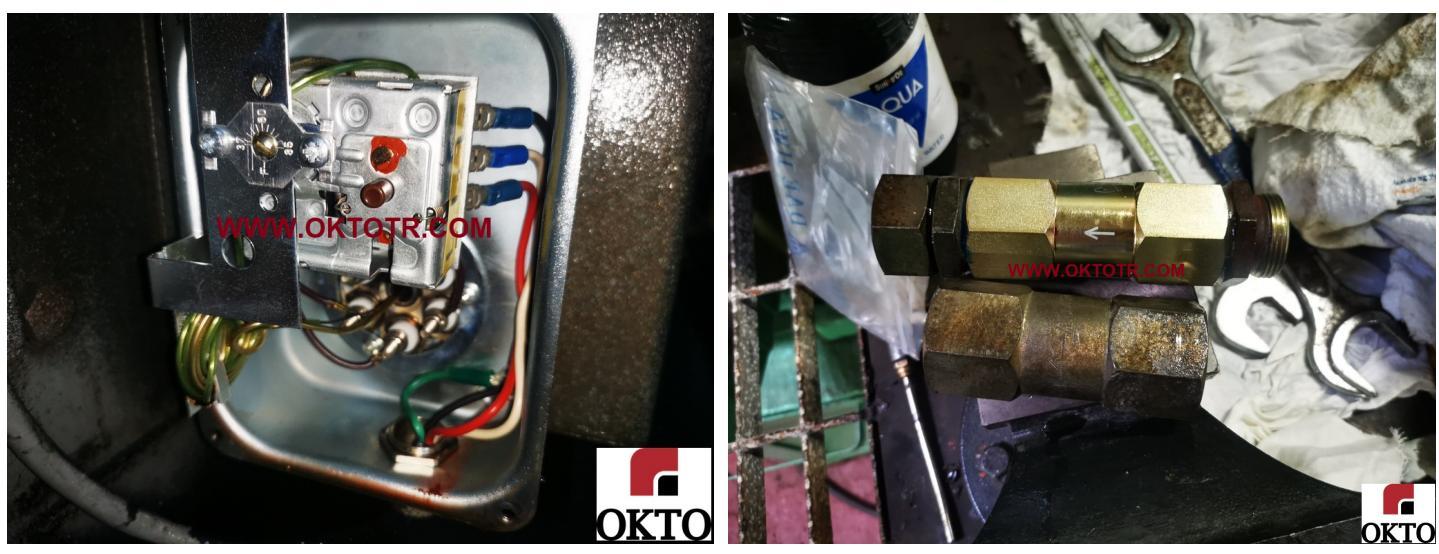
WRONG ADJUSTED HEATER OR DEFECTIVE THERMO VALVE

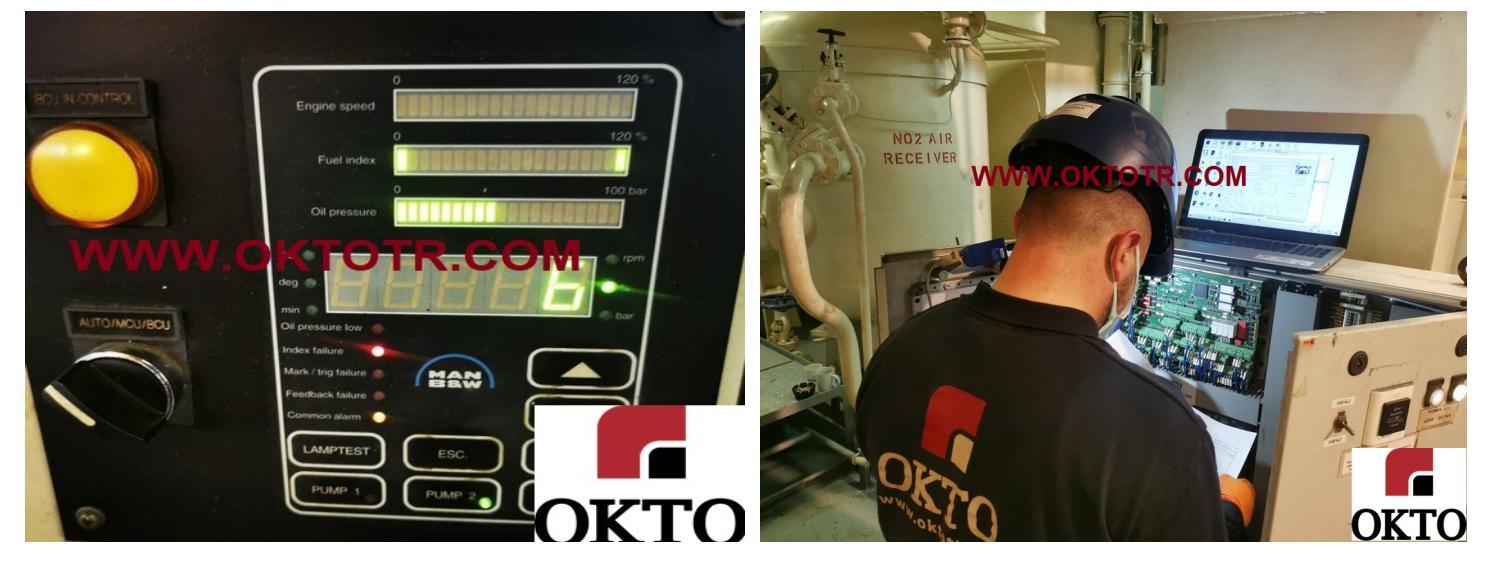
MALADJUSTED INDEX TRANSMITTER OR PARAMETERS

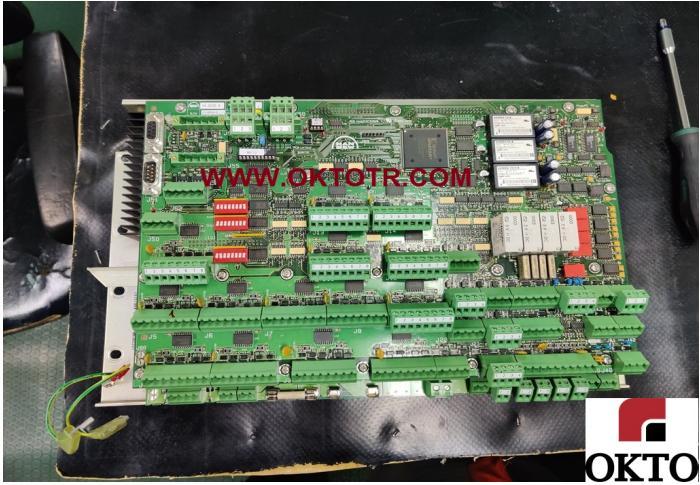
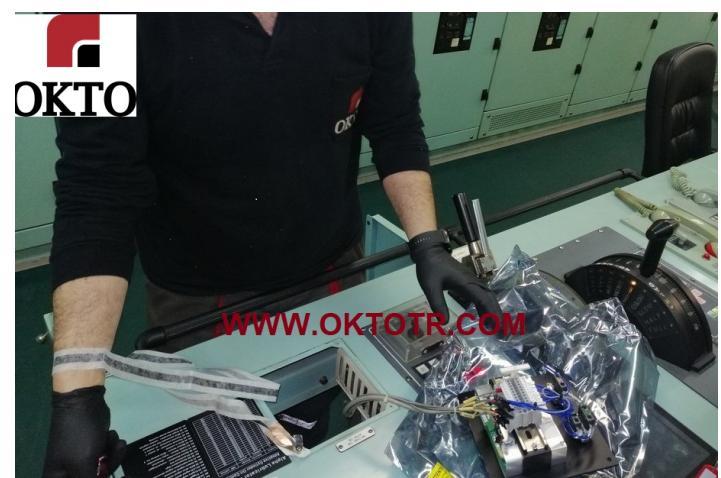
DEFECTIVE ELECTRONIC COMPONENTS

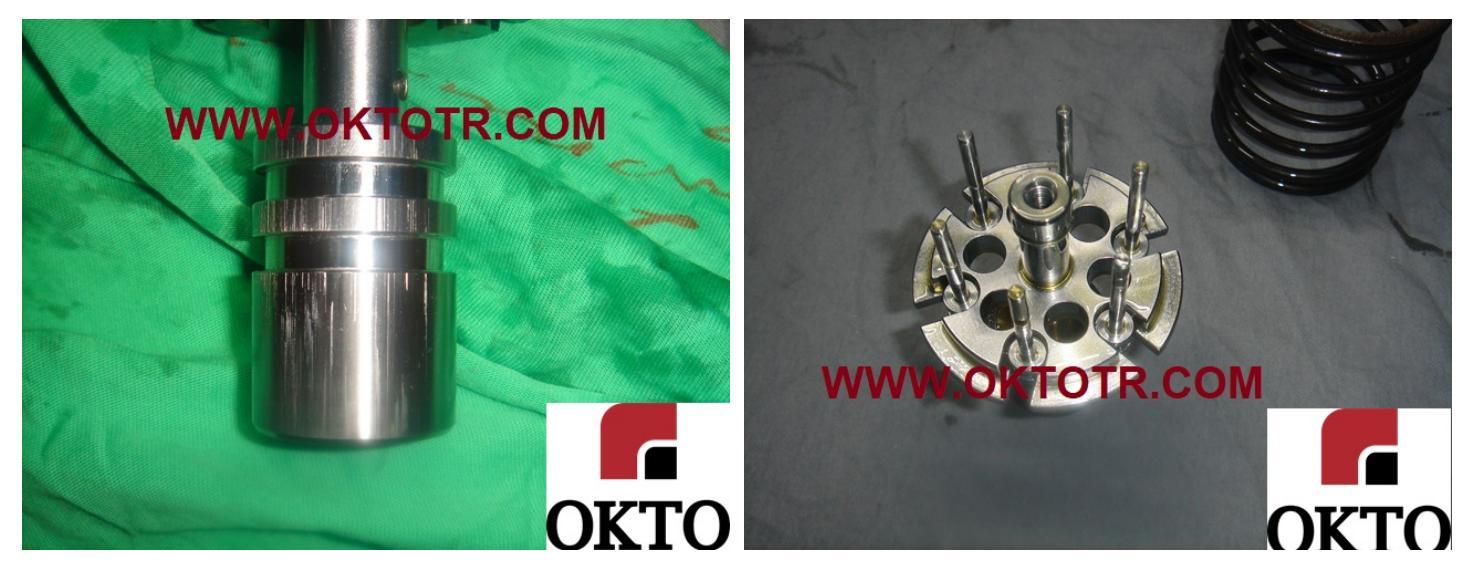
DAMAGED PISTON SURFACES

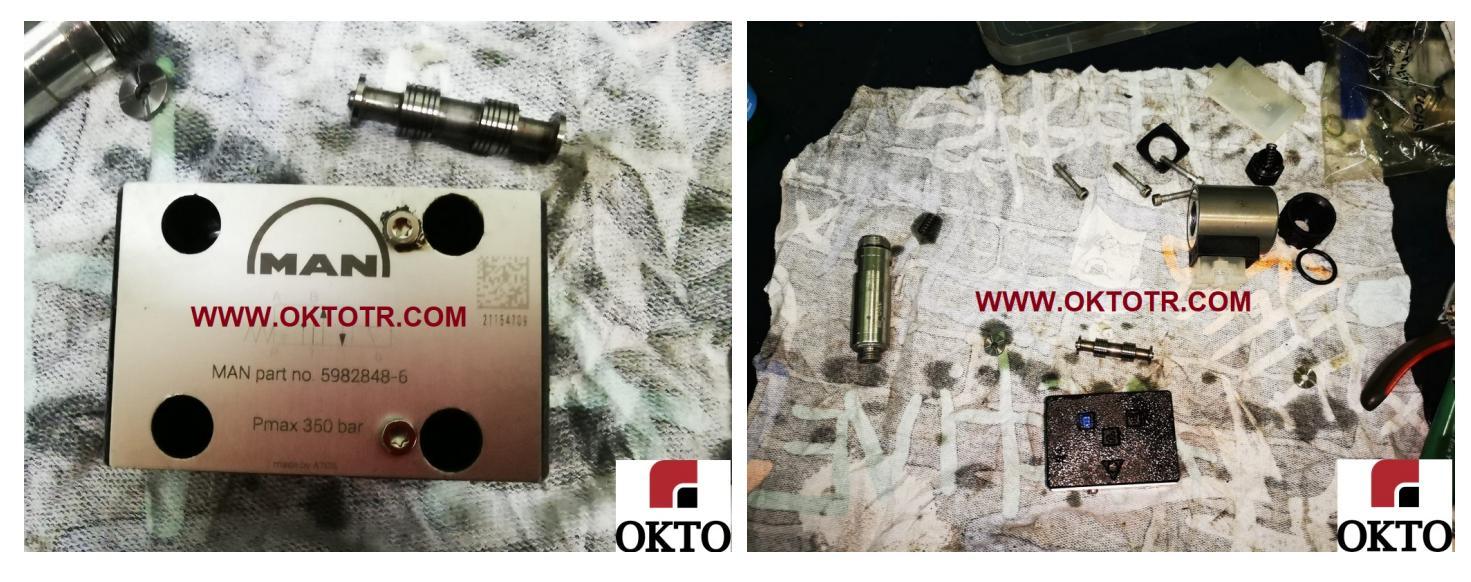
RECENT MAN SUPPLIED SOLENOID VALVES WHICH FABRICATED BY ATOS TEND TO FAILURE IN EARLY STAGE WHICH CAUSE THE FEEDBACK ALARM

WE ARE ABLE TO SUPPLY TROUBLEFREE REXROTH SOLENOID VALVES

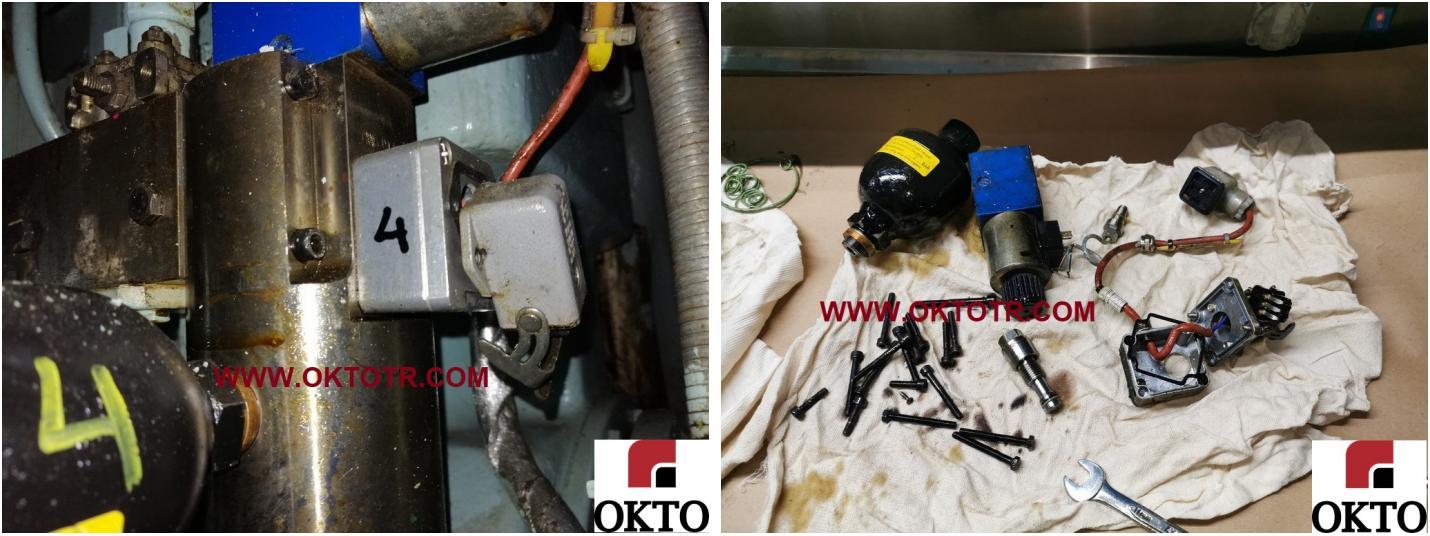
DEFECTIVE PLUG CONNECTIONS

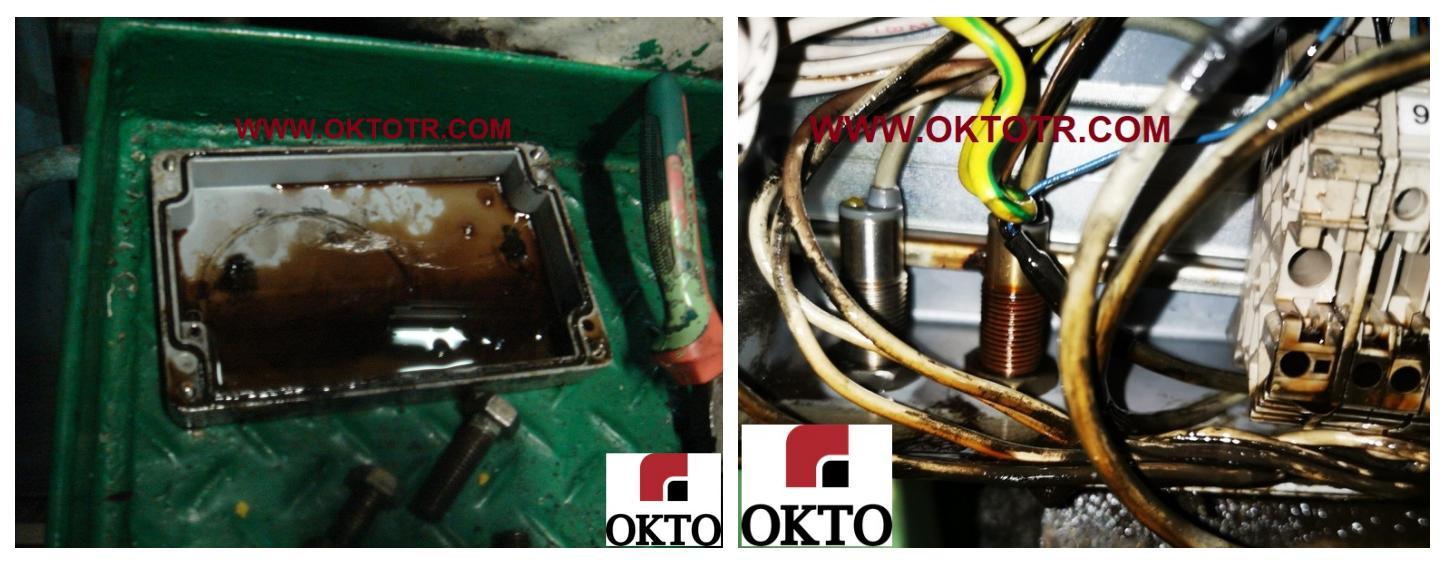
D. PICK UP SENSORS

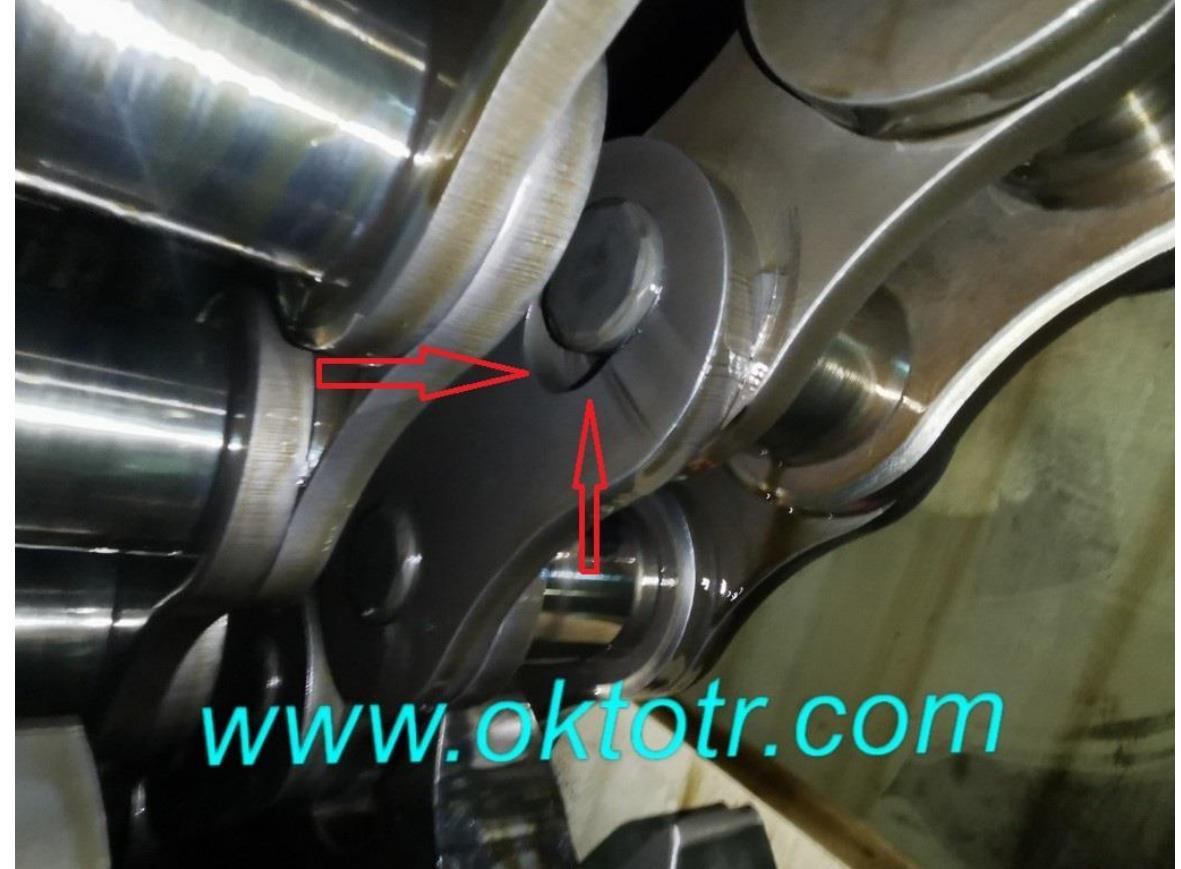
DEFECTIVE LINK

In order to rectify such serious defects, damaged ones have been replaced with new link thus the proper tightening adjustment performed according to the manufacturer specifications.

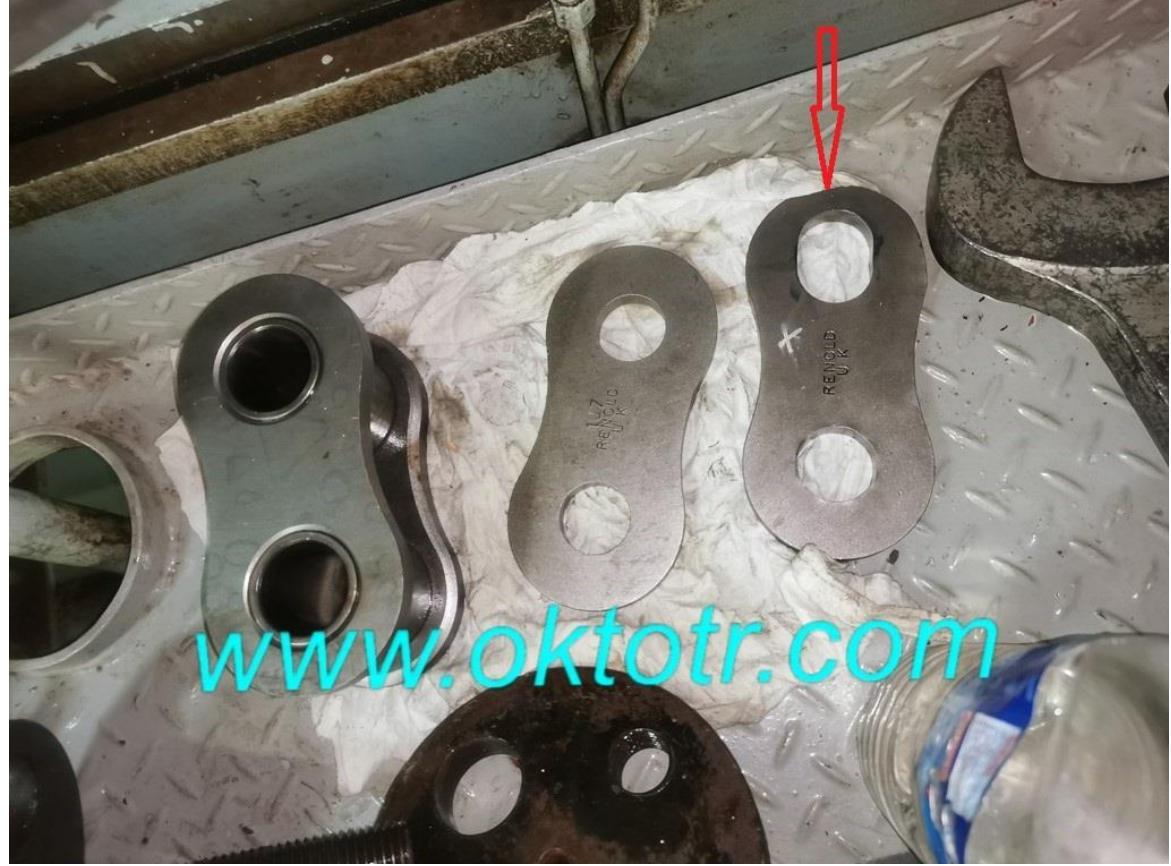
CHAIN LINK ABOUT TO DETACHED
