CHECKING AND ADJUSTMENT OF THE EXHAUST CAM FOR TWO STROKE MAN B&W MC ENGINES

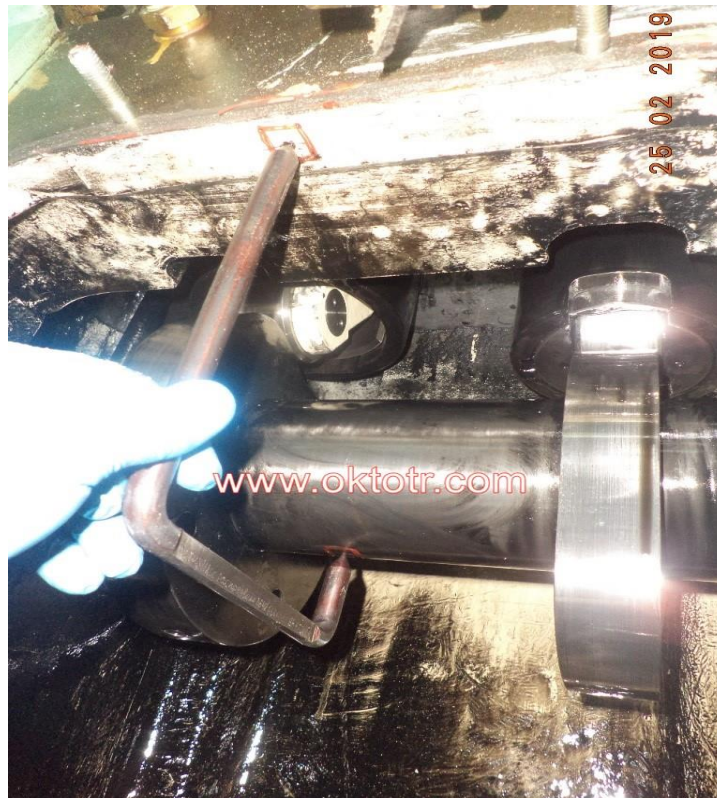
1. Stop the engine and close the starting air.
2. Stop the lubrication oil pump.
3. Remove the exhaust valve hydraulic pipe.
4. Bring the NO:1 cylinder to TDC. Measure the crankshaft position with pin gauge and confirm NO:1 cylinder exactly at TDC. (Recommended). Measure the camshaft position by pin gauge and confirm camshaft is in correct position. You should read 0 degrees on the turning wheel.

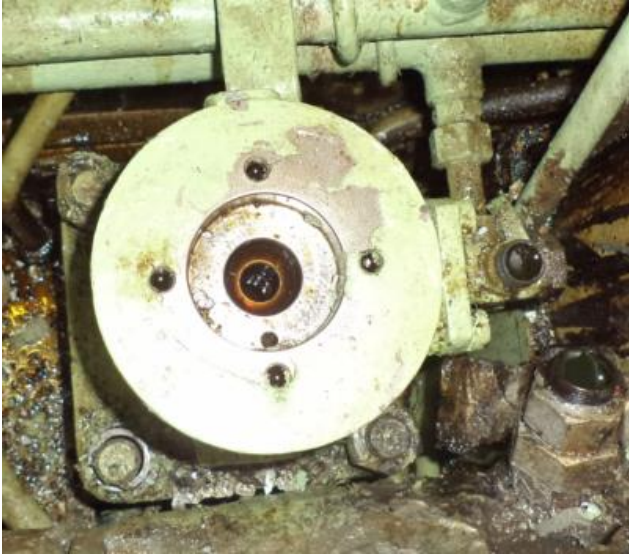
EXHAUST ROLLER OIL CYLINDER

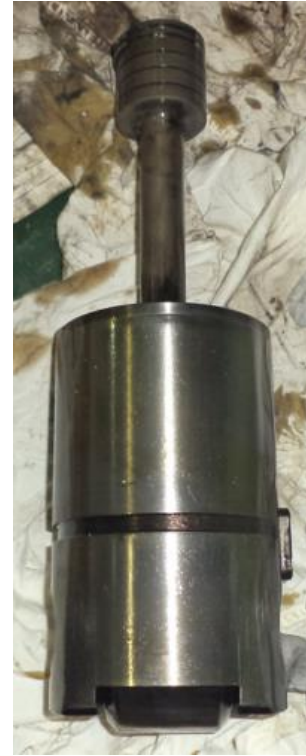
EXHAUST ROLLER AT
DISMANTLED CONDITION(FOR
REFERENCE ONLY) MEASUREMENT CAN
BE TAKEN ON THE TOP OF THE PISTON
WITHOUT REMOVING OIL CYLINDER AND
ROLLER
