EXPERIENCE SHARE BULLETIN

OKTO Engineering

THE FORGOTTEN PARTS OF MAIN ENGINE

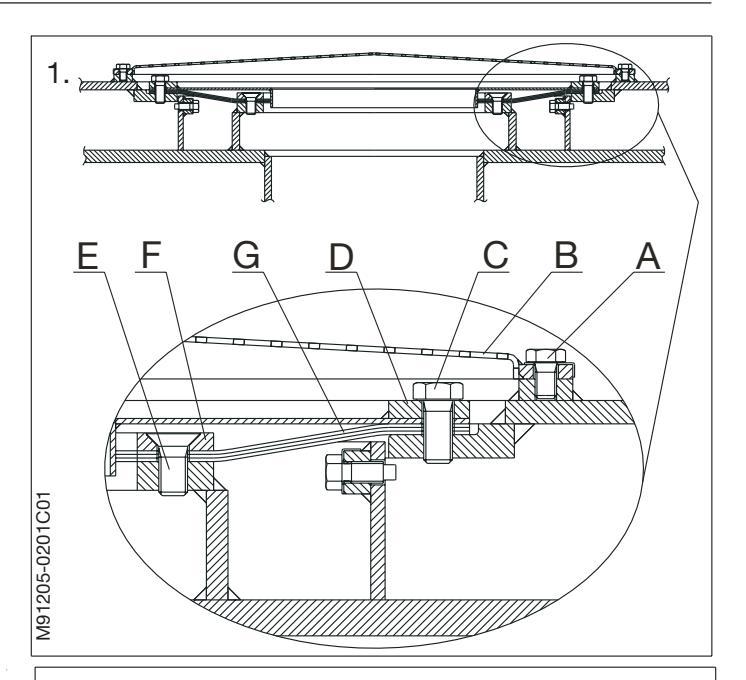
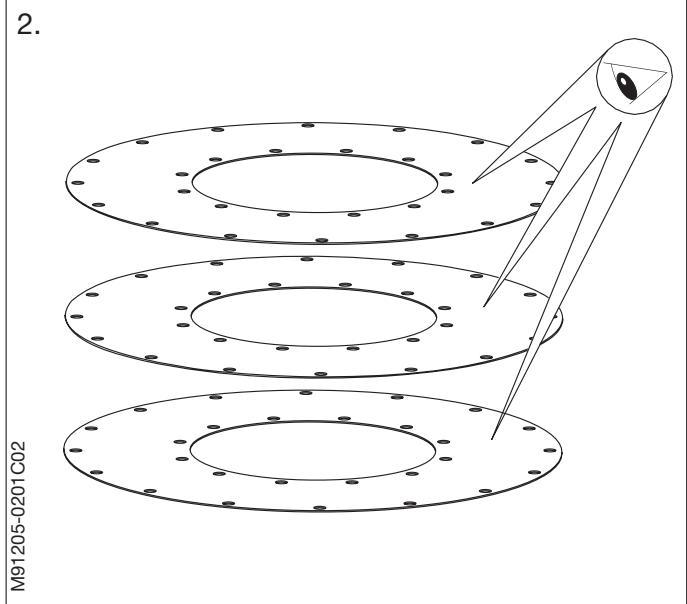
- To access the rubber diaphragm sealing remove: Screws A Grating B Screws C Cover plate D Screws E Steel ring F.
- 2. Lift away the rubber sealing diaphragms G and examine each diaphragm closely. In case of any rips or tears in the diaphragms, they must be replaced.

It is strongly recommended to always replace the diaphragms during inspection. If unavailable, new diaphragms may be made from three layers of 2 mm thick oil and temperature resistant rubber.

Remember to fit new locking plates at screws A.

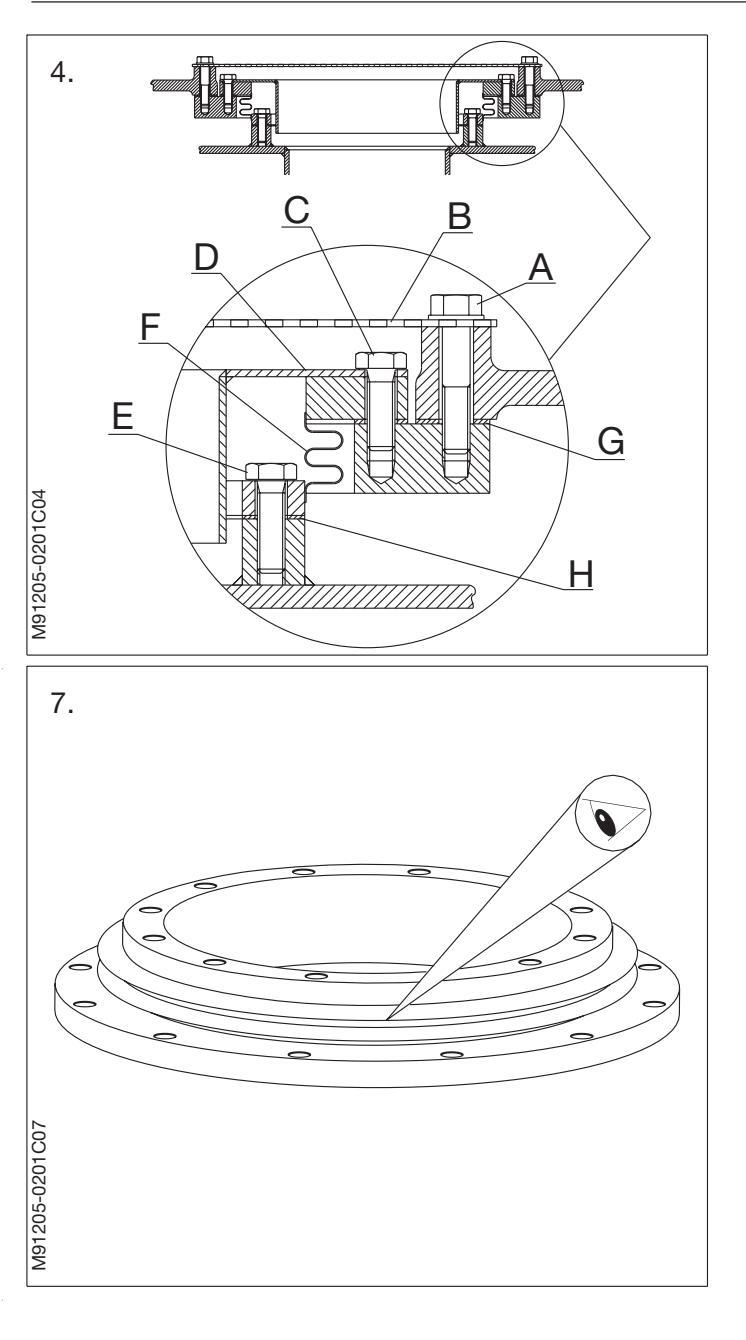
Metal bellow sealing

- 4. Remove all screws A and grating B.
- 5. Remount four of the screws A at diametrically opposite positions.
- 6. Remove: Screws C Cover plate D Screws E.
- 7. Lift away metal bellow sealing F and examine it closely. If any cracks or punctures are found in the metal bellow sealing, it must be replaced.

It is recommended to always replace the metal bellow sealing during inspection.

- 8. Replace gaskets G and H.
- 9. Mount metal bellow sealing F.
- 10. Mount: Screws E Cover plate D Screws C.
- 11. Remove the four screws A.
- 12. Mount grating B.
- 13. Mount all screws A.

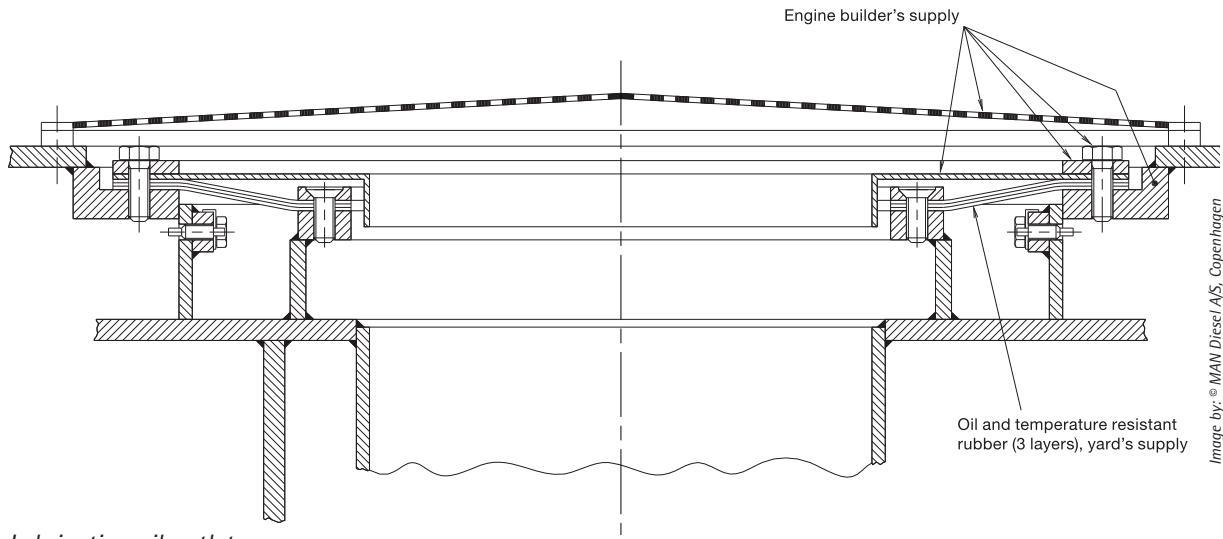
Failed diaphragm

Deteriorated diaphragm

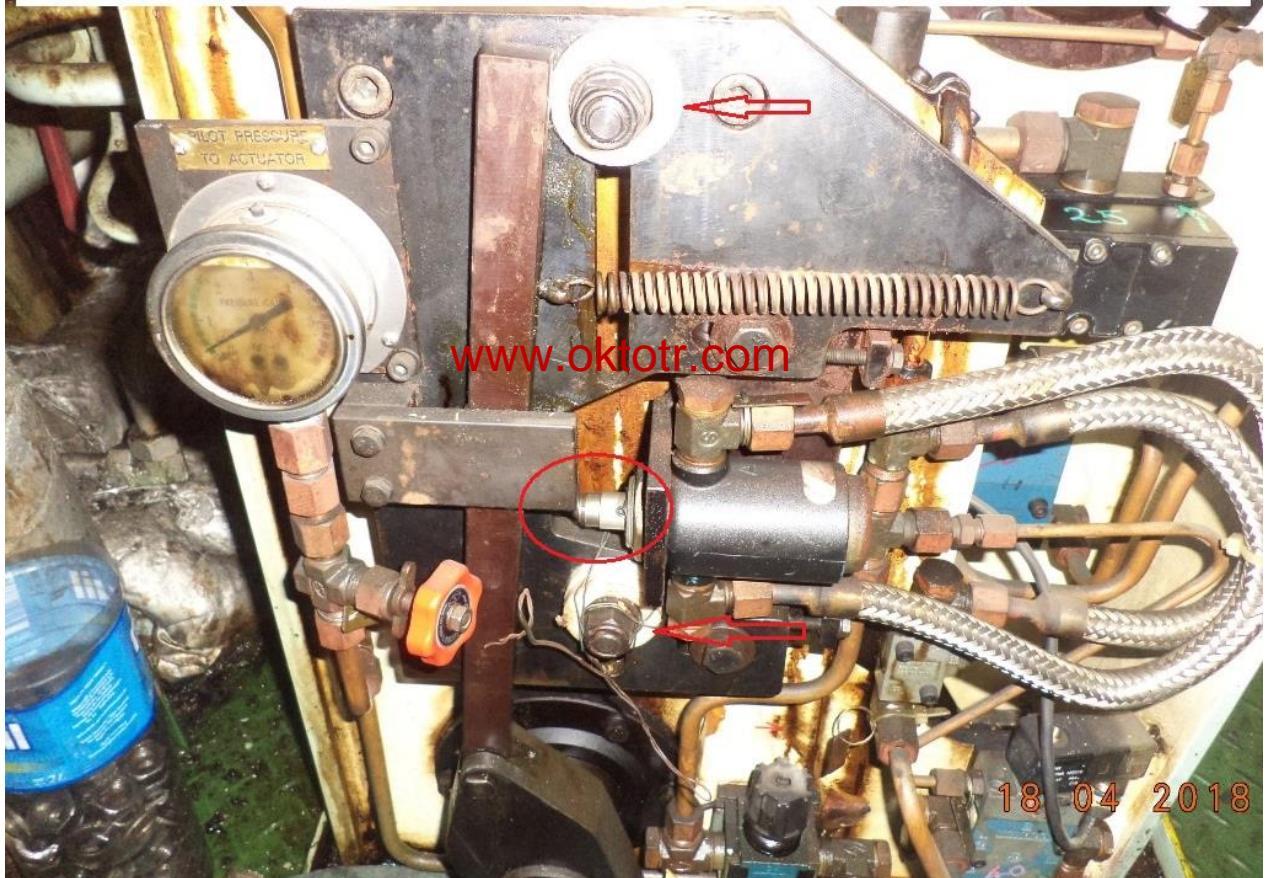
VIT SYSTEM FOUND AS BELOW.TEFLON RINGS INSTALLED, TIGHTENED WITH WIRE.IT IS NOT POSSIBLE TO ARM PUSH THE VIT CONTROL VALVE. VIT CAN NOT WORK.

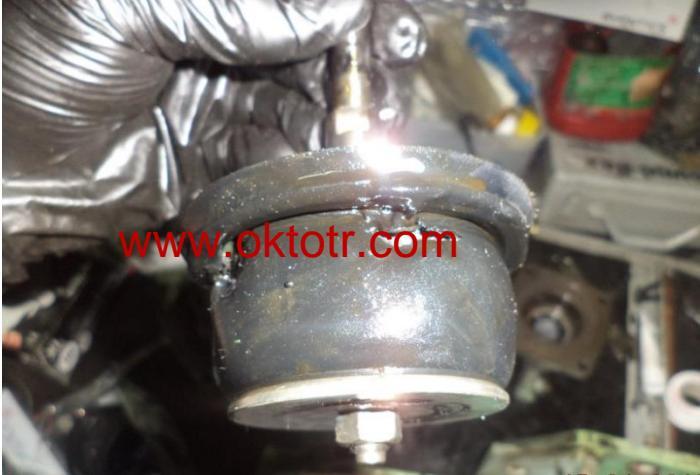
SCRATCH ON VIT ACTUATOR SPINDLE

TEAR ON VIT ACTUATOR DIAPHRAGM

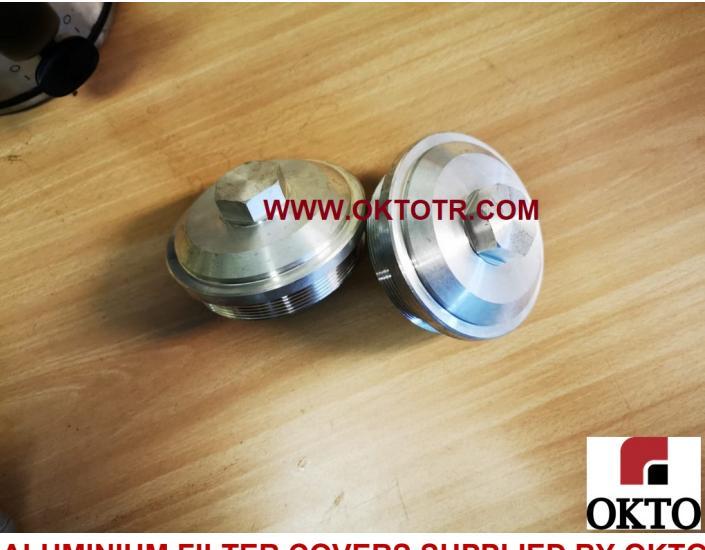
BROKEN FILTER COVERS

ALUMINIUM FILTER COVERS SUPPLIED BY OKTO

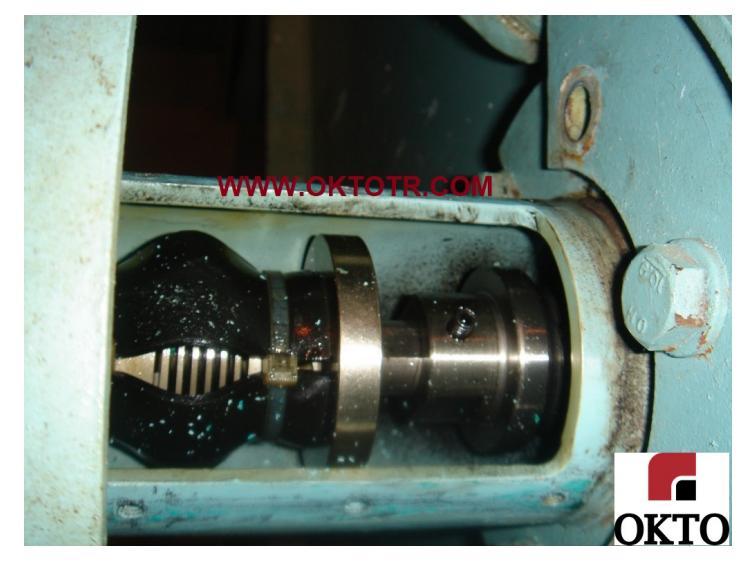
MALADJUSTED ENCODER

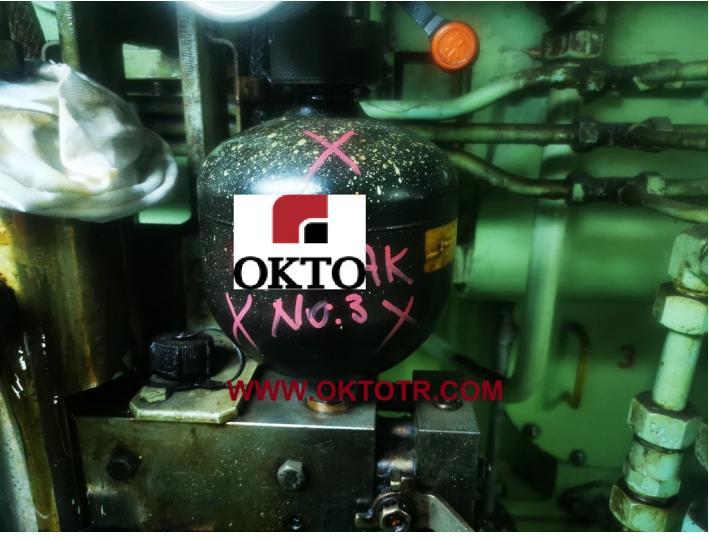
BURST OR DE-PRESSURIZED ACCUMULATORS

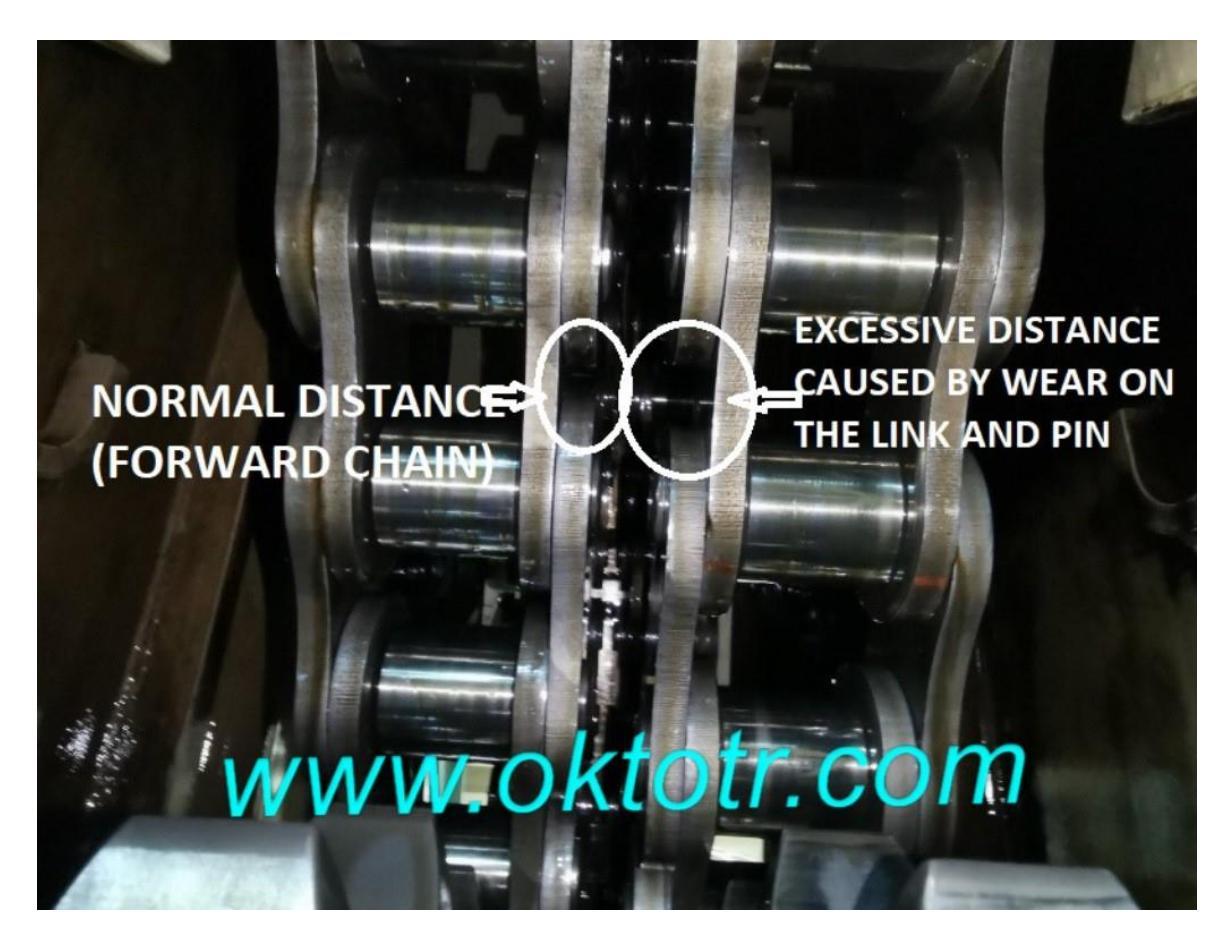
DEFECTIVE LINK

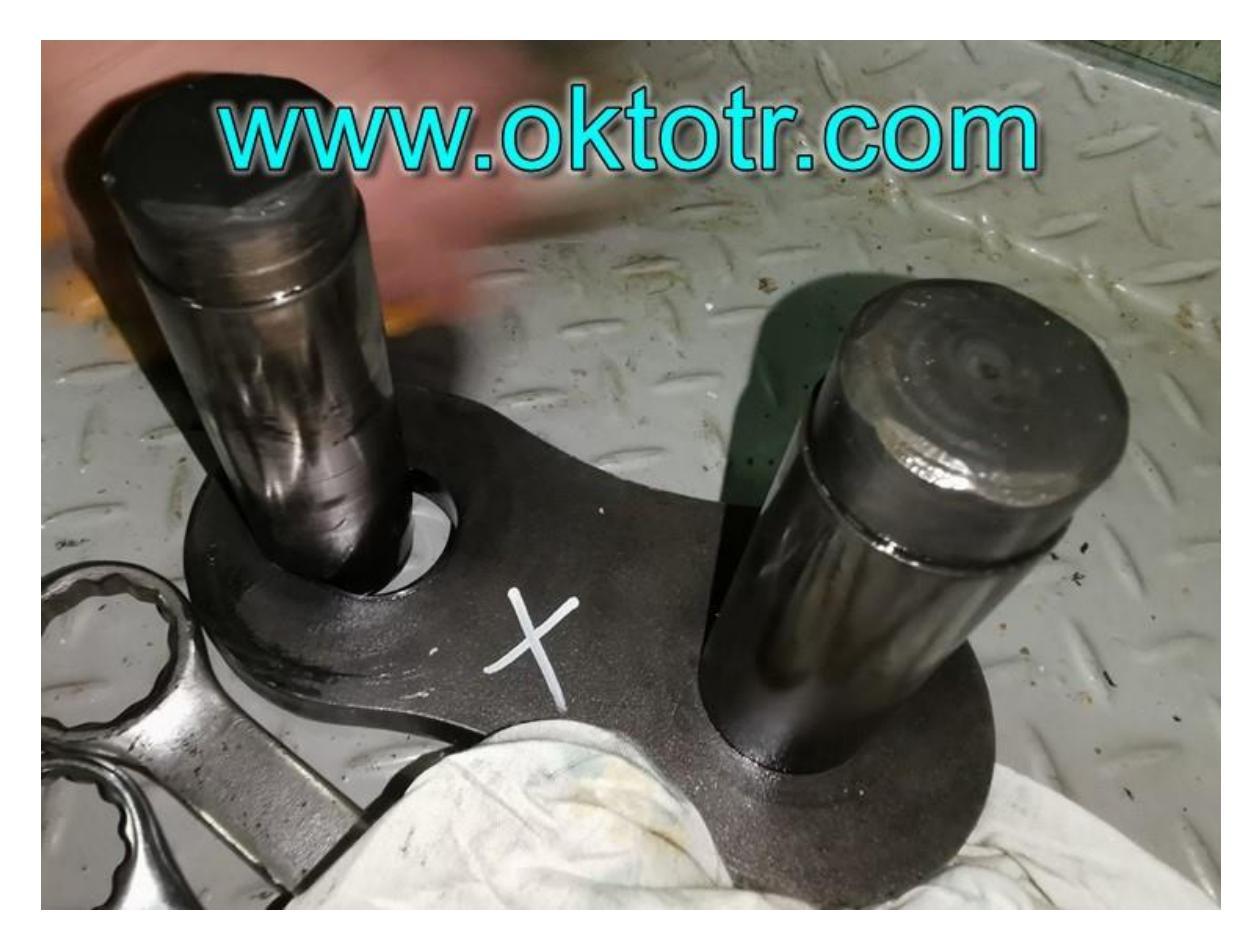
CHAIN LINK ABOUT TO DETACHED

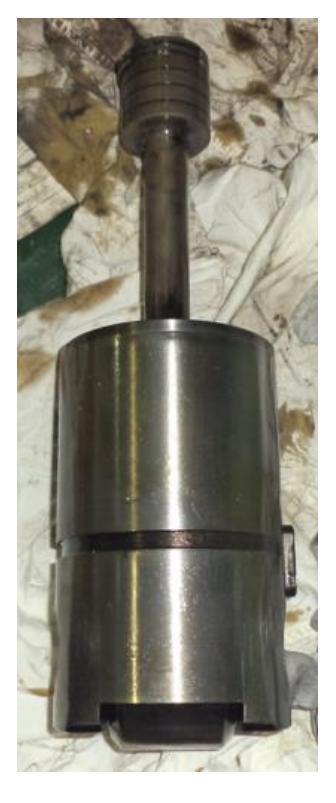
EXHAUST ROLLER AT DISMANTLED CONDITION(FOR REFERENCE ONLY) MEASUREMENT CAN BE TAKEN ON THE TOP OF THE PISTON WITHOUT REMOVING OIL CYLINDER AND ROLLER

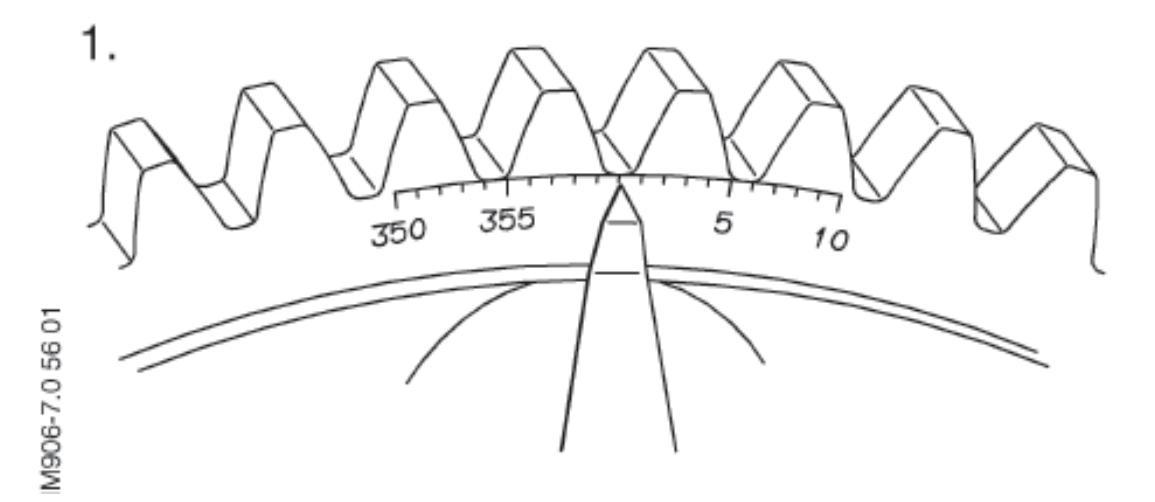
READ AND NOTE THE ANGLE ON THE TURNING WHEEL (NO:1 CYL AT TDC AT ILLUSTRATION)

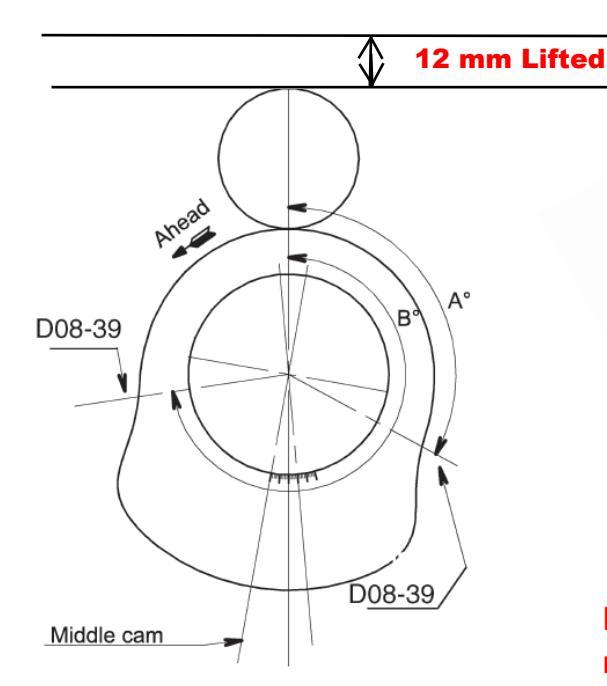
Fig.1 Subject cylinder at TDC

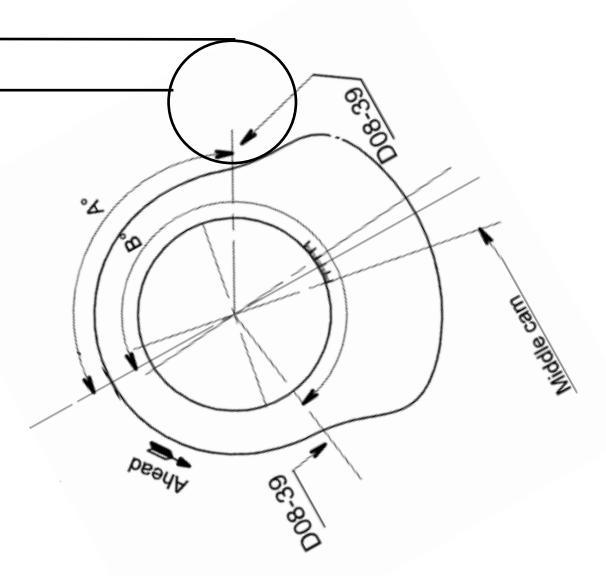
Fig.2 Exhaust cam has turned A degree until roller has lifted to determined value(113,70 deg and 12,00 mm in our example) .

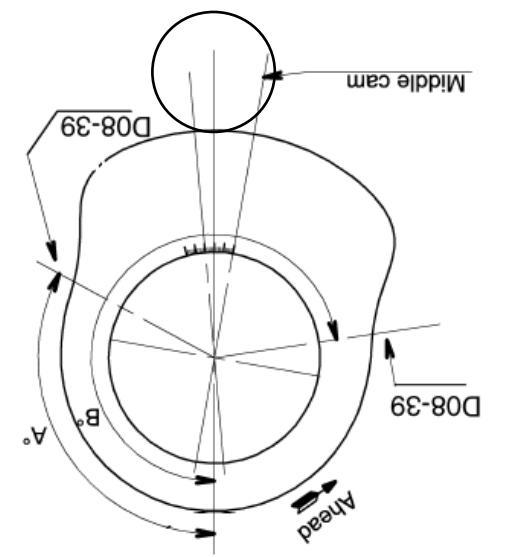
Fig.3 Exhaust cam further turned. Roller at highest point.

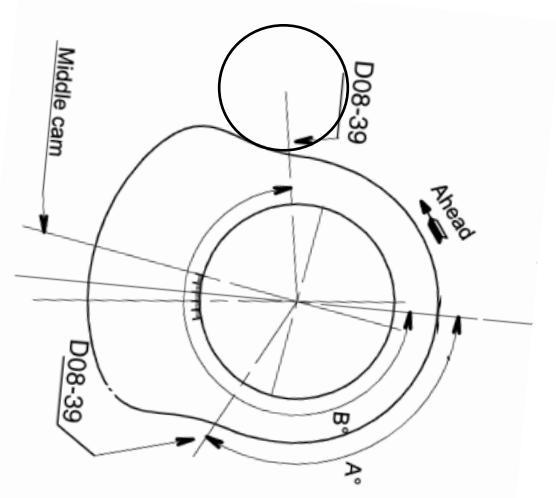
Fig.4 Exhaust cam turned total B degrees (258,30 deg.in our example) and same roller height (12 mm) with Fig.2 obtained.

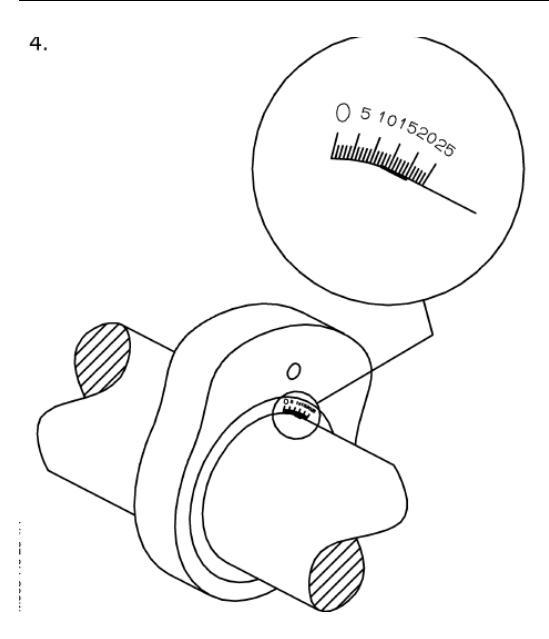
Several incidents reported that some or all the exhaust or fuel cams lost their correct position due to roller damages. In that case, cams in questions to be adjusted back to correct position.

Recommendation:

- 1. One of the common reason of the roller damages is malfunction of the reversing system. In case the reversing is not complete or doesn't take place, forces acting on the roller guide and reversing arm is so high that it can cause such damage to the components. Adjustment of the reversing arms to be checked during overhaul of the roller. Please see service letter SL1988-243 in line with maintenance manual related section in Plate no 909.

- 2. Another possible reason of the roller damages is water leakages to roller sections. In case no effective sealing between roller housing and engine frame, and excessive water leak from cooling jackets with blocked drains, it is possible to water enter to roller housing and brake the oil film which result stuck of the roller. Therefor it is very important to keep engine free from any leakages and make sure drain holes not blocked by foreign materials.

- 3. Roller overhaul and inspection should not be skipped and to be completed together with fuel pump overhauls. Crack tests will inform you in advance if any crack developed on the rollers which will cause damage in due course. Loose guide blocks also will cause misalignment and damage of the roller. Please see service letter SL1997-345 for more info.
